AUDIT SURVEYS IN THE NRA THAMES REGION

A report on the surveys carried out in 1992/93 to assess the retention and enhancement of
wildlife habitats during routine dredging operations

Angela M. Walker
April 1993

NRA THAMES REGION : AUDIT SURVEYS 1992/93

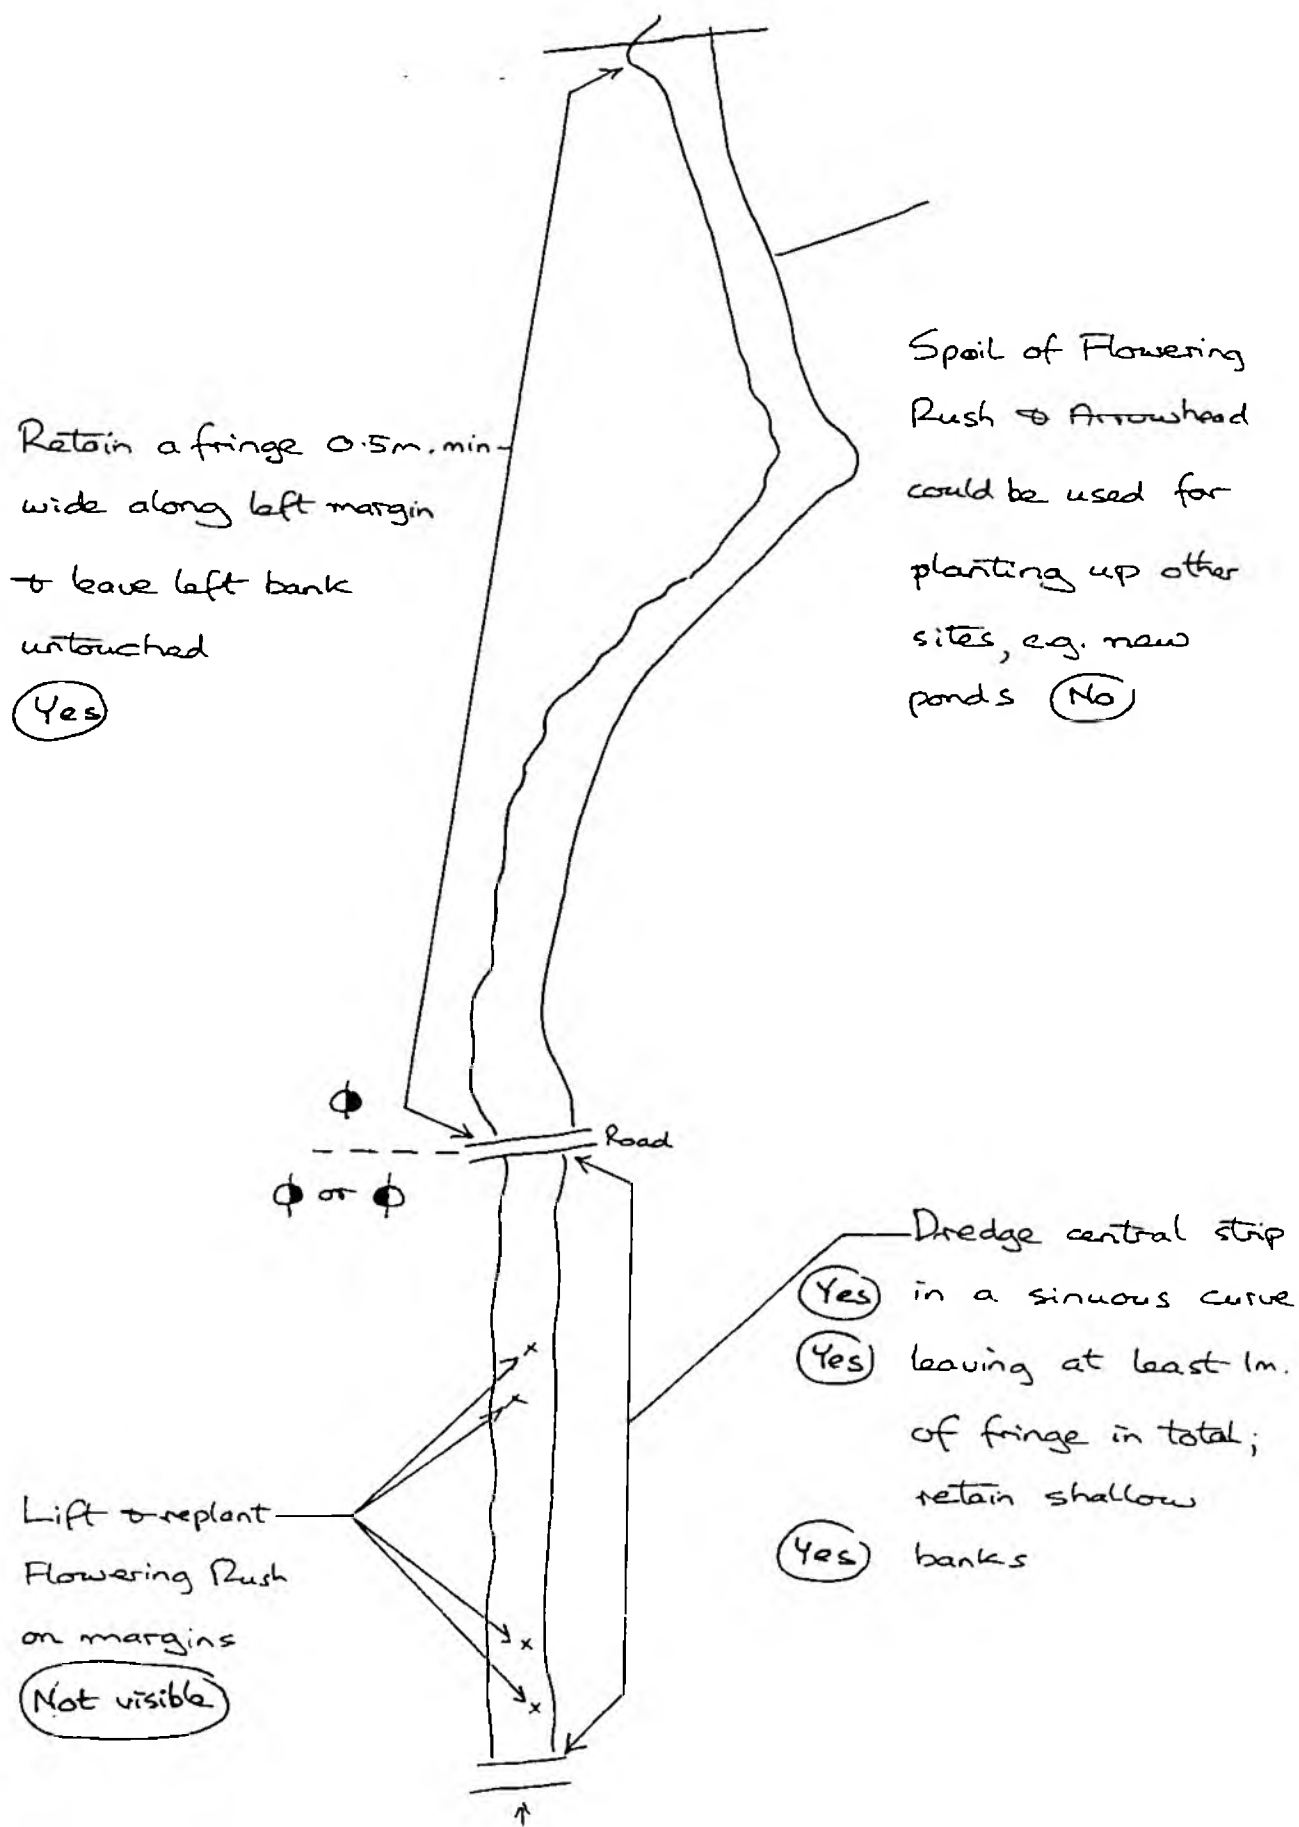
BISHAM BROOK DREDGING RECOMMENDATIONS (3)

Retain a fringe 0.5m. min. wide along left margin
to leave left bank untouched
(Yes)

Spoil of Flowering Rush & Arrowhead could be used for planting up other sites, e.g. new ponds (No)

Lift & replant Flowering Rush on margins
(Not visible)

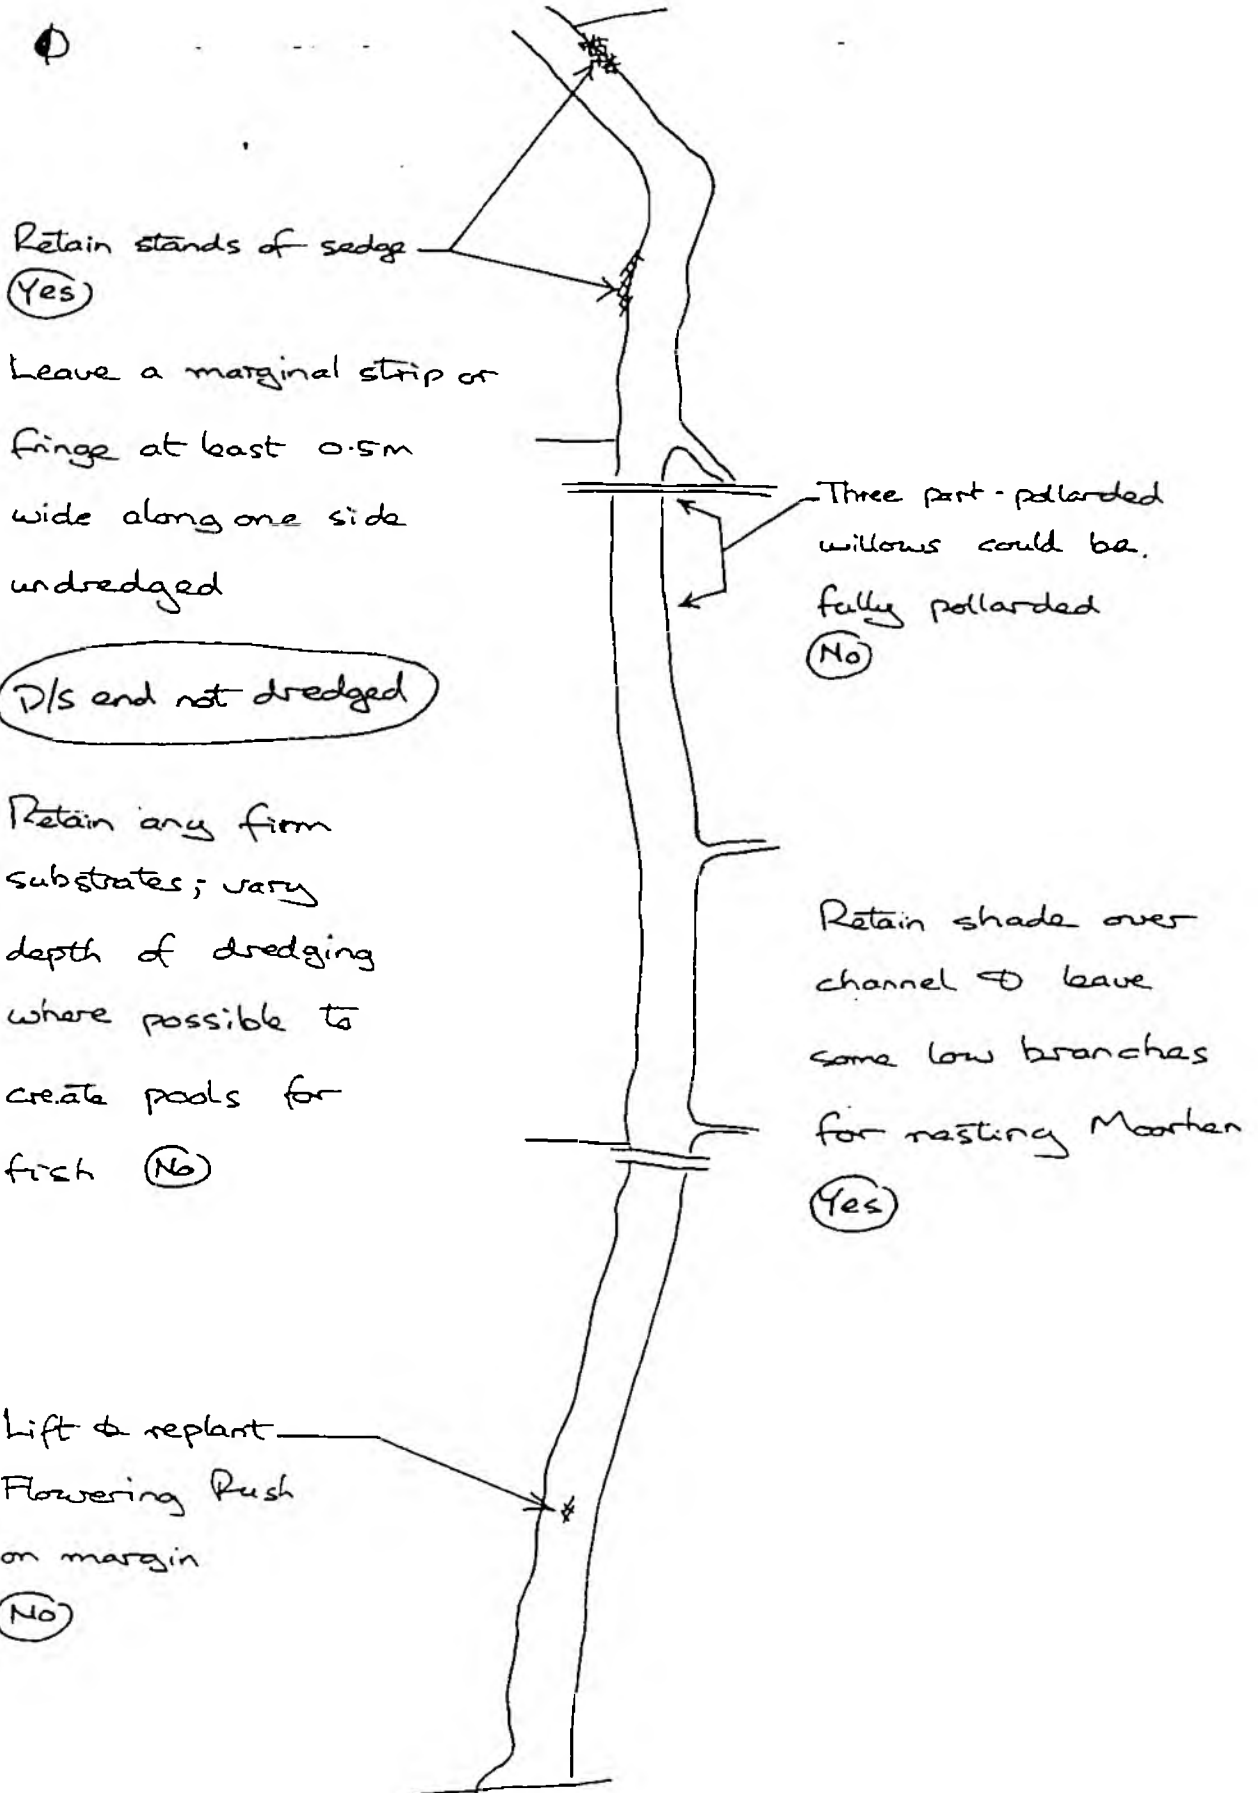
BISHAM BROOK DREDGING RECOMMENDATIONS (4)

Retain stands of sedge
(Yes)

Leave a marginal strip or fringe at least 0.5m wide along one side undredged
