Riverbank Protection Using Willows Scoping Study

Research and Development
Technical Report
W154

Scoping Study

Technical Report W154

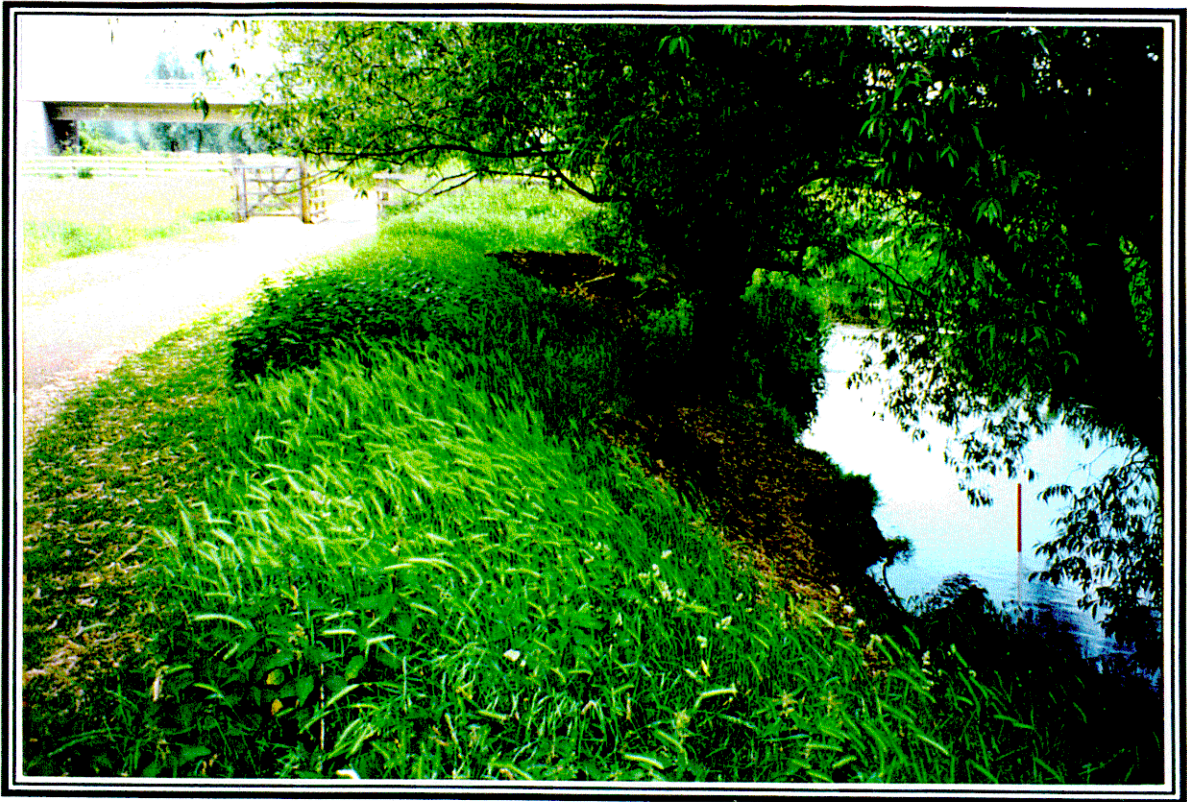
Plate 1: River Ouzel (Milton Keynes Valley Park) - erosion of banks behind the mature willows, *S. alba*

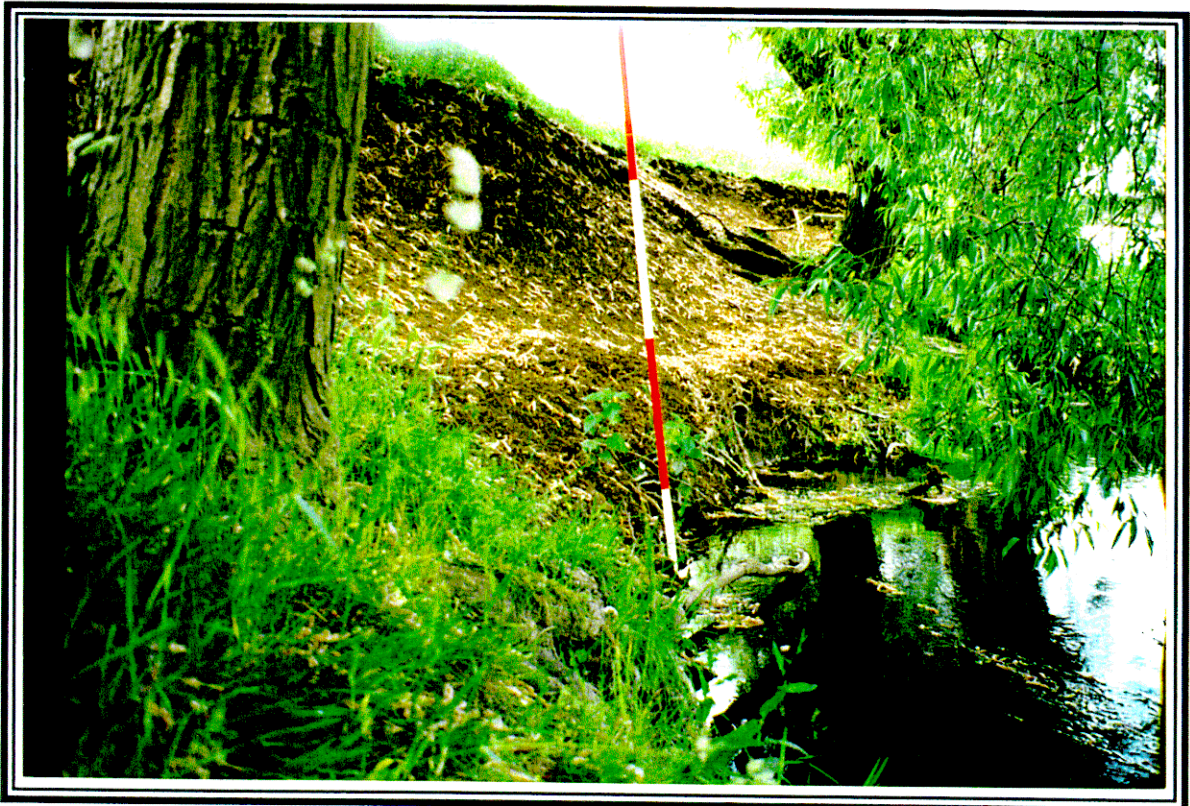
Plate 2: River Ouzel (Milton Keynes Valley Park) - corrosion (and not rotational slide) appears to be the process. Note the exposed lateral roots of the distant willow and the mature, rigid bifurcating roots of the nearside willow

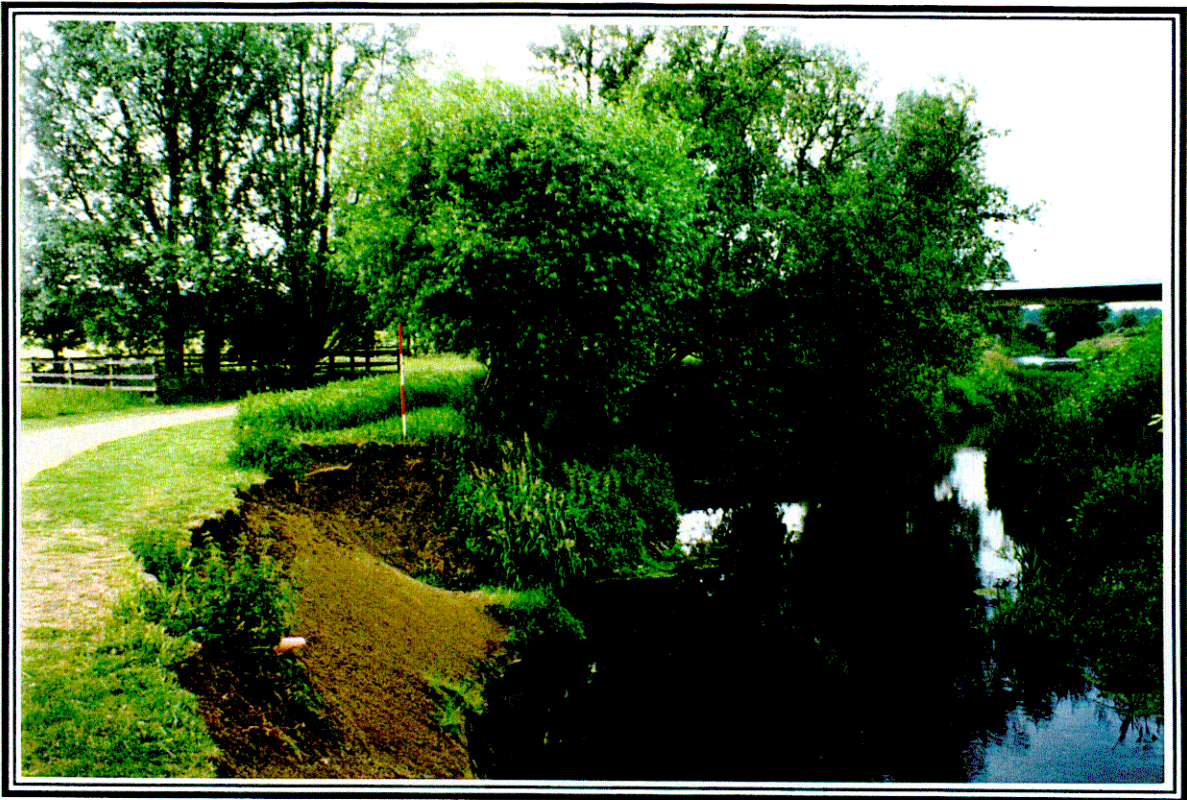
Plate 3: River Ouzel (Milton Keynes Valley Park) - traditionally pollarded willow in the foreground with un-pollarded, yet mature, willows beyond. Note the extreme erosion before the pollarded willow, and under the un-pollarded willows. Note also the difference in herbaceous vegetation diversity between the willows

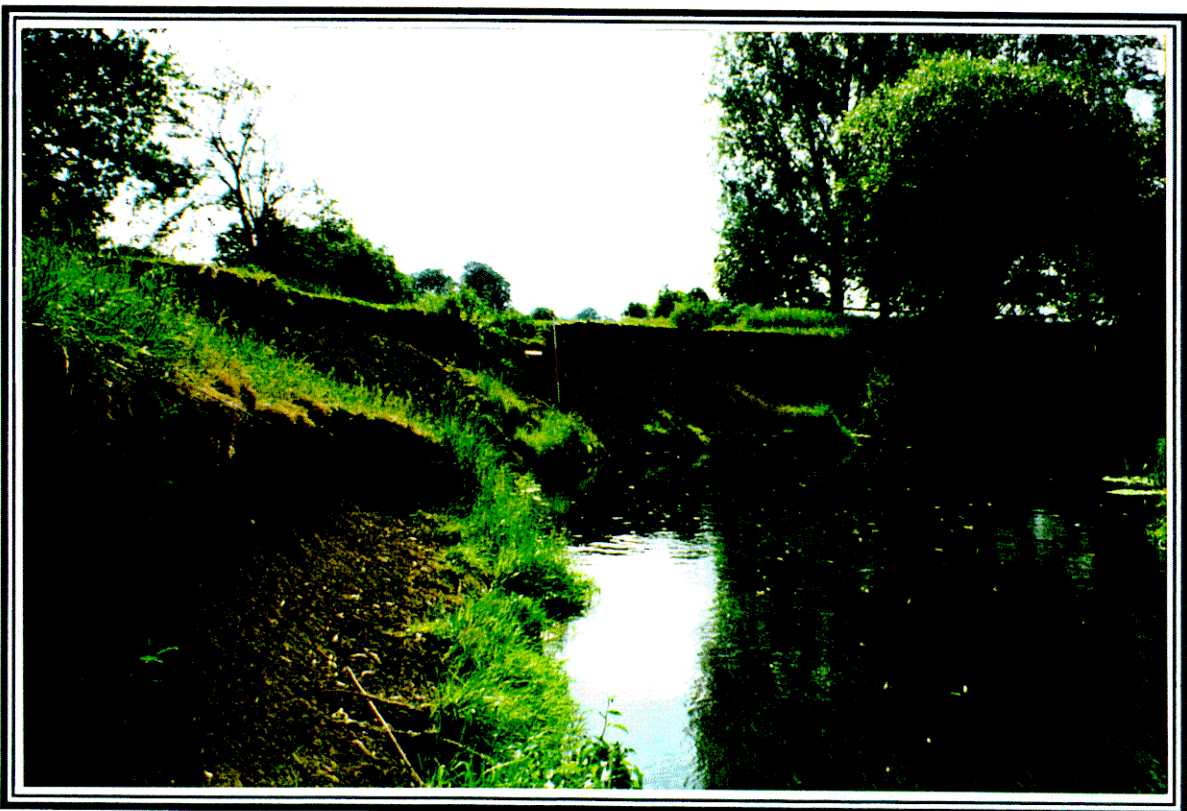
Plate 4: River Ouzel (Milton Keynes Valley Park) - note the mid- and upper-bank erosion

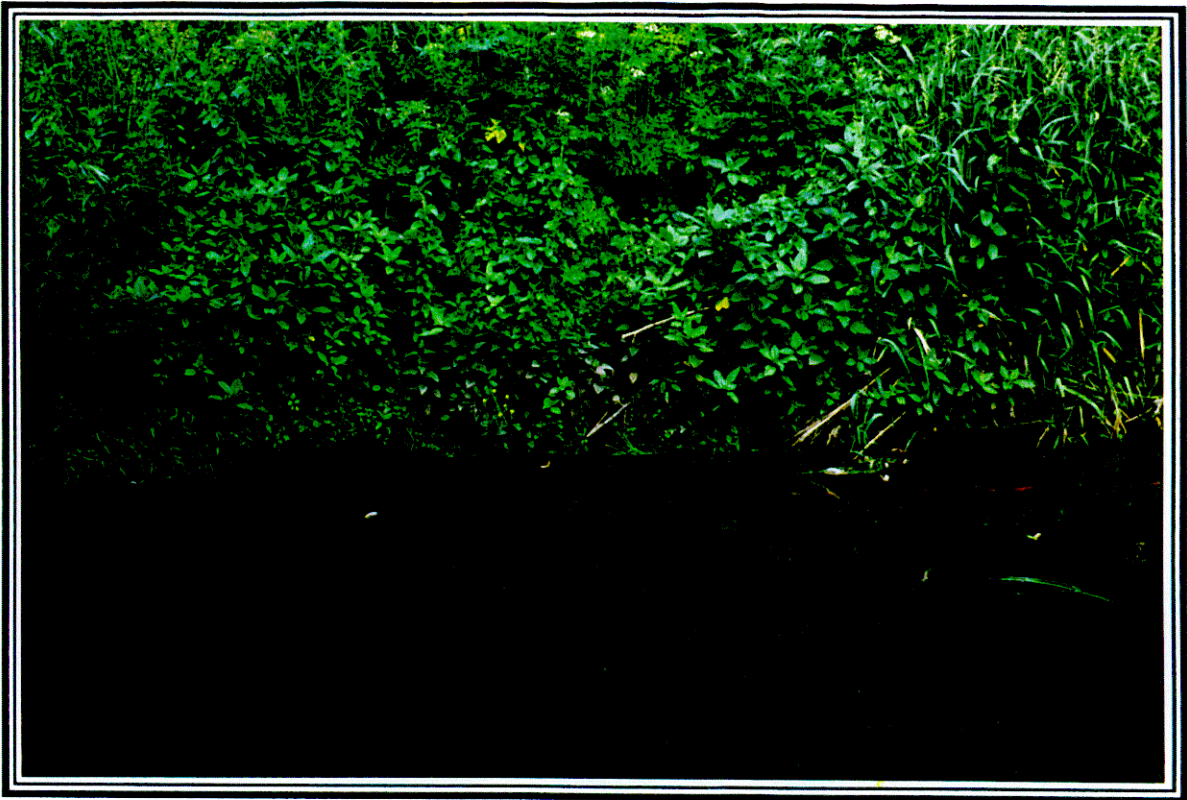
Plate 5: River Ouzel (Milton Keynes Valley Park) - well vegetated inner bank of meander band, unshaded by any trees

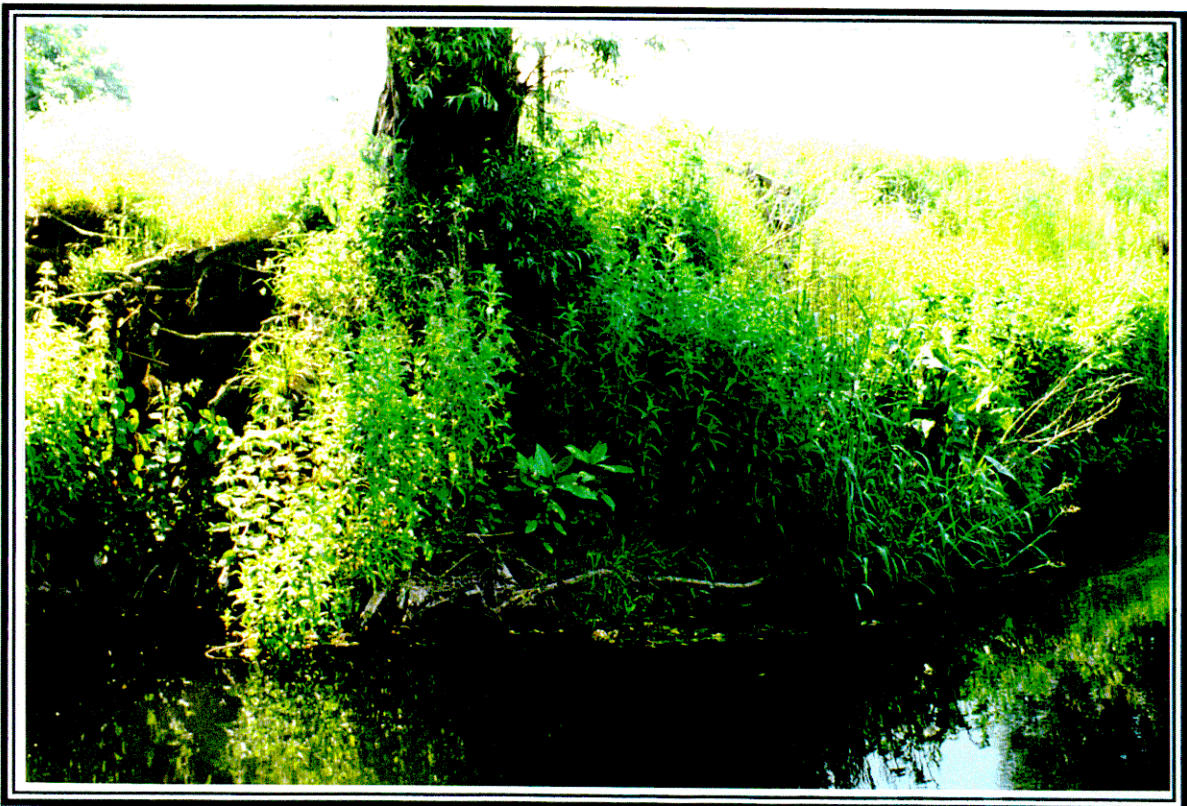
Plate 6: River Ouzel (Milton Keynes Valley Park) -note the exposed roots due to past erosion, and the diversity of herbaceous vegetation which has subsequently colonized the area of exposed roots

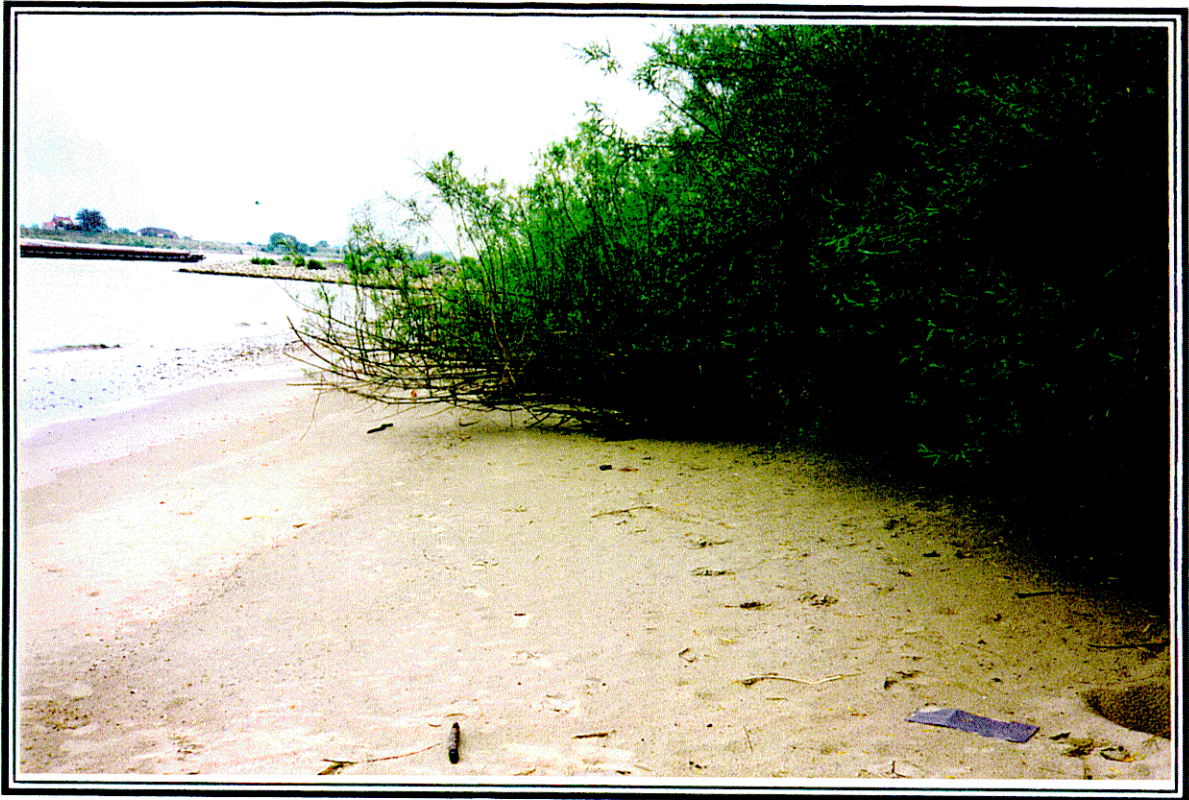
Plate 7: River Waal (Lower Rhine, Netherlands) - fallen willows at riverward edge of the stand. Willows to riverside have died due to inundation for 200+ days per year

There is a rule of thumb that 40 days is the temporal limit of submergence tolerance by willow roots (Mike Greaves, pers. comm.), but more rigorous testing of species tolerances and natural habitat preferences will advance knowledge of management applications. Field experience from the River Waal in the Netherlands indicates that willow bank protection certainly fails when plants are inundated for more than 200 days per year (Splunder, pers. comm., 1996).

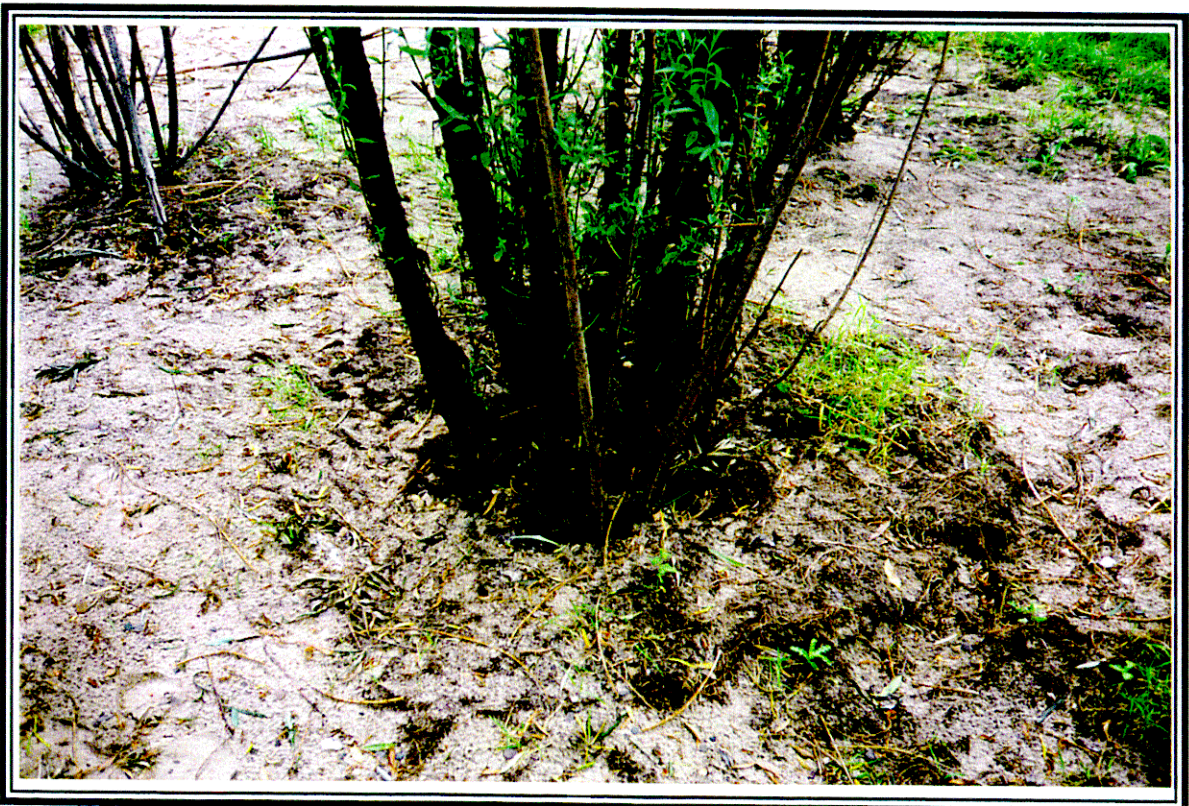
Plate 8: River Waal (Lower Rhine, Netherlands) - willow stand showing accretion of sediments and lack of understorey

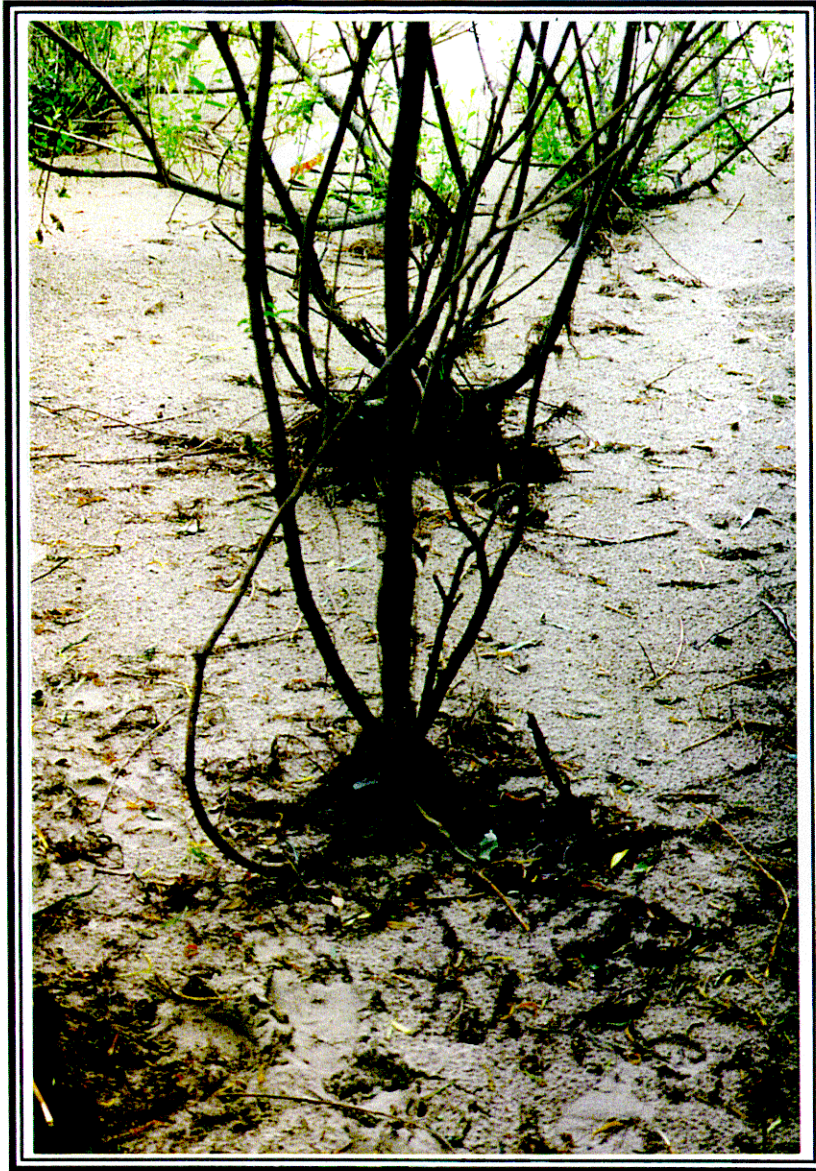
Plate 9: River Waal (Lower Rhine, Netherlands) - willow stand in eroding area at margin of protection plot

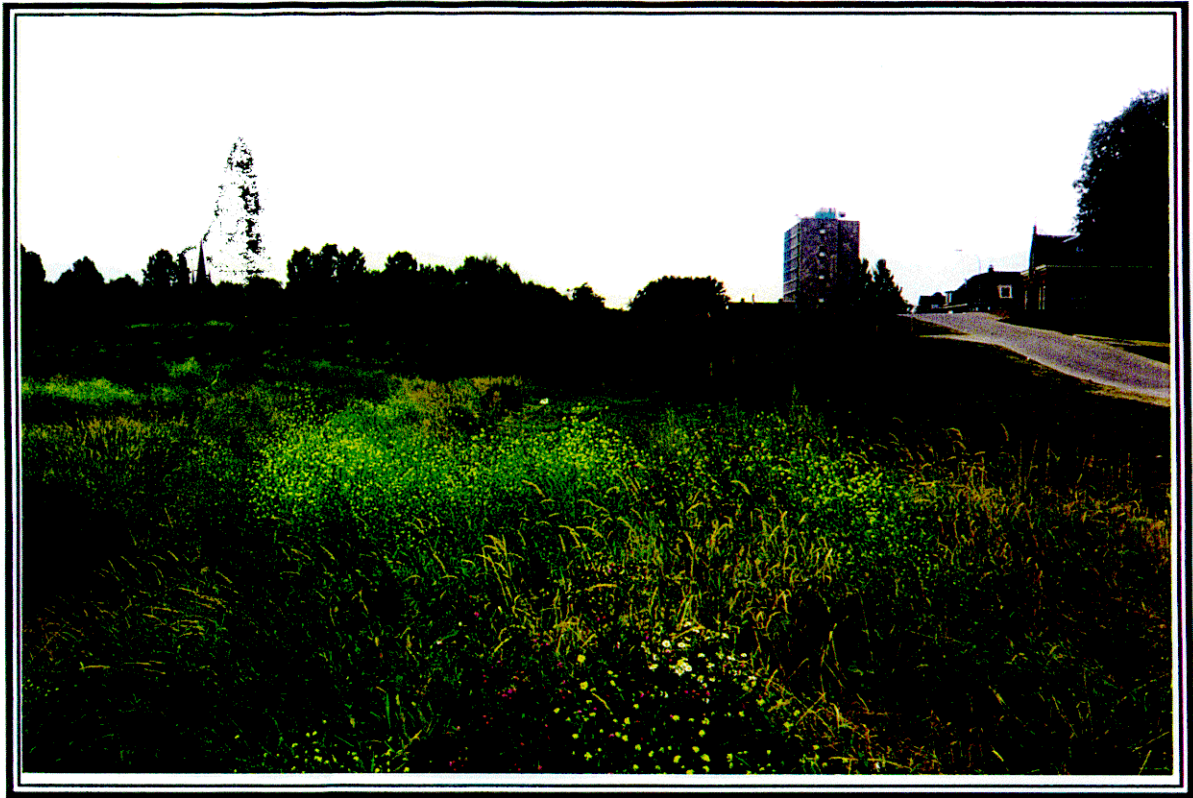
Plate 10: River Waal (Lower Rhine, Netherlands) - view south to main levee showing new construction and summer berm behind willow stand

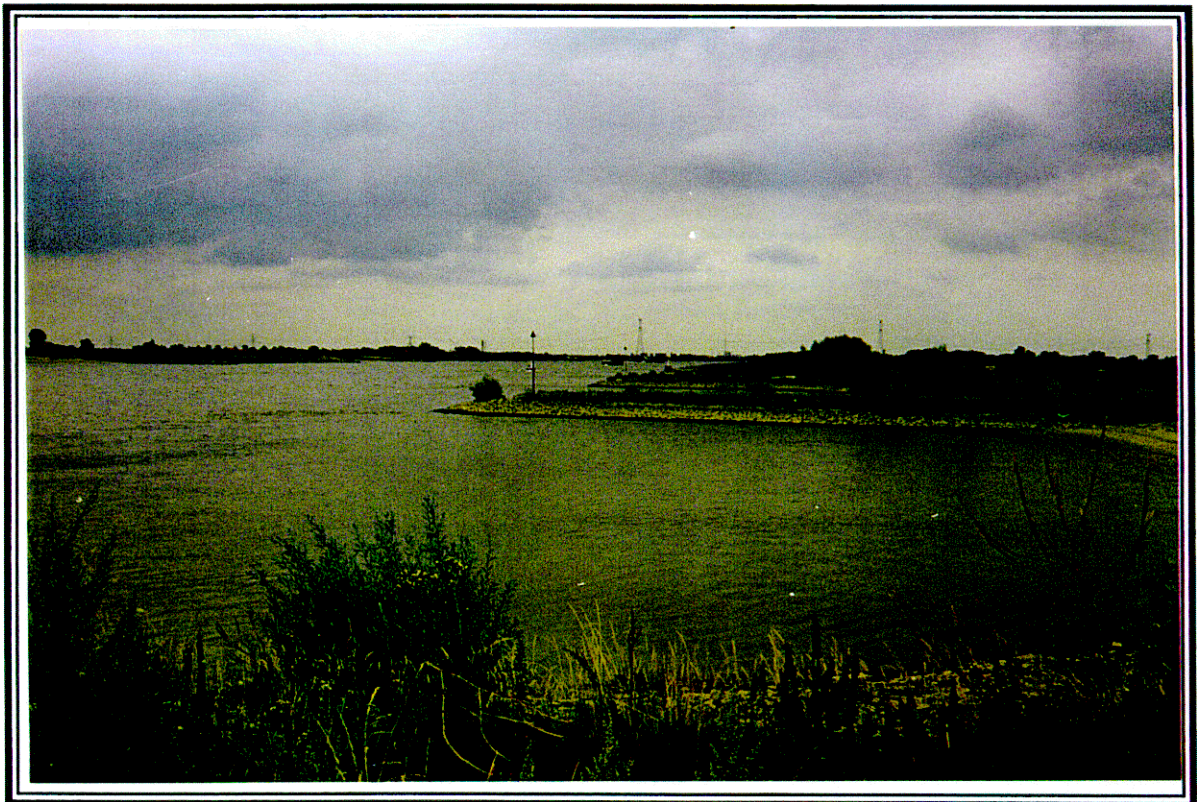
Plate 11: River Waal (Lower Rhine, Netherlands) -view upstream along bank to willow site in middle distance

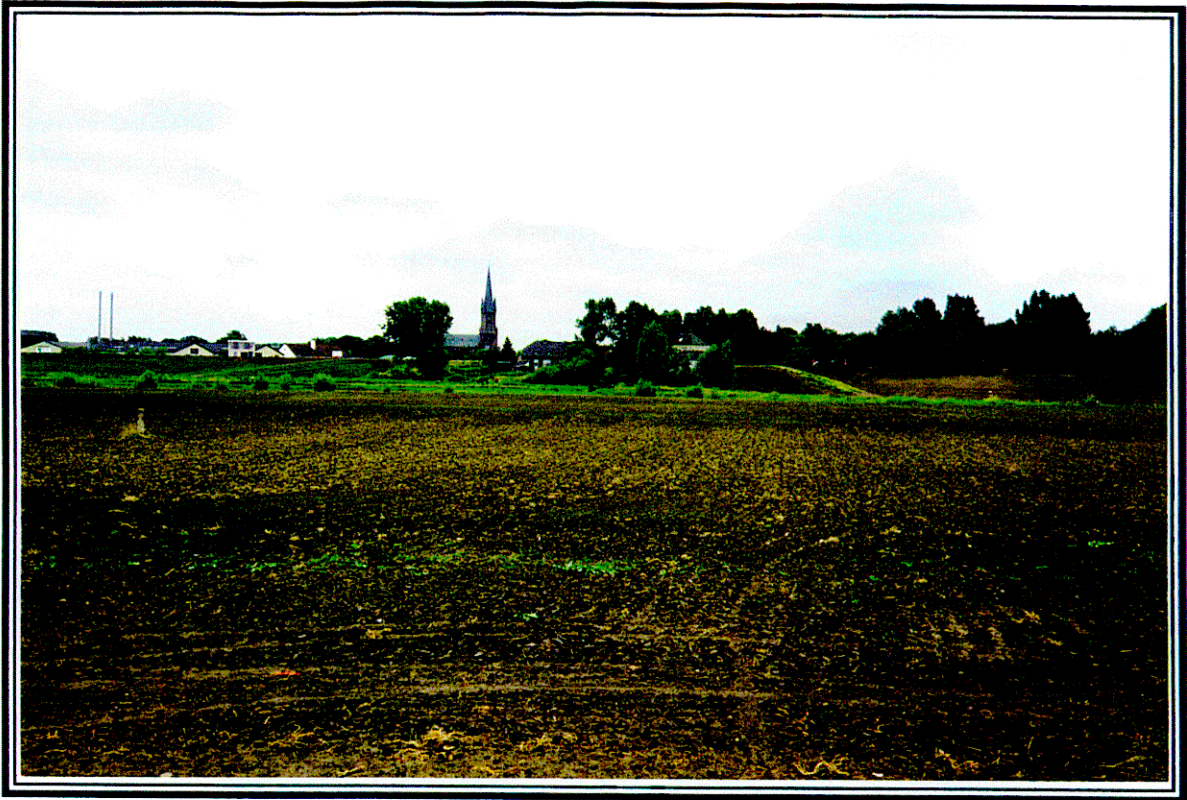
Plate 12: River Waal (Lower Rhine, Netherlands) - view south from willow site to main levee across the washland (flooded in winter and dry in the summer)

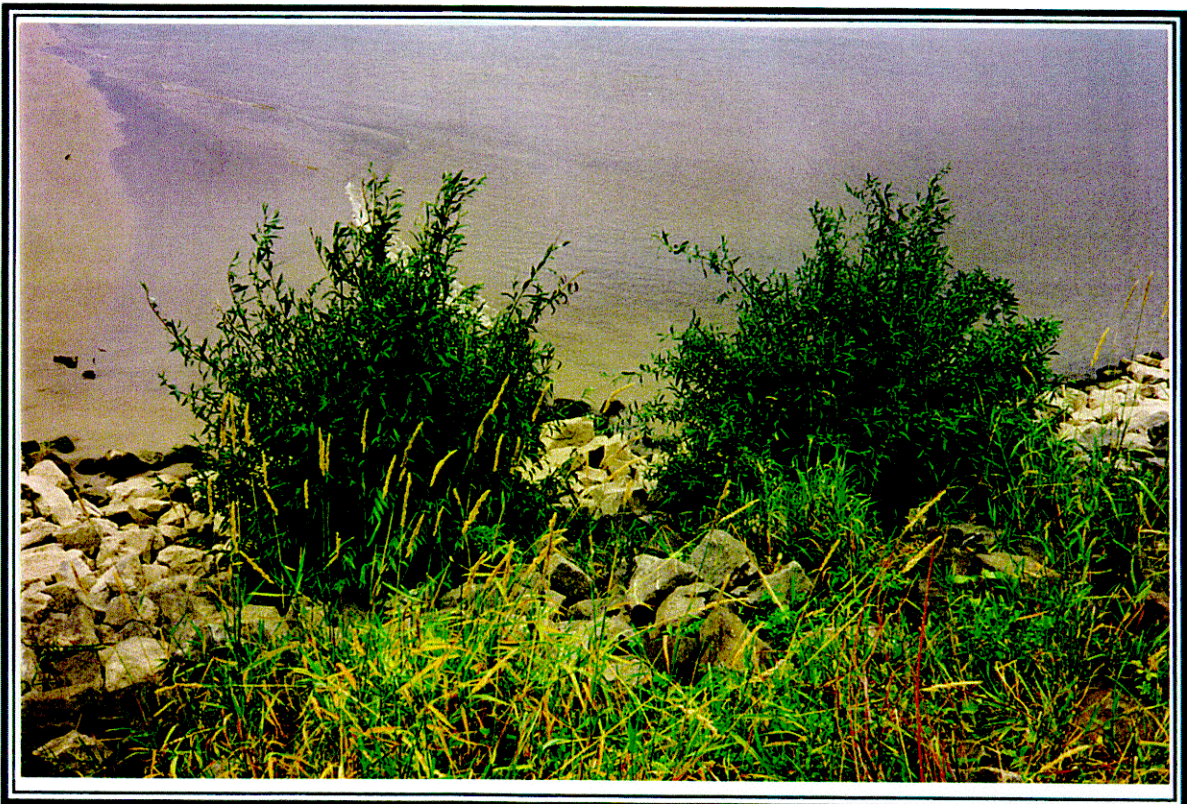
Plate 13: River Waal (Lower Rhine, Netherlands) - volunteer willows on a rock groyne

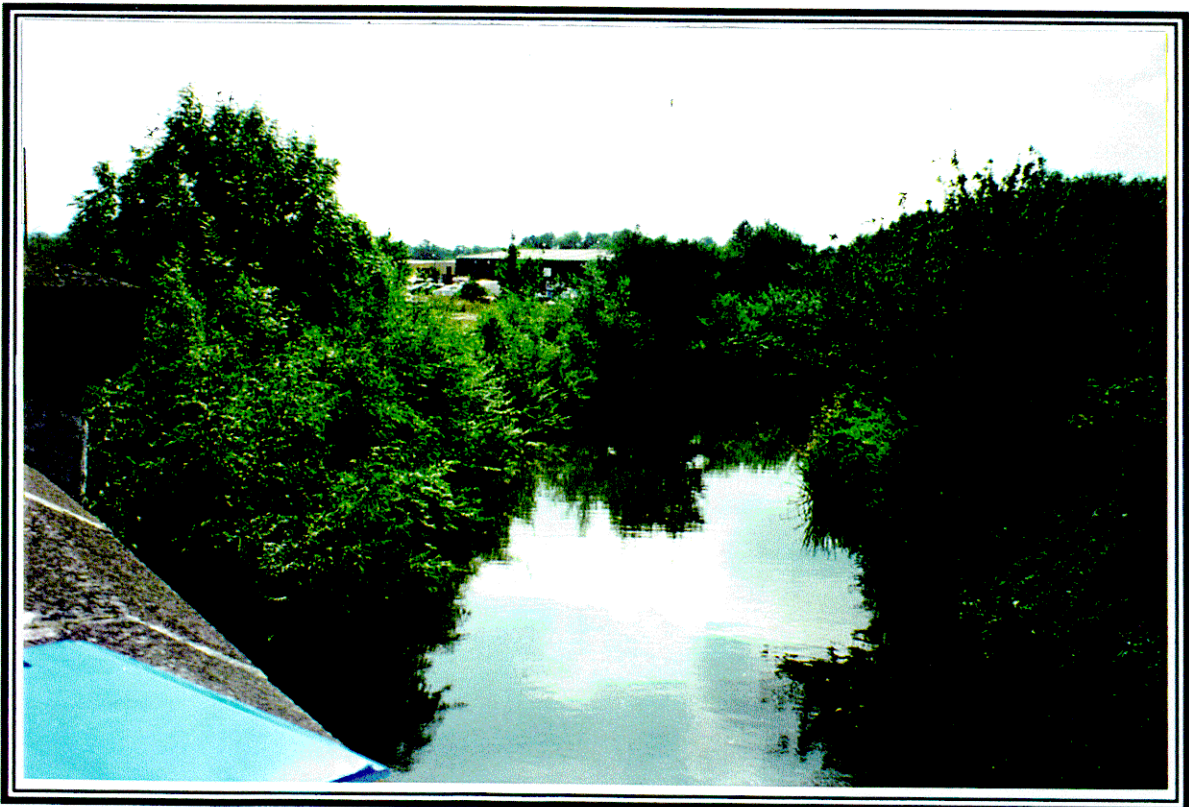
Plate 15: River Medway (Banbridge, Kent) - note the well established willow bank protection

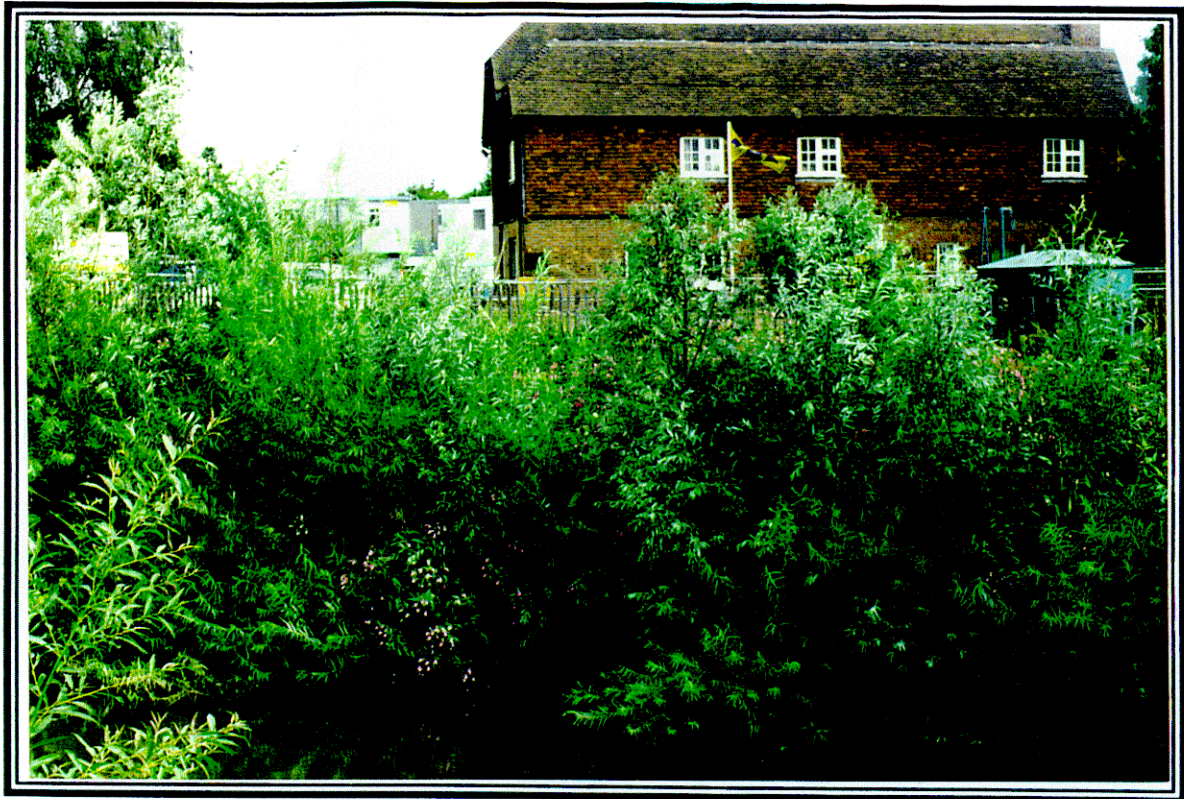
Plate 16: River Medway (Banbridge, Kent) - the willow spilings have grown, but note the excess horizontal growth of branches

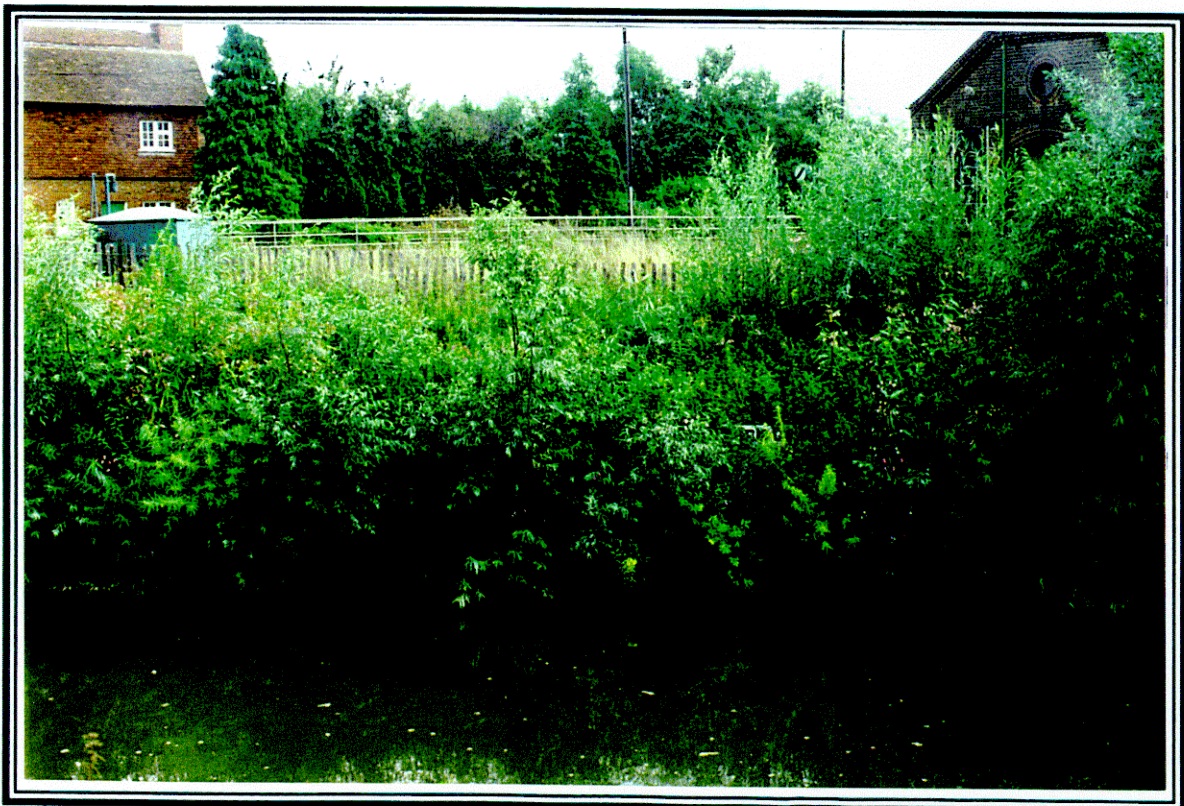
Plate 17: River Medway (Banbridge, Kent) - overhanging spiling may inhibit the establishment of semi-emergent fringe vegetation but may protect against undercutting

This caused concern among most interviewees (managerial, technical and conservation staff) on the long-term outcome of willow spiling as a mode of bank protection. Causes for their concern included the possibilities of wind-throw, excessive channel narrowing and formation of secondary currents increasing erosivity of the flow, as well as possible exclusion of fringe vegetation due to overhanging foliage.

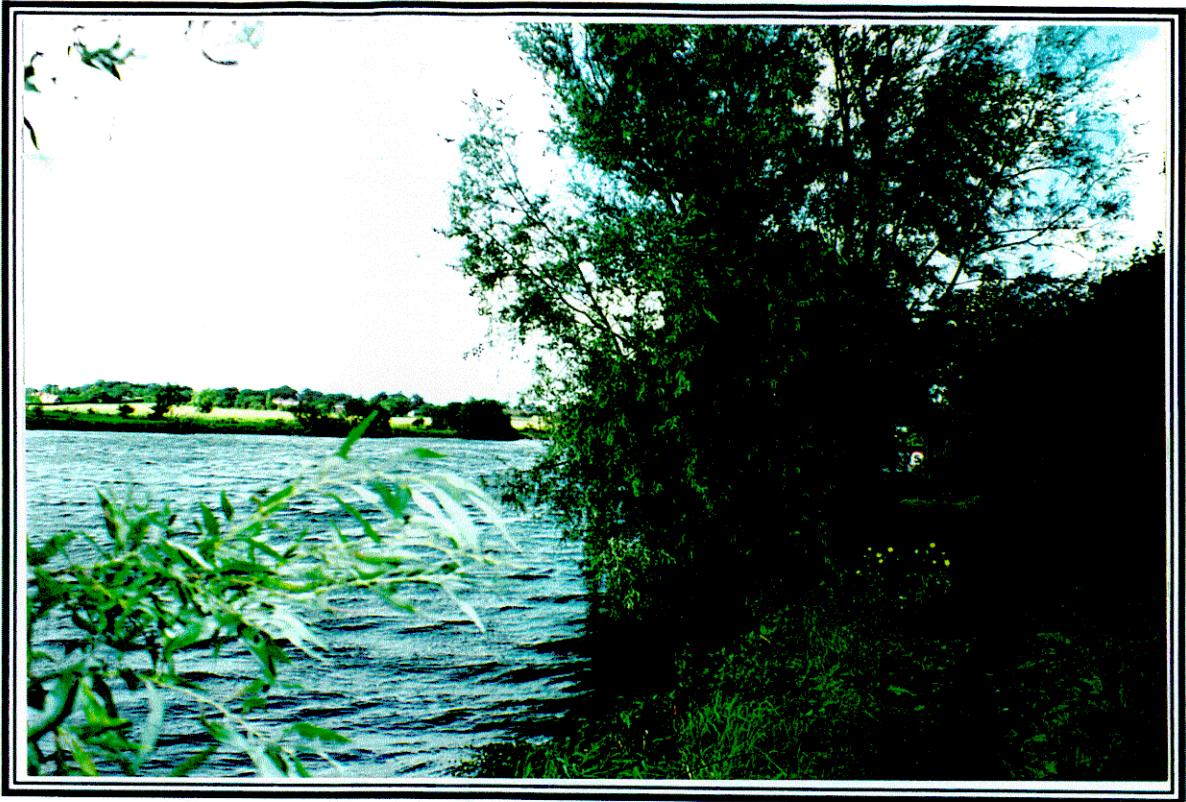
Plate 18: River Yare (Norfolk) - footpaths along bank with young shoots of a previously coppiced willow

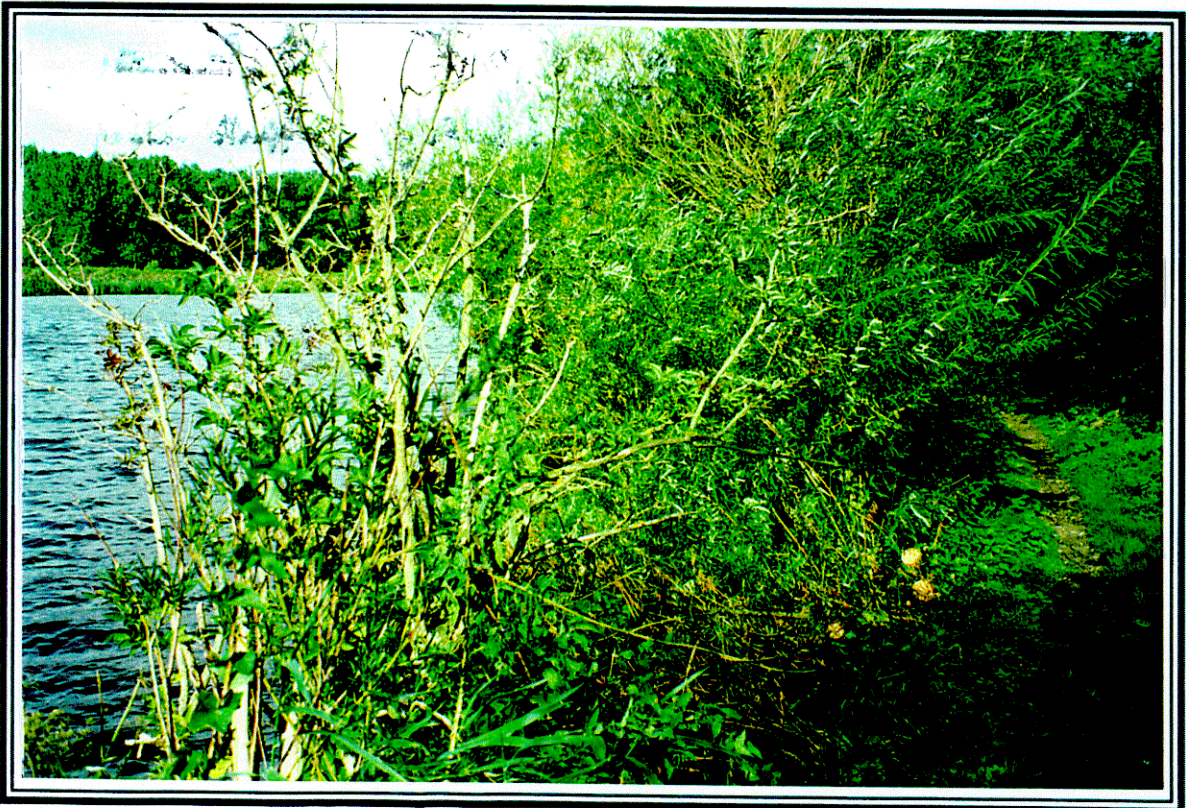
Plate 19: River Yare (Norfolk) - note the recent spiling with alder poles, willows and alder poles only

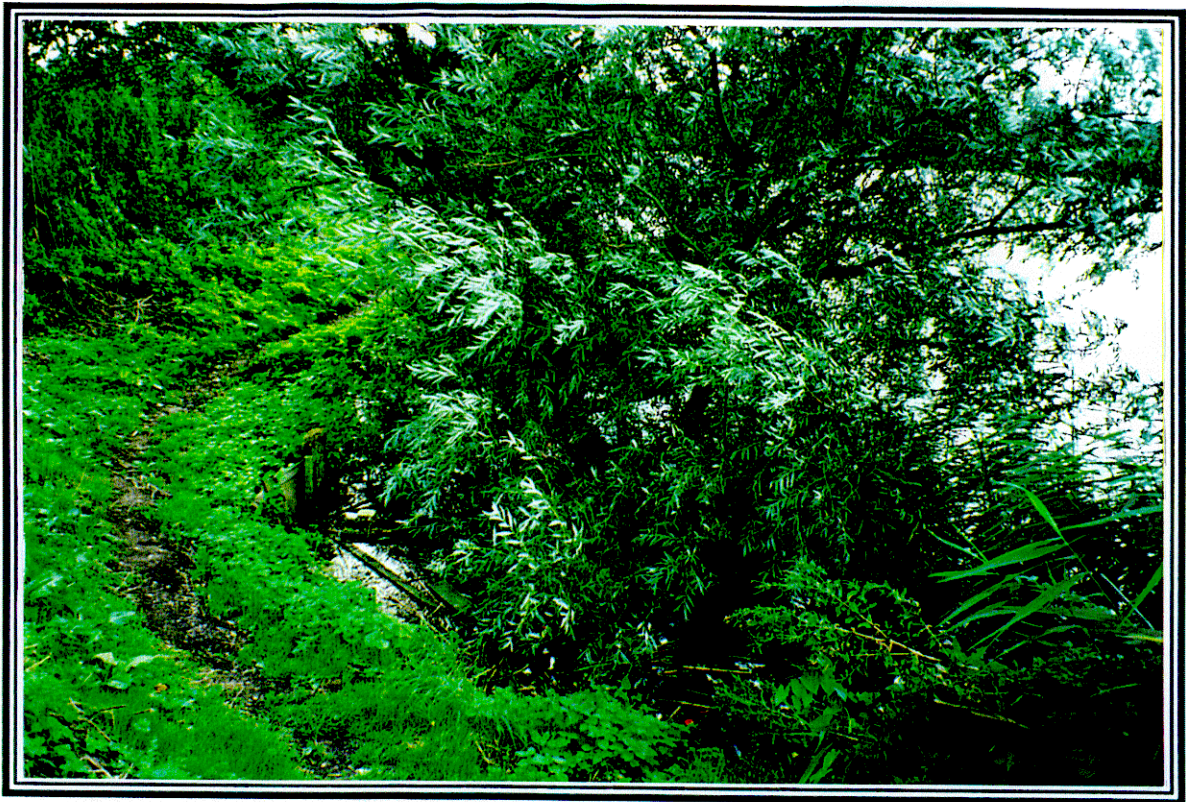
Plate 20: River Yare (Norfolk) - note the large willow leaning into the river, the attempts at wood piling and the large woody debris accumulated at the eroded bank

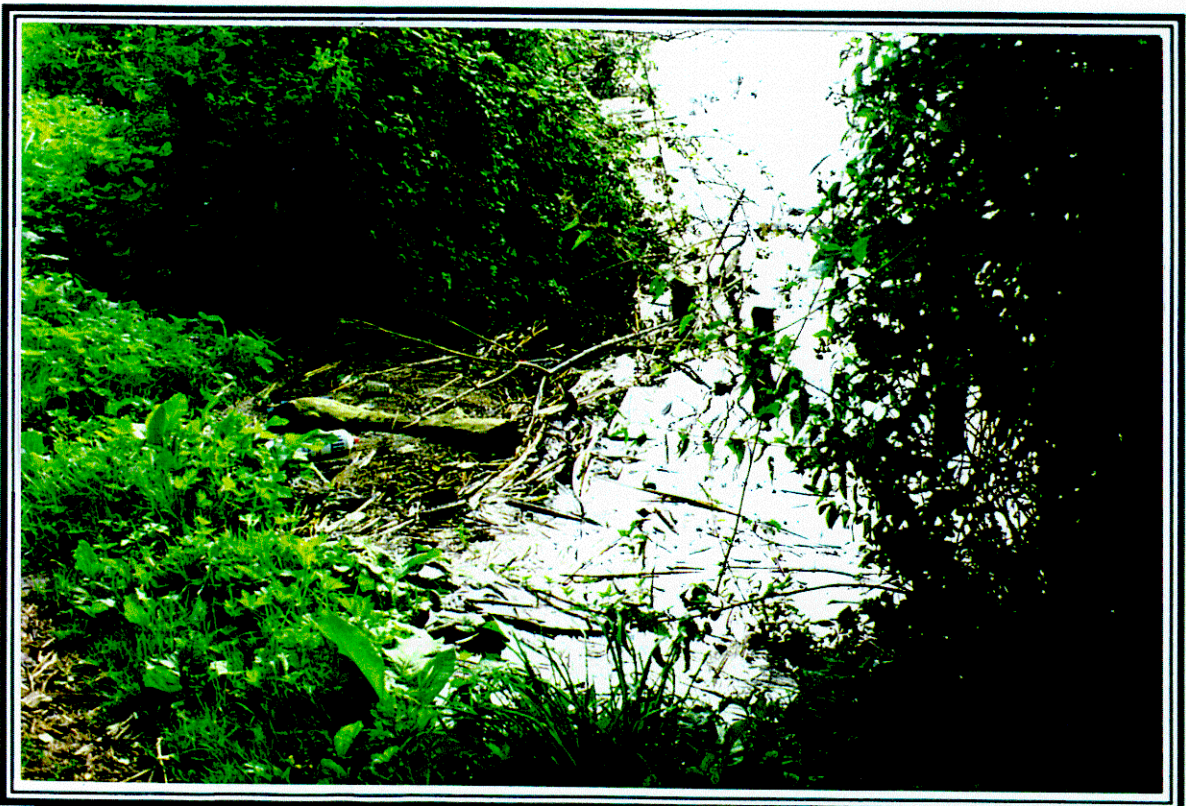
Plate 21: River Yare (Norfolk) - collection of woody debris in an erosion pocket between sections of heavily vegetated bank

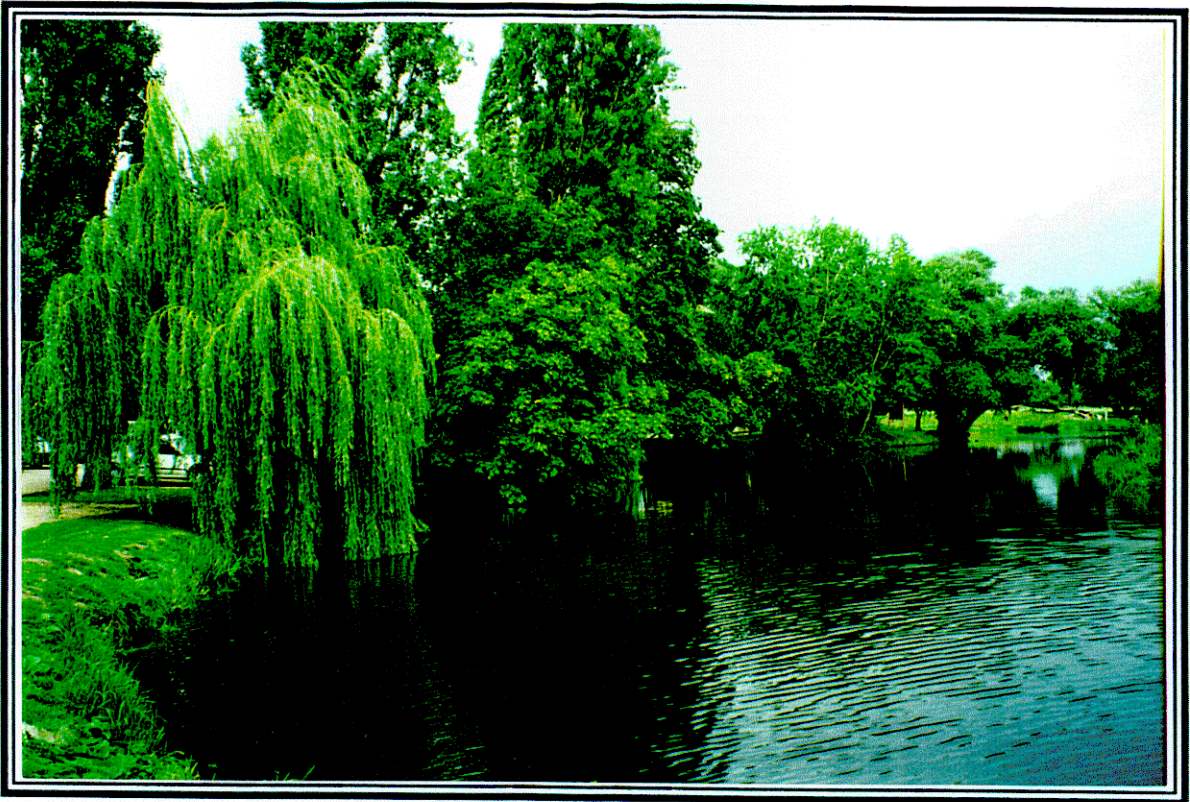
Plate 22: River Great Ouse (Brampton, Cambridgeshire) -note the stability of the bank even though on the outer bend of meander reach. There are five species of willow, as well as other tree species

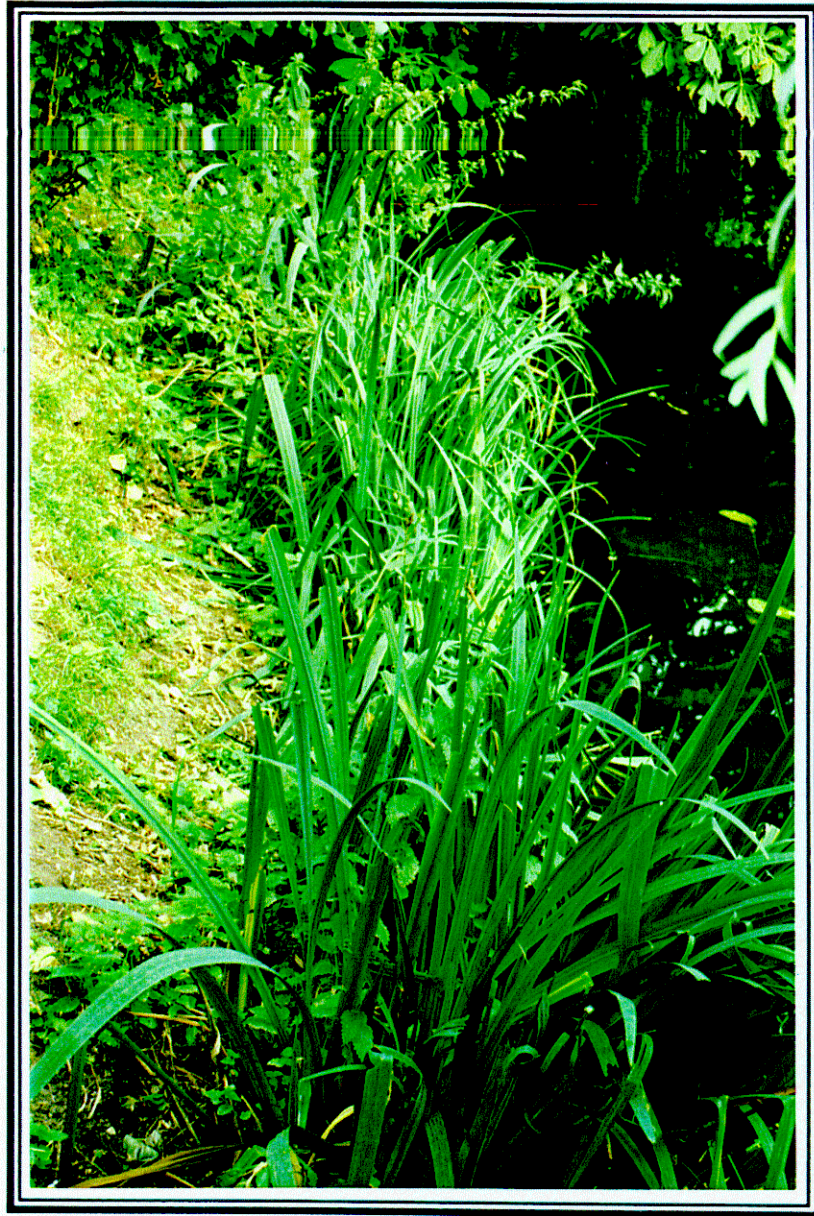
Plate 24: River Great Ouse (Brampton, Cambridgeshire) - herbaceous vegetation on the banks dominated by nettles and sedges

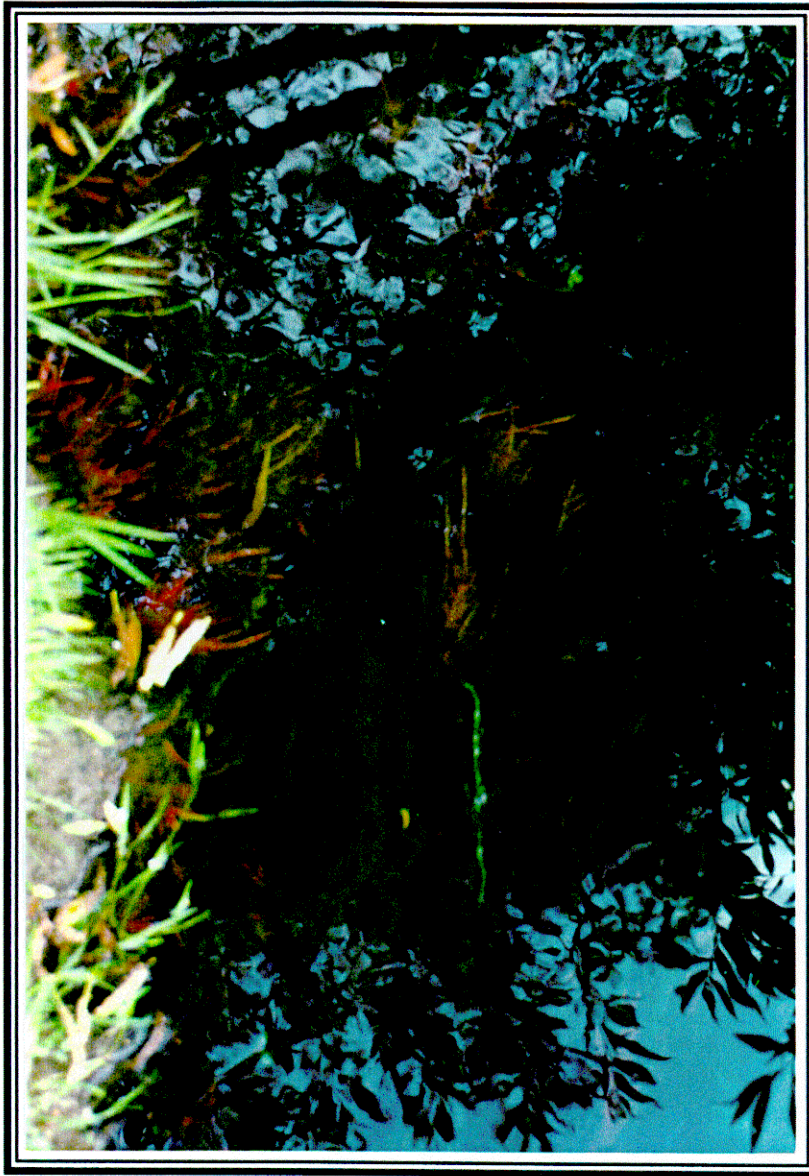
Plate 25: River Great Ouse (Brampton, Cambridgeshire) - note the dense, red-purple, fibrous root mattress "dipping-in" to the water from the base of fully grown willows, mainly *S. alba*
