Riverbank Protection Using Willows Scoping Study

Research and Development
Technical Report
W154

Scoping Study

Technical Report W154

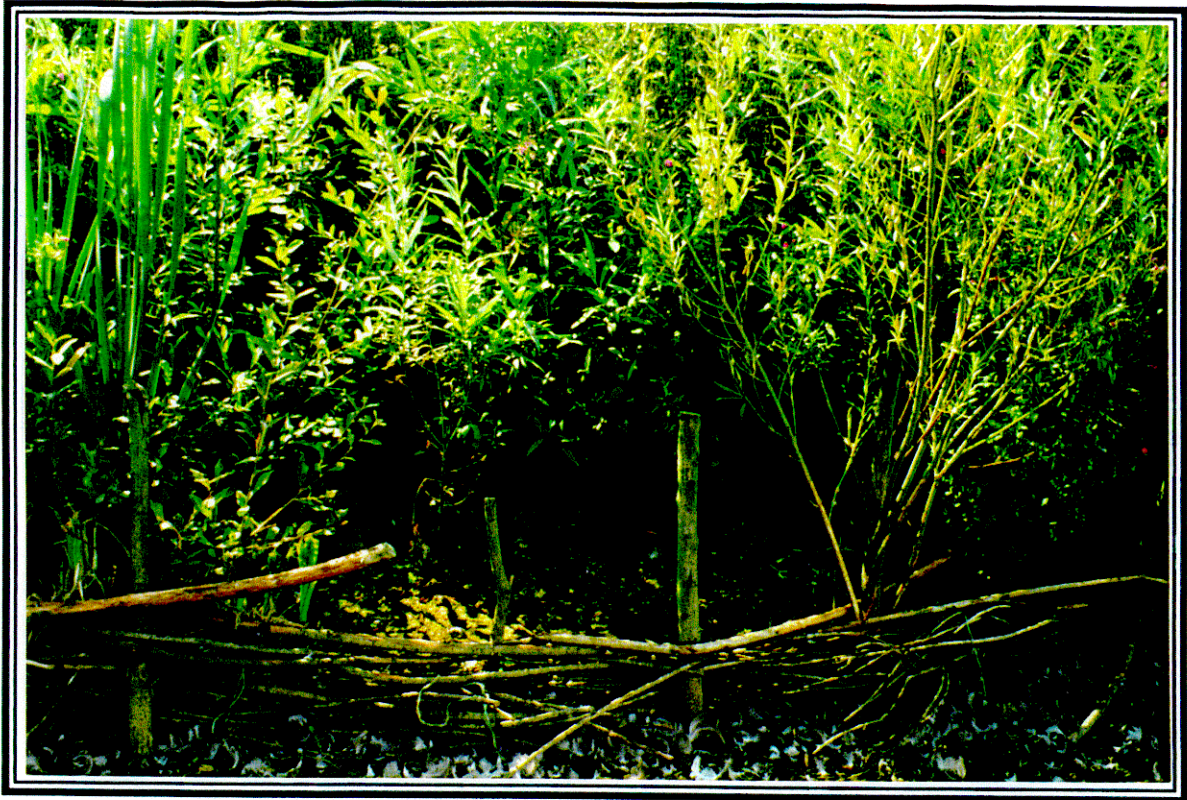
Plate 27: River Great Ouse (Milton Keynes) - note the willow poles have grown, but the spilings have not grown. The spilings act as a barrier to continued erosion

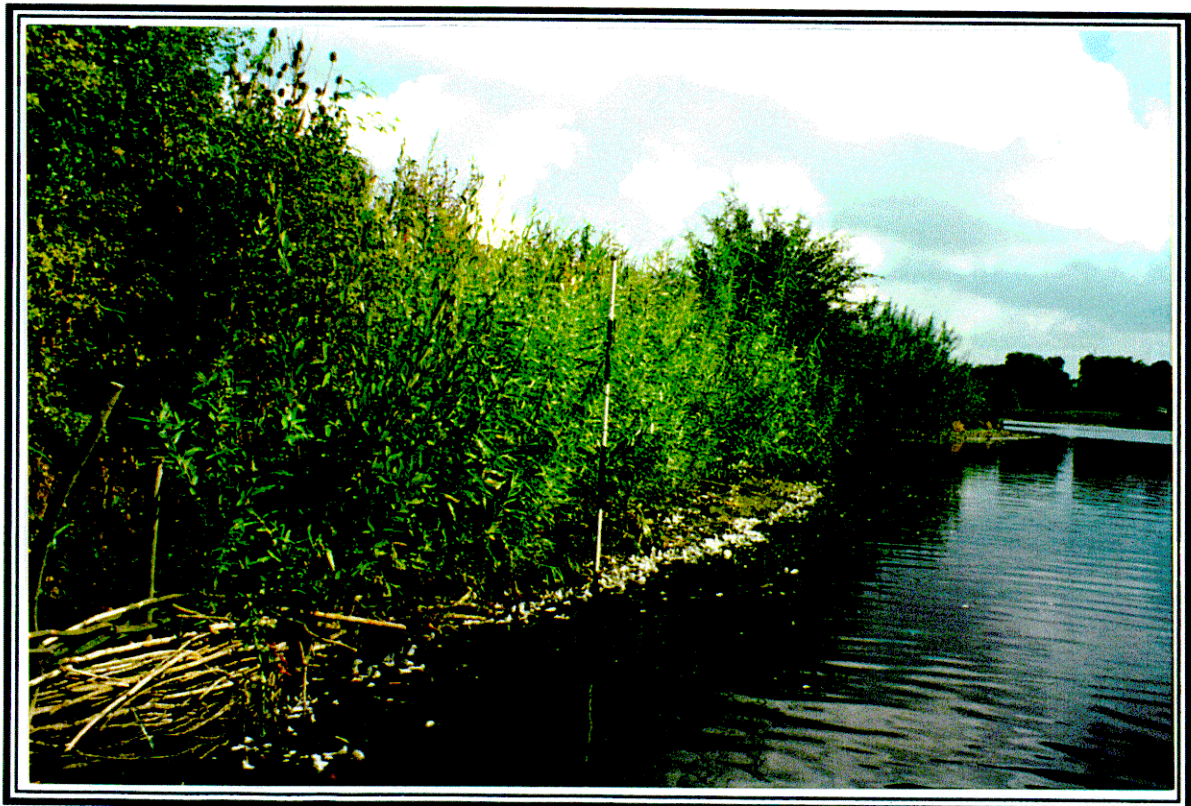
Plate 28: River Great Ouse (Milton Keynes) - willow poles and spilings have grown. Note the failed spilings in the foreground

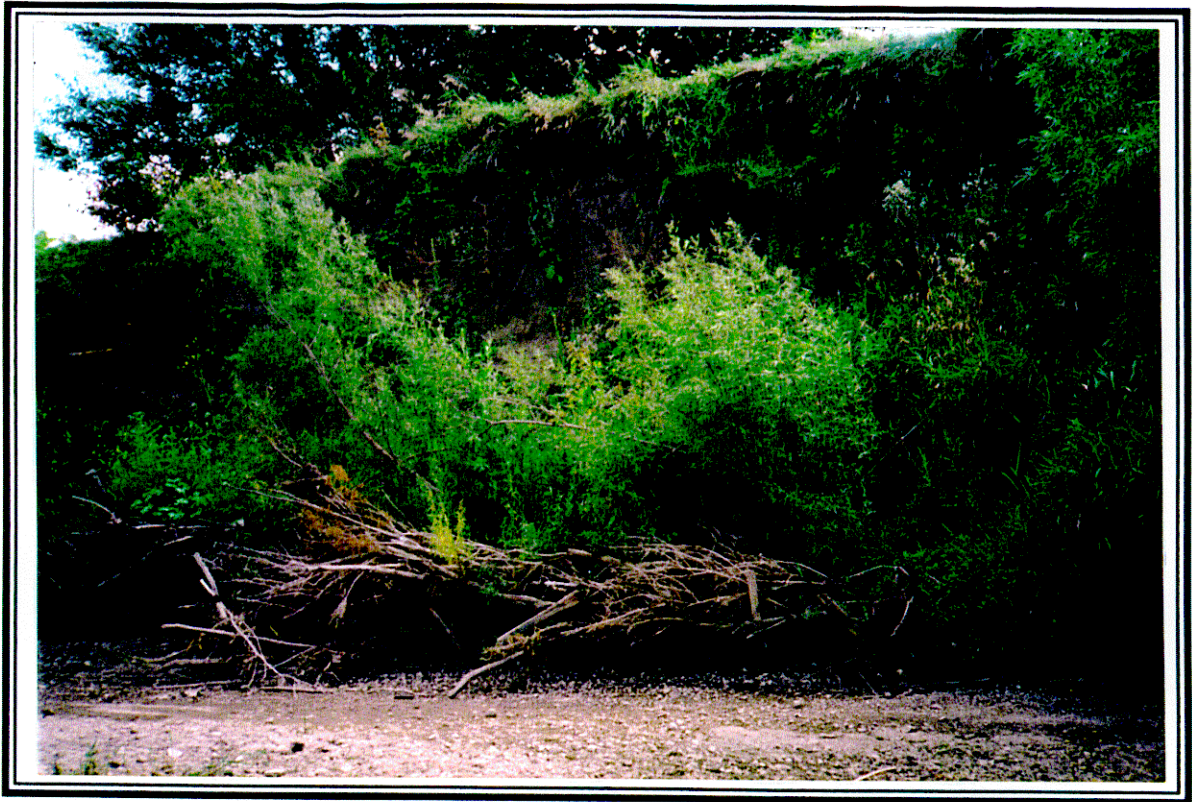
Plate 30: Crow Creek (Illinois, USA) - eroded cliff (glacial sand deposits) with stabilizing vegetation, planted using Roseboom's willow post method
