Diagnostic tool for source apportionment
of heavy metals around roads

Science report SC000030

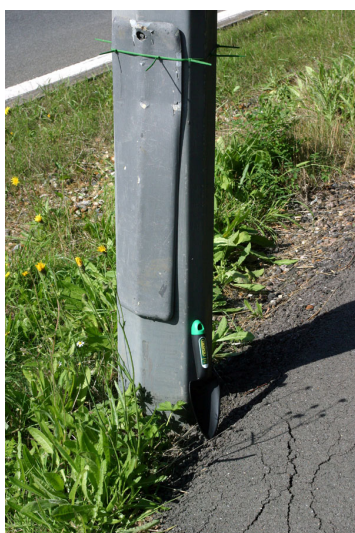
Figure 2.1: Transport Research Laboratory research track – small road system – showing sampling locations

The land adjacent to and surrounding the Research Track Facility is densely vegetated with pine forest forming an effective barrier between the Small Road System and the Large Loop, and between the Research Track and adjacent public road. The layout of the Research Track Facility is shown in Figure 2.1.

A similar approach can be applied to displaying the trace element characteristics of other aspects of the roadside environment. The TRL research track has a road-side barrier located close to the junction of Bridle Hill Rise and Cornelius Avenue (Fig 2.1). Samples were collected by sweeping the upper surface of the barrier with a nylon brush and of the barrier itself by scraping with a stainless steel blade. A comparison of the trace element chemistry for the barrier and TRL soil are shown in Fig 3.3. It is reasonable to assume that some proportion of the dust deposited on the barrier surface will be wind blown soil particles and the trace element plot displays a good deal of similarity in pattern between the two samples although absolute concentrations may differ. In addition, the relative proportions of pairs of elements such as Th and U or Hf and Ta, for example, are also similar. However, there are a number of identifiable and significant differences between the two, notably the concentration and relative proportions of Nb, Mo and Ag. Unfortunately there is no Cd data available for the sweeping as insufficient material was available for analysis. These elements display a characteristic fingerprint which in the absence of any other information would distinguish these samples from each other.

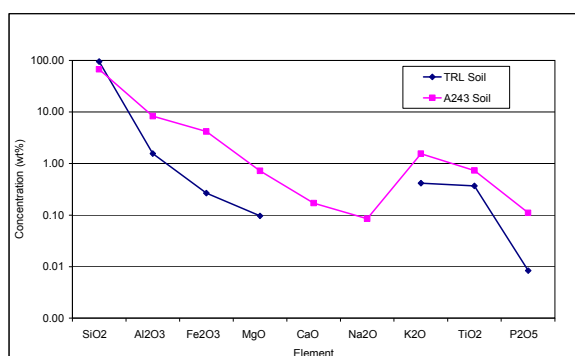
Figure 3.1 Major element soil data for TRL and A243

A comparison of major elements in average soil from the research track and the A243 are shown in Fig 3.1. Ca, Na and K data points are missing from TRL as these elements were less than the instrument detection limit. Concentration is shown on a log scale to accommodate the wide range of values. However, the general chemical characteristics are clear with the TRL soil being higher in SiO₂ than that at the A243. The relative proportions of elements such as Fe and Mg, for example, are similar for both soils.

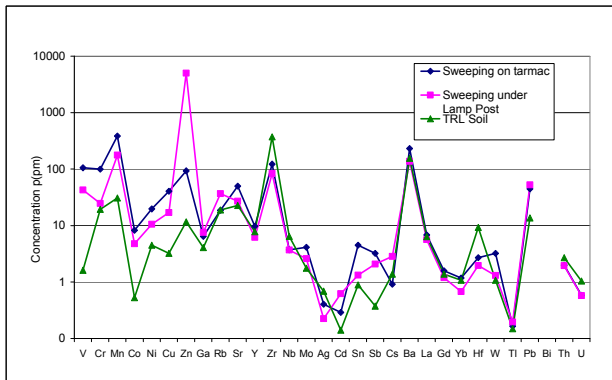
Figure 3.5 Comparison of sweepings from tarmac, tarmac under lamp post and TRL soil

The trace element chemistry for the remote asphalt sweeping, sweeping under lamp post and TRL soil are compared in Fig 3.5. Whilst many elements are present in the samples at similar concentrations or show similar relationships between element pairs, a number of elements display characteristic features. For example, the relationship between Ag and Cd is characteristic such that $Ag > Cd$ in soil, $Ag < Cd$ in sweeping under lamp post and $Ag = Cd$ in the sweeping from asphalt. There are similar characteristic patterns for other pairs of elements such as Hf/W, Cr/V and Sn/Sb.
