DEVON AREA INTERNAL REPORT

**AN INVESTIGATION TO DETERMINE THE
WATER QUALITY OF CHURCHSTANTON
STREAM.**

MARCH 1996

DEV/E/13/96

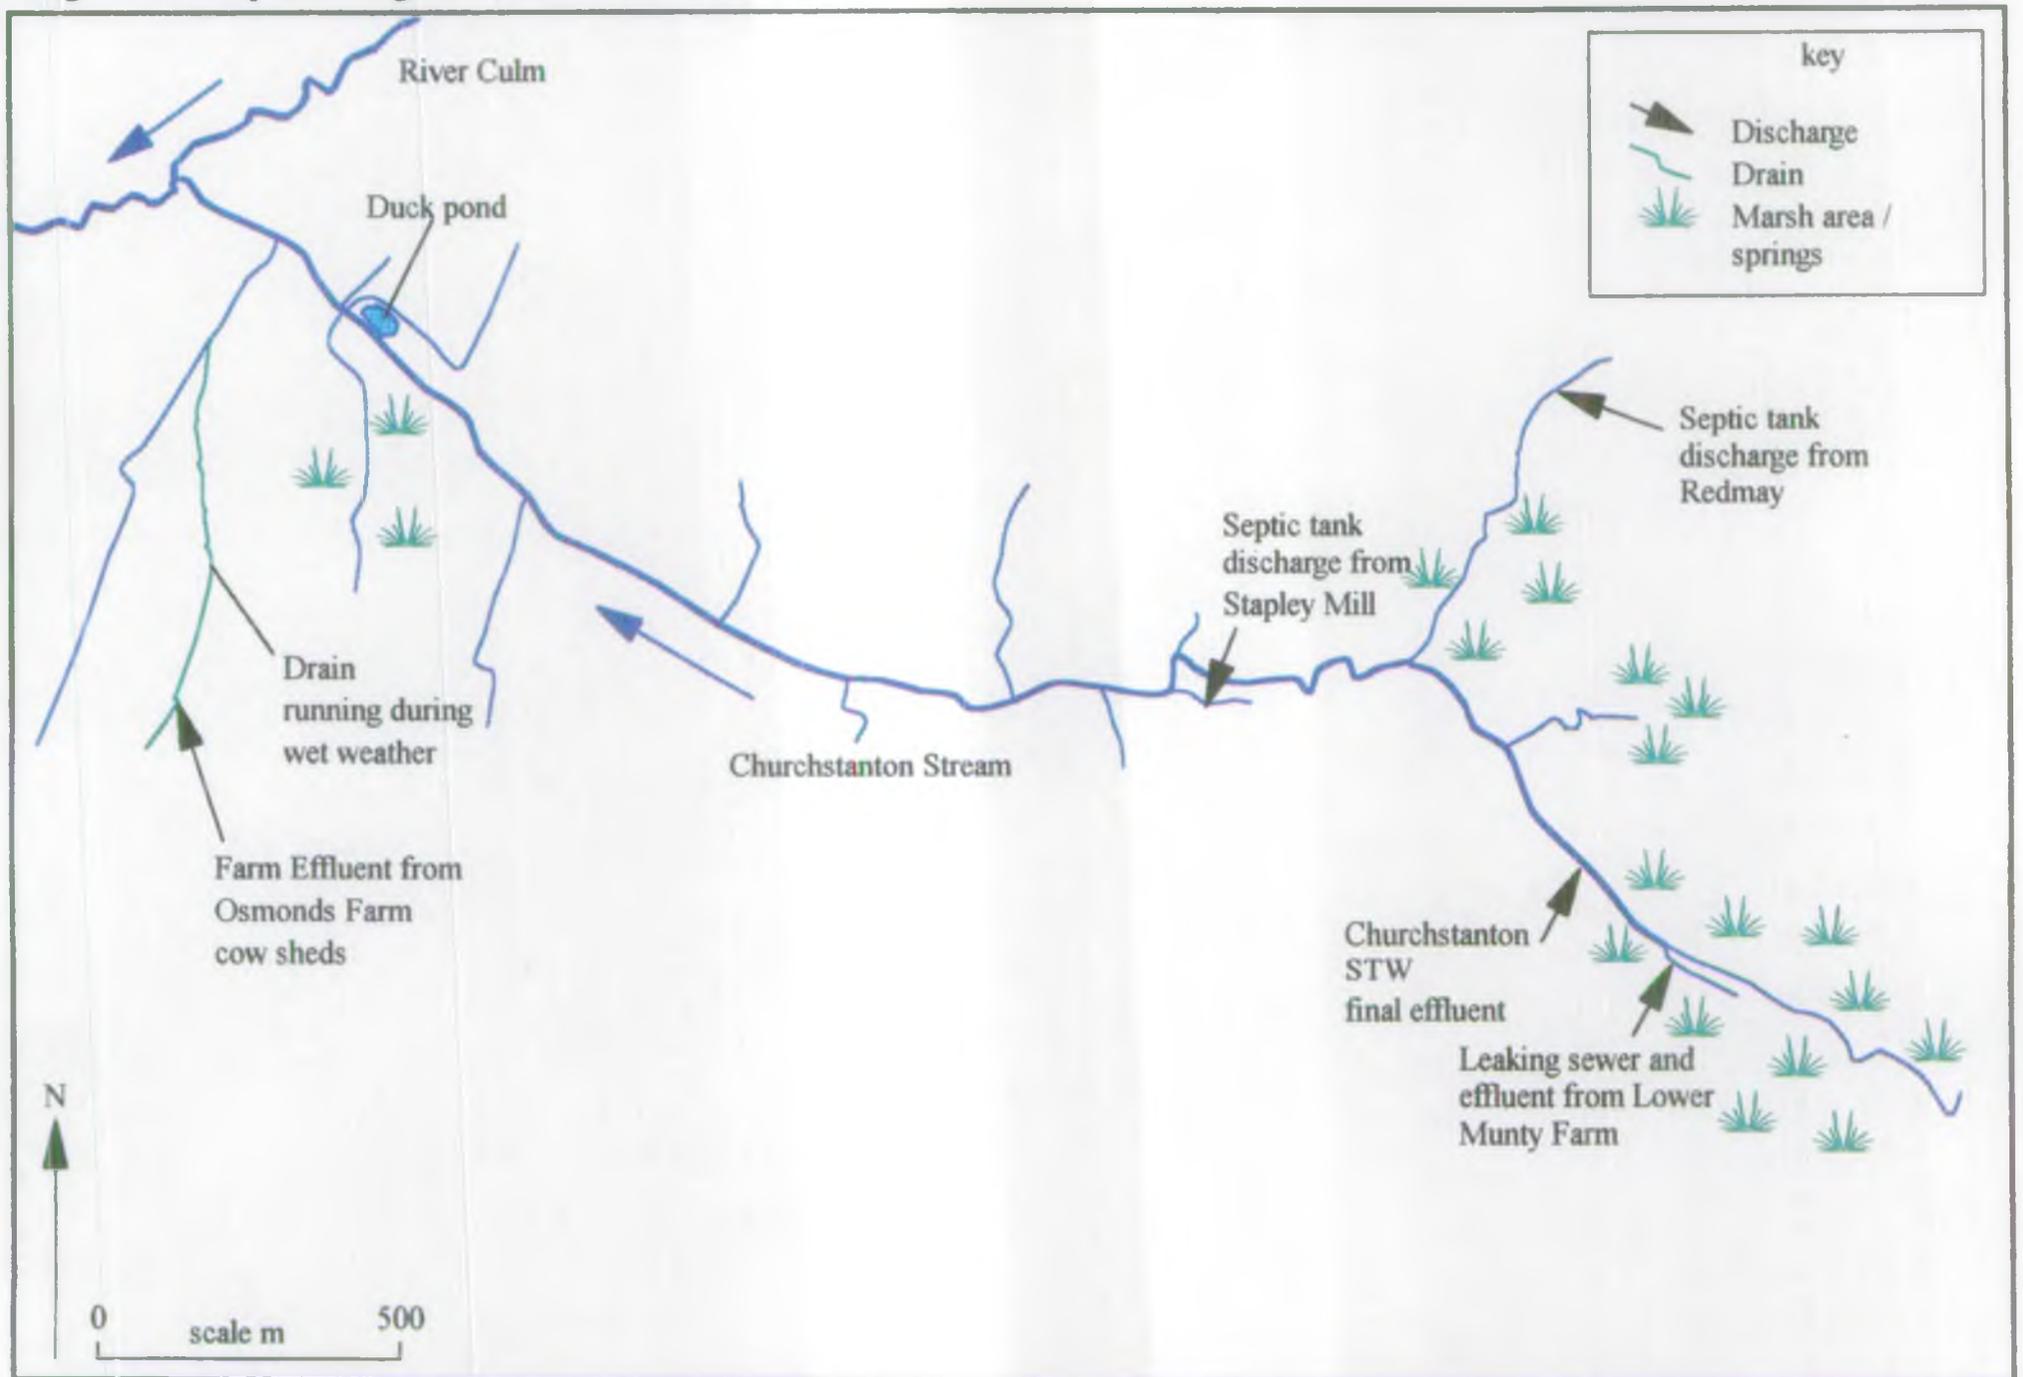
Figure 1. Map showing the Curchstanton Stream area.

The Churchstanton Sewage Treatment Works (WSTW7550FE) which has a descriptive consent was added to the routine programme mid 1995; no other discharges to the stream are routinely monitored (see Figure 1).

For results see Figure 1 and proforma.

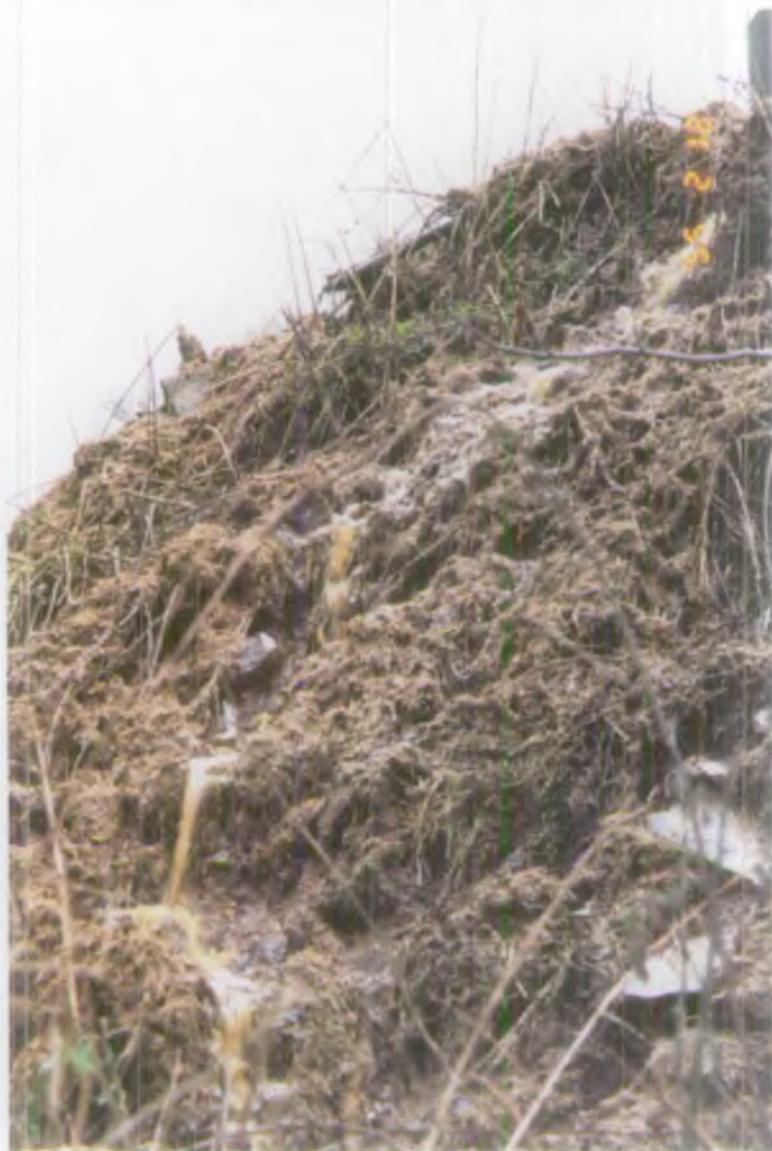
Photograph 1: Run off from Osmonds Farm cattle sheds.

During inspection of the catchment in wet weather a road drain was green and smelt of farm effluent. The drain was fed by a field ditch coming from the direction of a set of cow sheds.

Surface water and farm waste was running off the open hard-standing of the sheds down to the field ditch (see photographs 1 & 2).

The ditch only runs during wet weather. On talking to local people, this problem has happened frequently in the past. Because of the quantity of rain required to result in the ditch running, dilution within the Churchstanton stream will be high and chemical impact will probably be evident but localised. It is unlikely that there would be any chemical impact within the River Culm during these conditions.

The Water Quality Officer has been notified and will be visiting the farm.

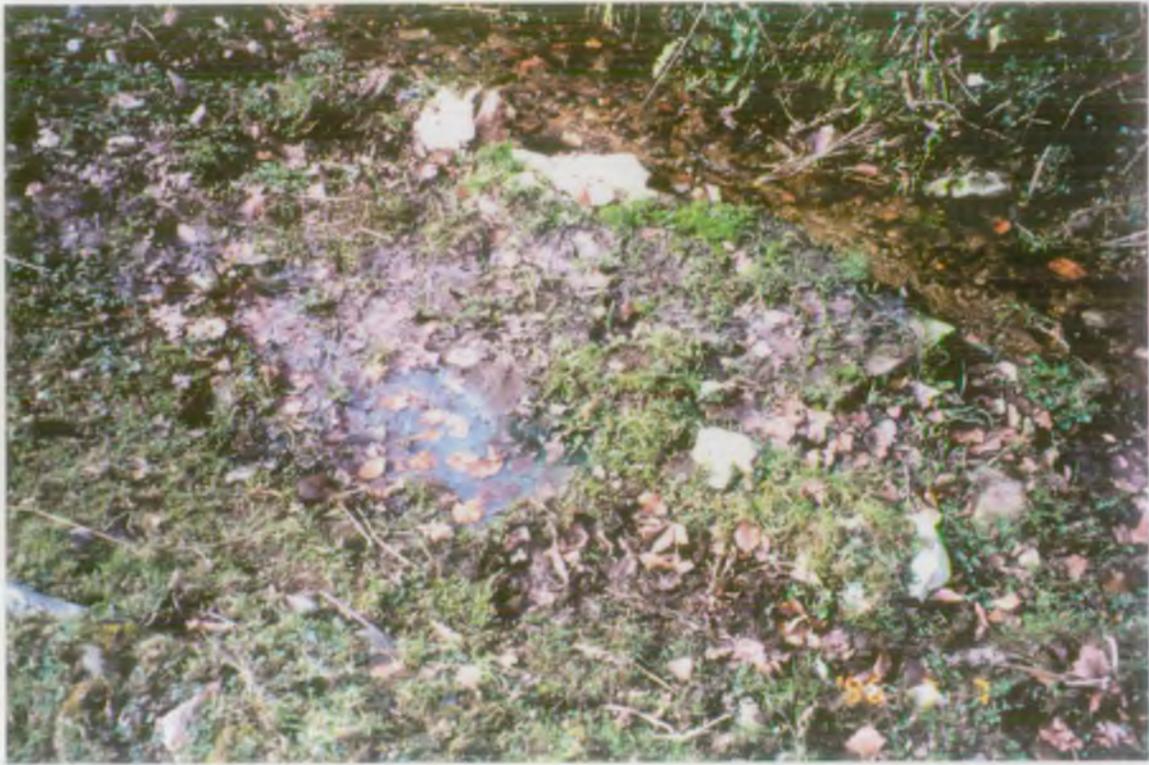
Photograph 3: Septic Tank discharge at Acombe.

The tributary had a reduced macroinvertebrate taxa list and poorer substrate than other sites on the stream. On following up the watercourse, a septic tank discharge was found seeping up through the soil and entering the tributary.

Besides the septic tank in the field, a barn / cattle shed upstream of the discharge had farm effluent oozing out of the wall into the ground near by the watercourse although none of the waste was directly entering the stream at the time of investigation (a small length of the stream is culverted at this point, see photographs 3 & 4).

None of the inputs were resulting in EQS exceedances for a RE class 2 river at the time of sampling. However, during wet weather the farm waste from the barn may have a localised impact on the stream and during dry weather flows in summer, the septic tank discharge in the field and that to the road drain may impact the tributary chemically.

The Water Quality Officer has been notified and will be visiting the site.

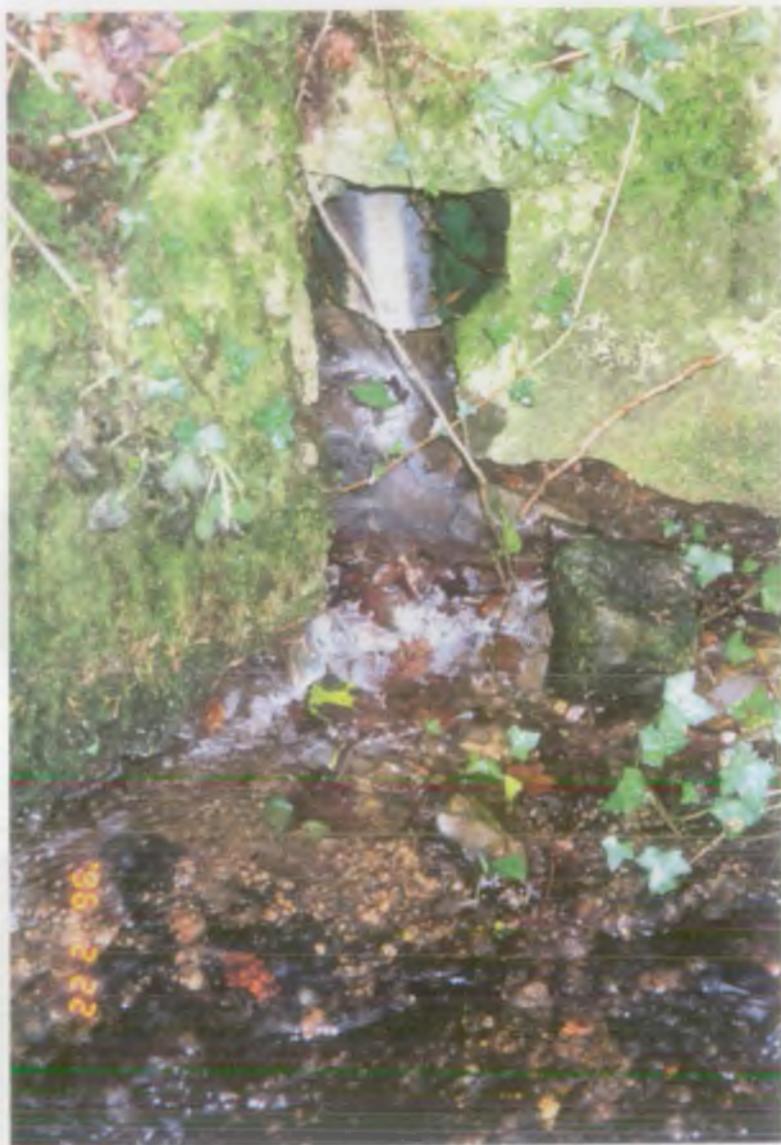
Photograph 5: Septic Tank discharge Stapley Mill.

During the appraisal there was a septic tank effluent smell around Stapley Mill. On closer examination a septic tank discharge was located in a small tributary of the stream. Sewage fungus D/S of the effluent was approximately 11.5% compared to 1% cover U/S.

An outflow from a septic tank discharging into the tributary.

The biological community D/S of the discharge was poorer than that U/S but was by no means indicative of bad water quality. The input did not result in exceedance of the EQS's for a class 2 river. However, during the summer months with low dilution, there may be a localised chemical impact in the tributary.

The Water Quality Officer has been notified.
