**AN INVESTIGATION INTO  
THE EFFECTS OF ALTON  
SEWAGE WORKS ON THE  
RIVER WEY NORTH**

**P.GREAVES APRIL 1992**

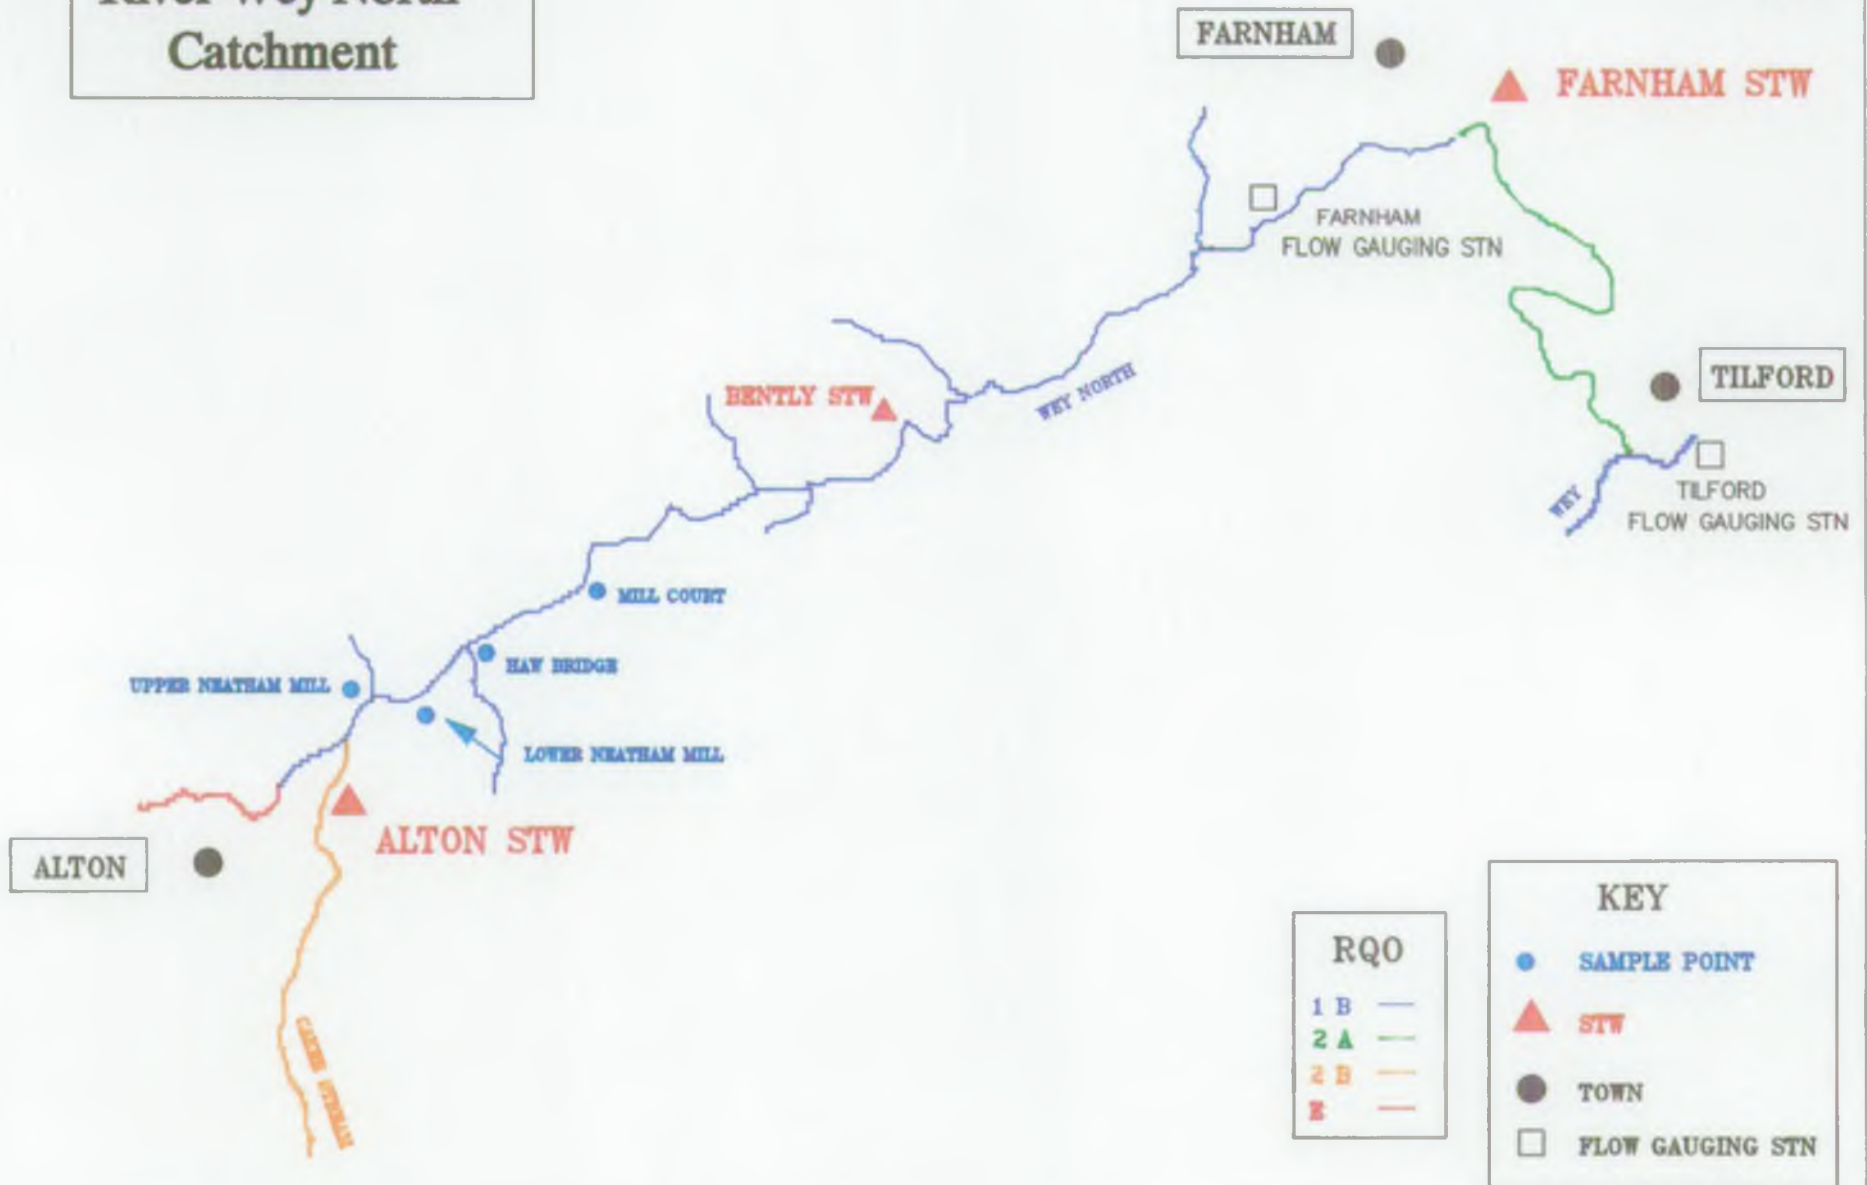
Fig 1.

# River Wey North Catchment

The monitoring site for the river downstream of the sewage works is at Mill Court, Wyke, some 3.5km downstream. The relative locations of all these points can be seen on the catchment map Fig. 1. The stretch from Alton to Mill Court, and beyond, is normally of very good quality, and complies with the 1B RQO. However, towards the end of the summer of 1991, the water quality deteriorated dramatically due to the sewage works discharging a poor effluent.

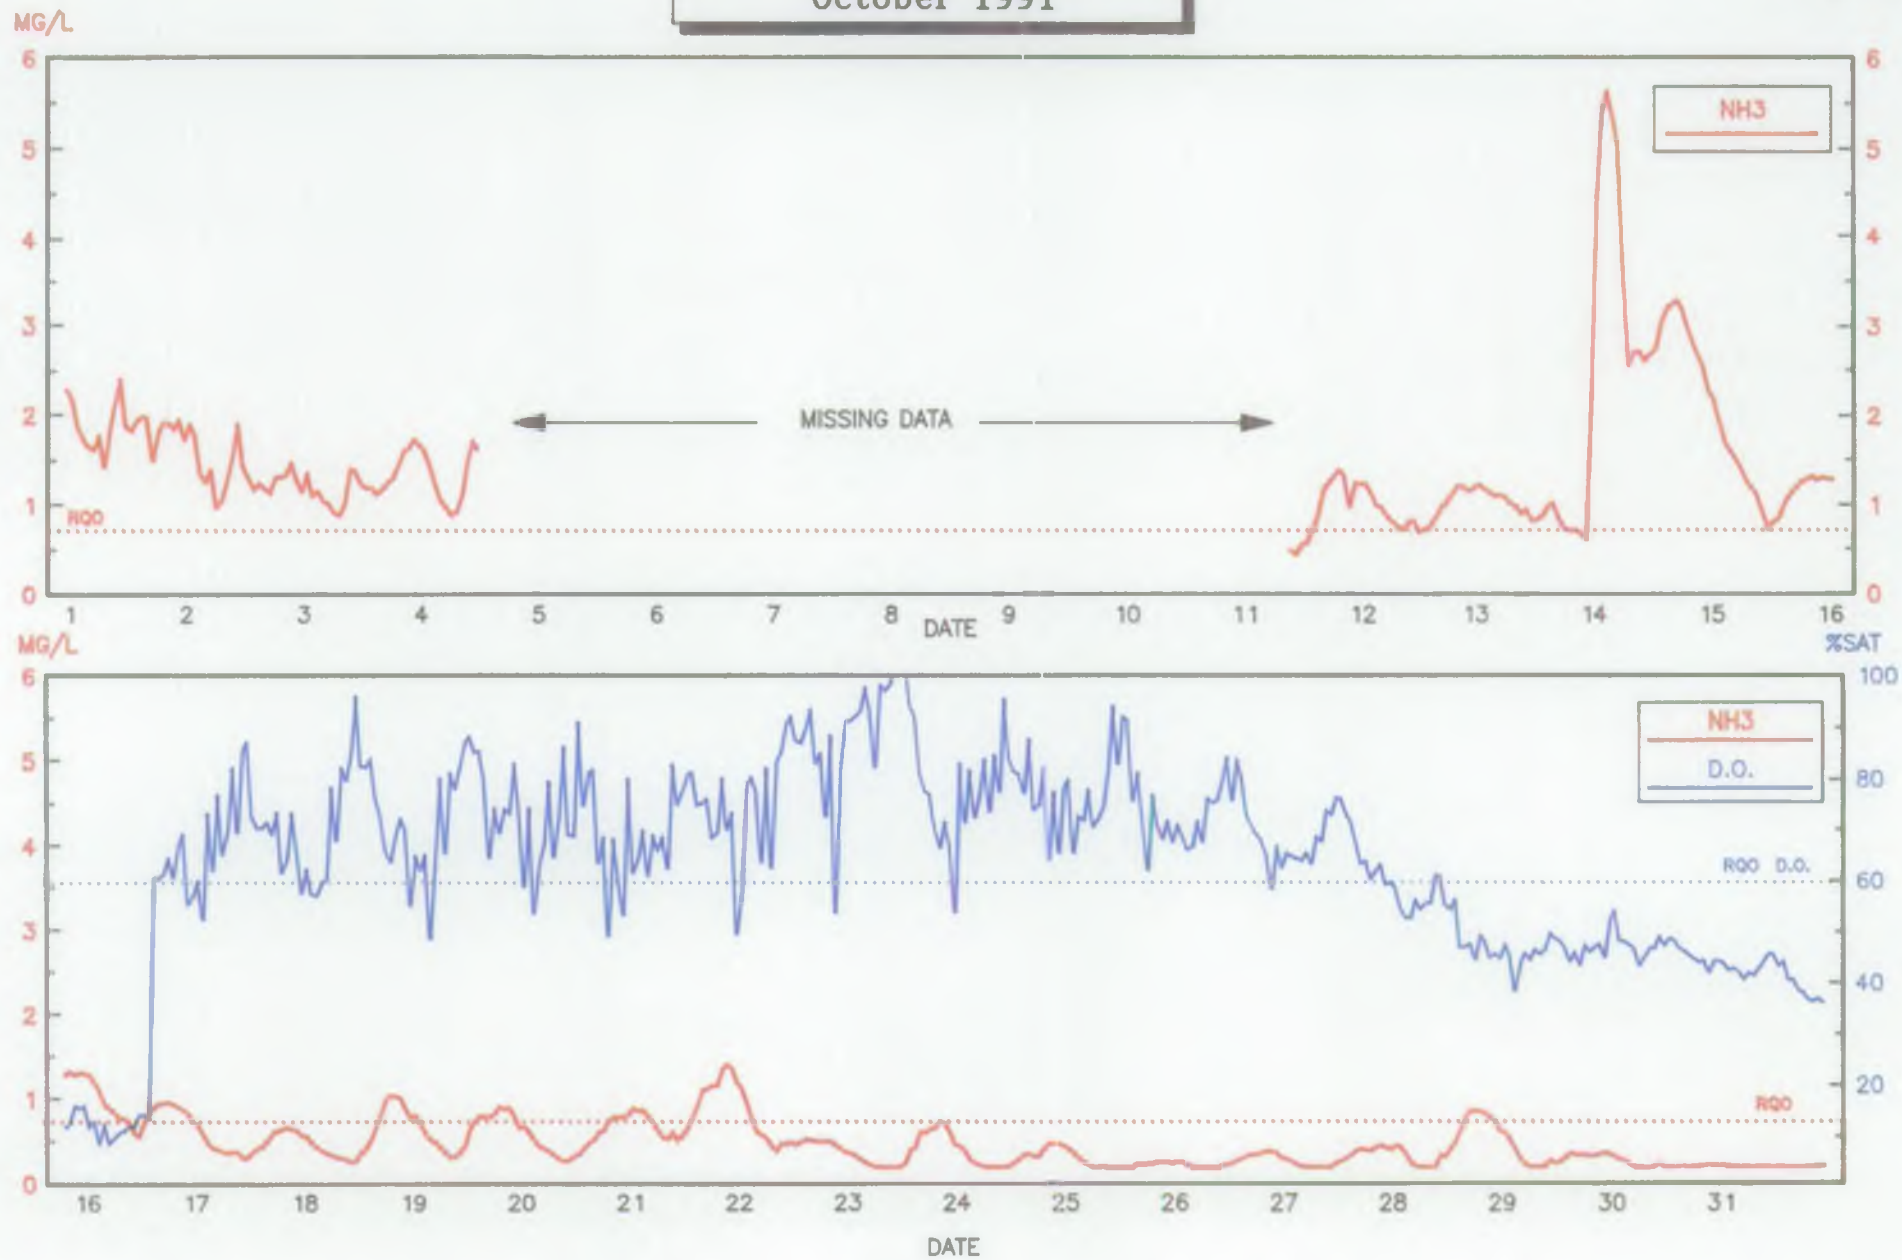
Fig 5.

AQMS Upper Neatham Mill  
October 1991

#### Data from the A.Q.M.S. Figs. 5-8

The situation had improved by the time the AQMS was working reliably, but the data does show frequent RQO failures for ammoniacal nitrogen and D.O. It also confirms the pattern for ammoniacal nitrogen seen in the 24 hour survey. Fig. 4, namely the peak value arriving at Upper Neatham Mill during the late evening, approaching midnight. However, the levels seen at this point during the 24 hour survey were considerably higher.

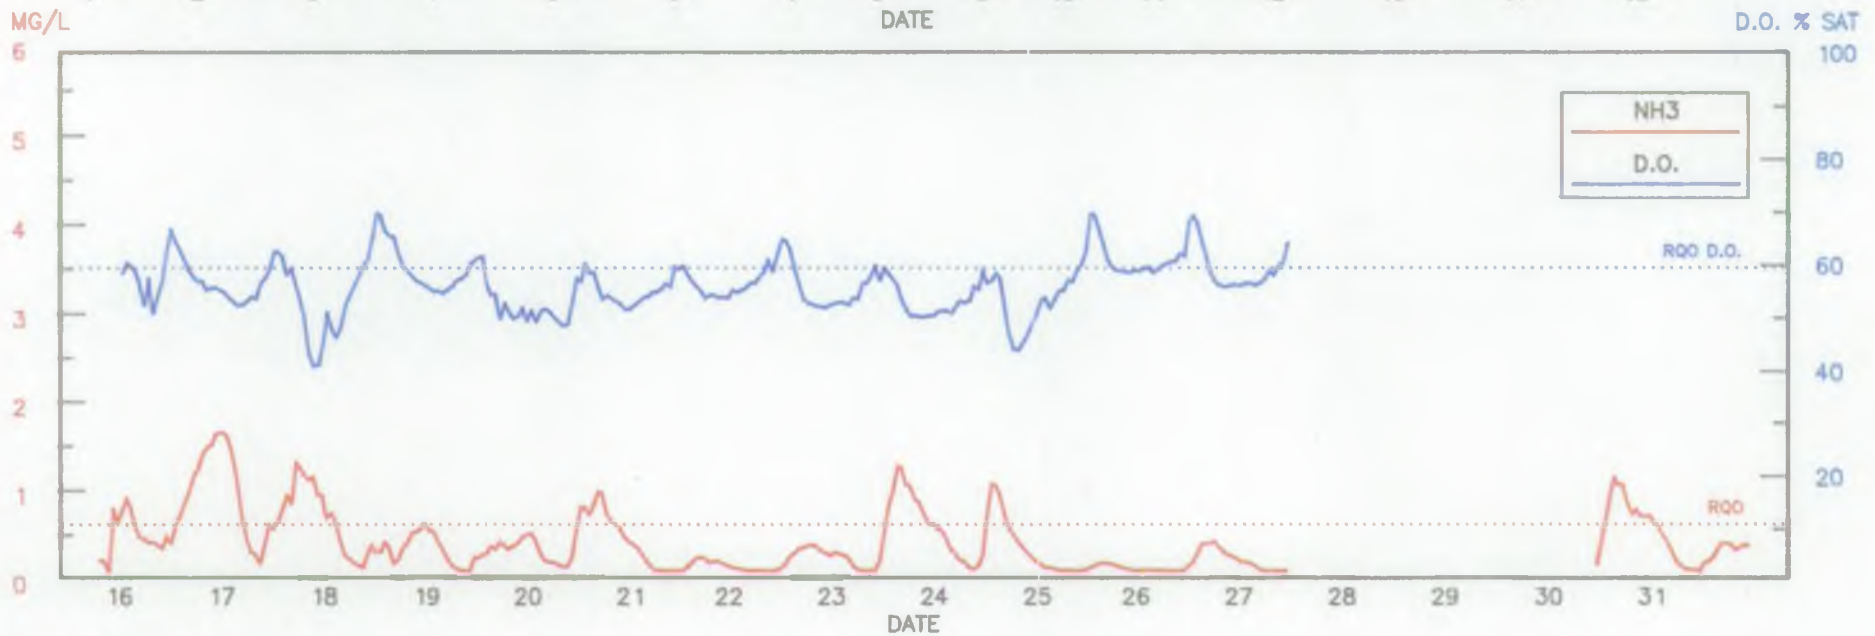
Fig 7.

AQMS Upper Neatham Mill  
December 1991

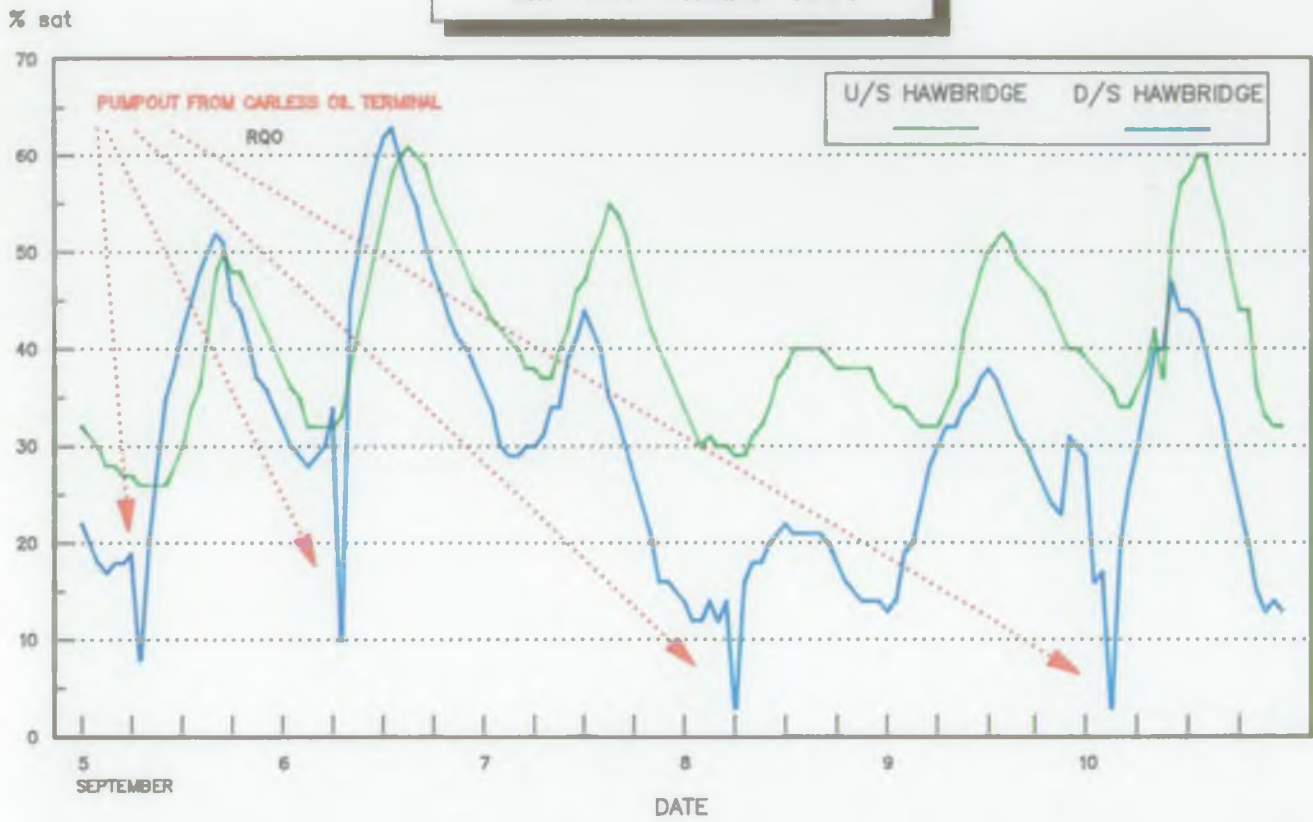
Fig 10.

R.Wey North at Hawbridge  
Recording D.O. Meter Data  
5th-10th October 1991

#### **Carless Oil Terminal, Holybourne Fig. 10**

In the course of monitoring the effects of Alton sewage works on the river, another interesting effect was discovered from the surface water outfall serving the Carless Oil Terminal which enters the river just below Haw Bridge. All of the surface water from the site drains via a large oil separator prior to being manually pumped to the river. The system cannot gravitate to the river, nor is it on an automated pumping system. The result is that every few days, depending on rainfall, a very large volume of deoxygenated water from the separator is pumped into the river at a high rate over a short time period. This was found to cause a very sudden and substantial D.O. sag in the river immediately downstream of the outfall. Fig. 10 shows these sags to be as much as 25% saturation and on some occasions reduced the D.O. in the river to a level approaching 0% saturation. If the fish and invertebrate population were able to survive the low D.O.'s caused by the sewage works, these additional D.O. sags would almost certainly have caused mortalities in the river close to the outfall, Under normal circumstances, although undesirable, this discharge would have little significant effect.

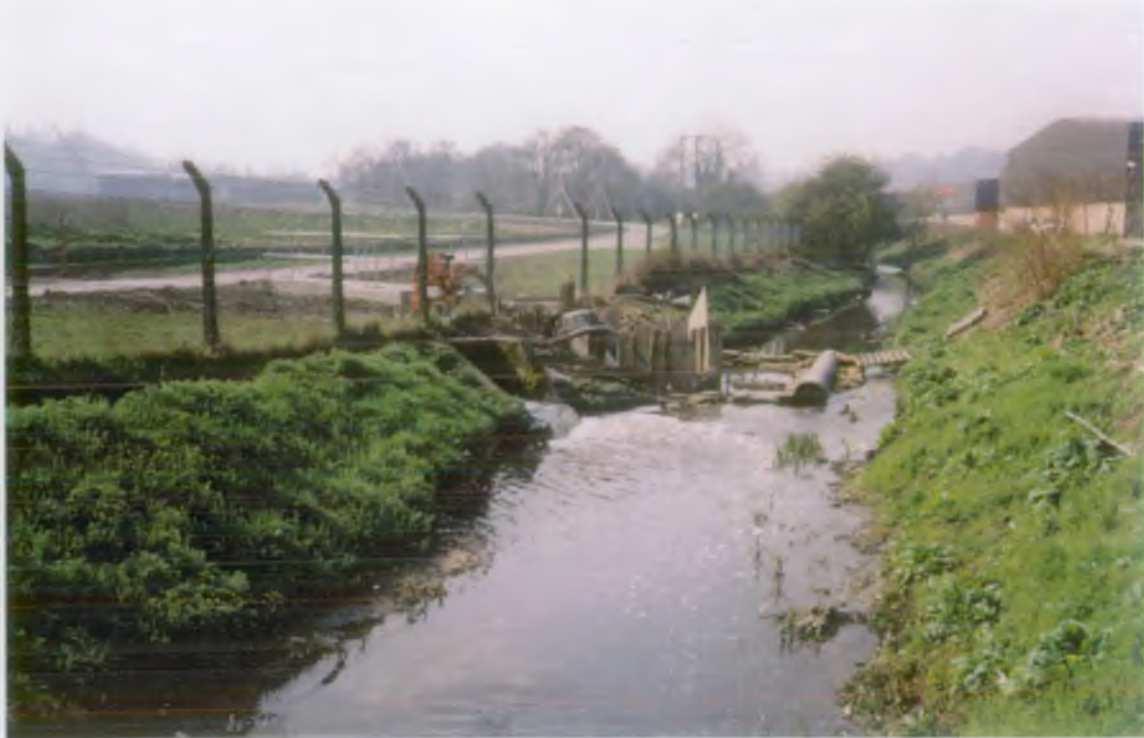
Outfall from Alton Sewage Works into the Caker Stream

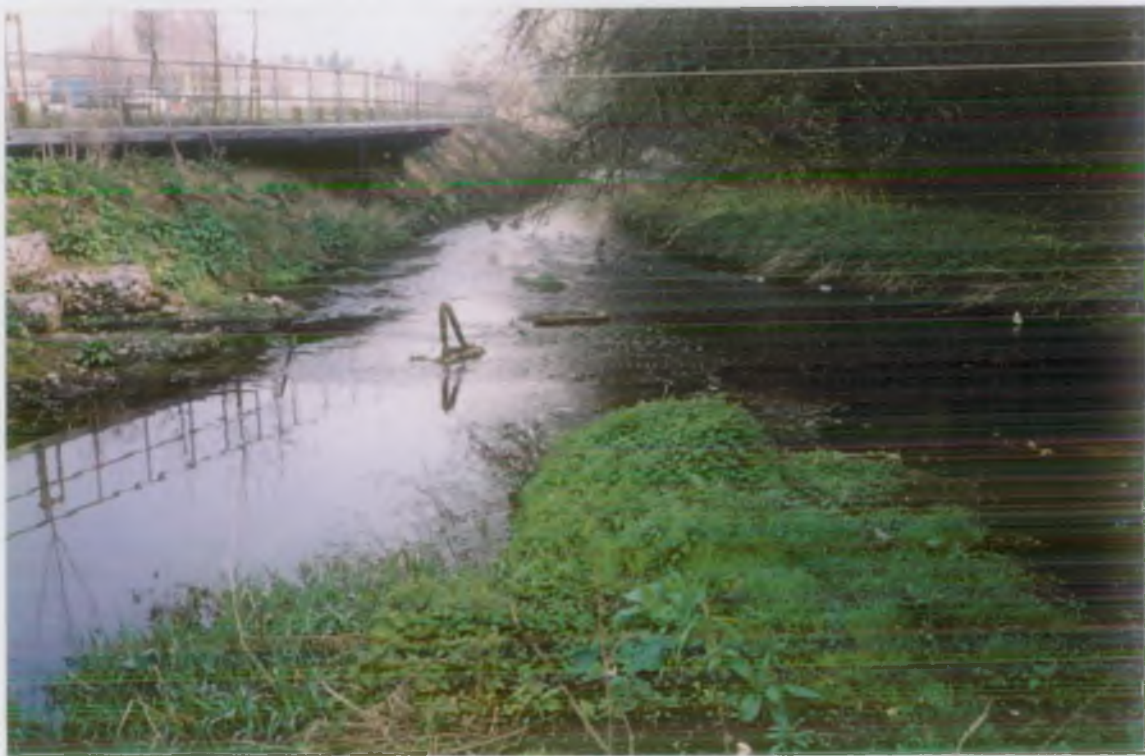
Confluence of the Caker Stream with the Wey North

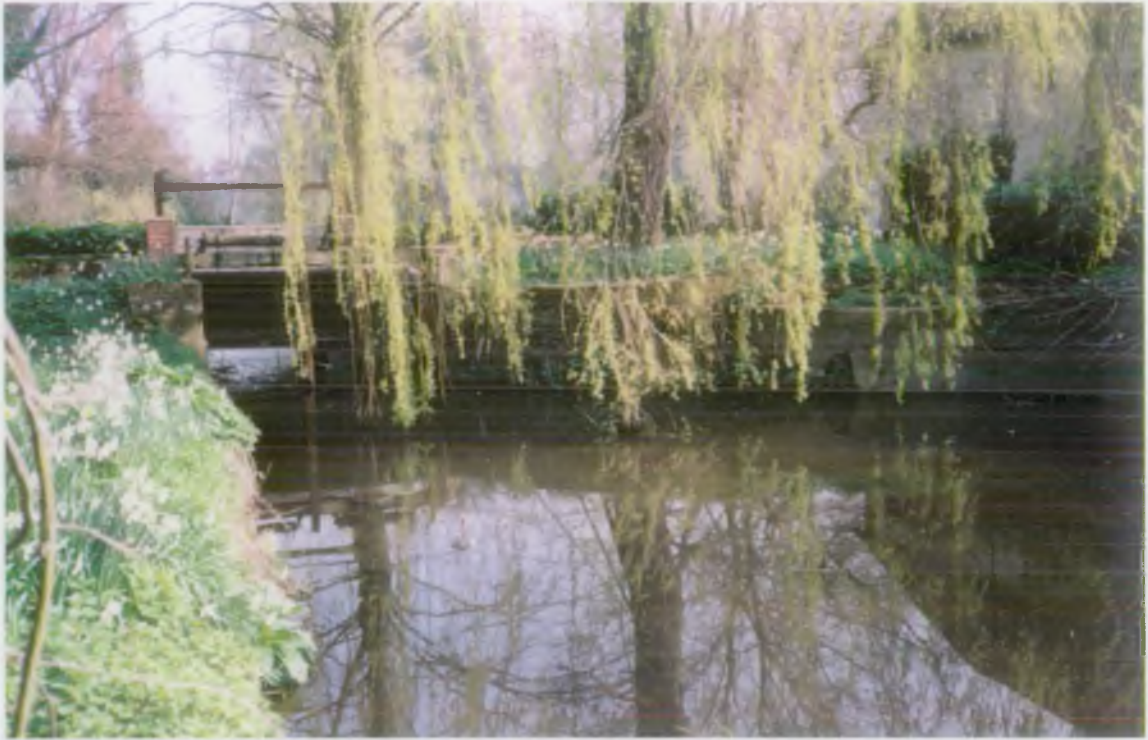
Wey North at Upper Neatham Mill

The river sites most vulnerable below the sewage works are Upper Neatham Mill, behind the weir, and at Haw Bridge. The situation at Haw Bridge has been made worse by the over dredging of a stretch of the river upstream. It has been estimated that to put this right would cost in the region of £35,000, it therefore seems improbable that the river will be reinstated as the dredging took place some time ago, and recovery of the cost from the landowner would be unlikely.

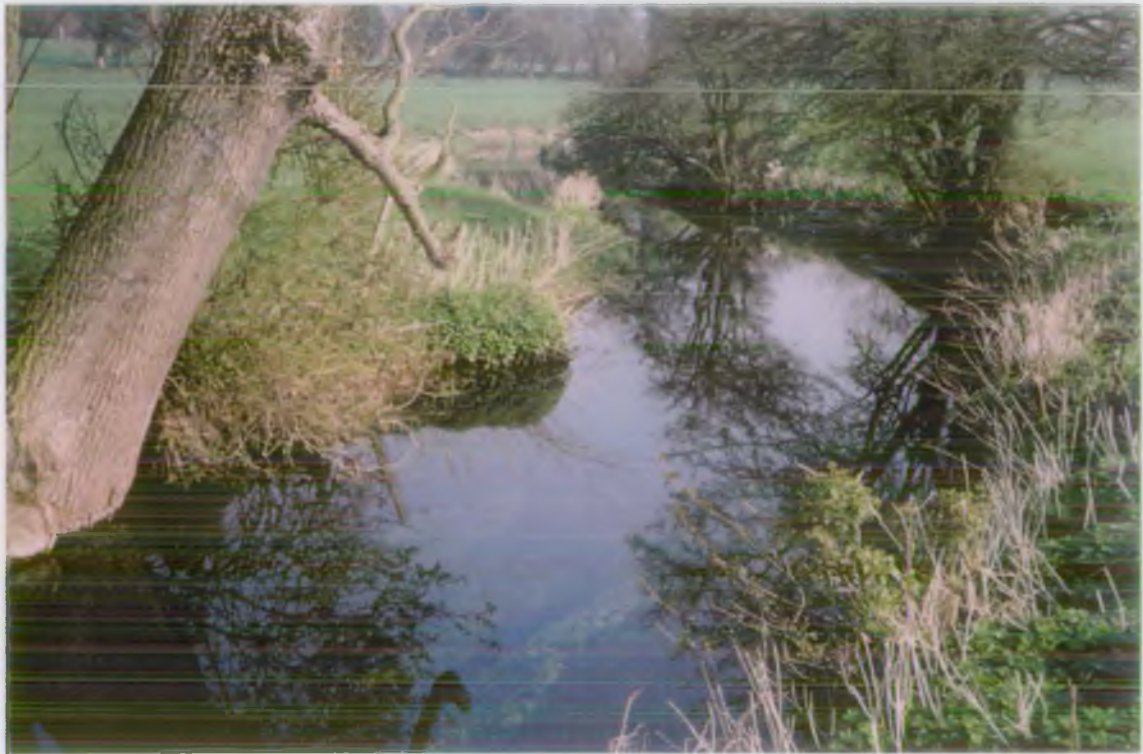
Wey North Overdeepened Stretch above Haw Bridge

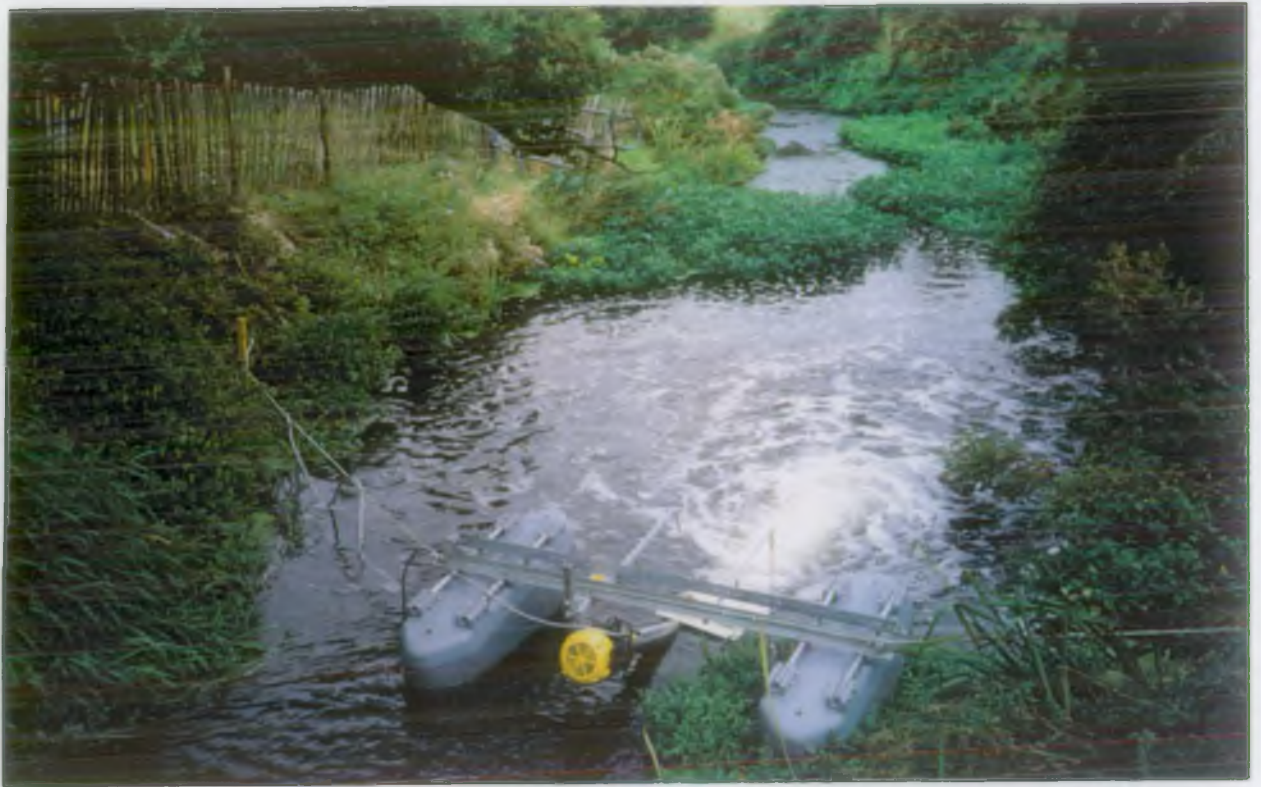
Aero II Aerator below Haw Bridge

The D.O. levels in the river were considered to be critical, so NRA Fisheries staff installed on "Aero II" aerator in the river at Haw Bridge on 19th September 1991. Additional aerators were put in later at Upper Neatham Mill and Lower Neatham Mill.

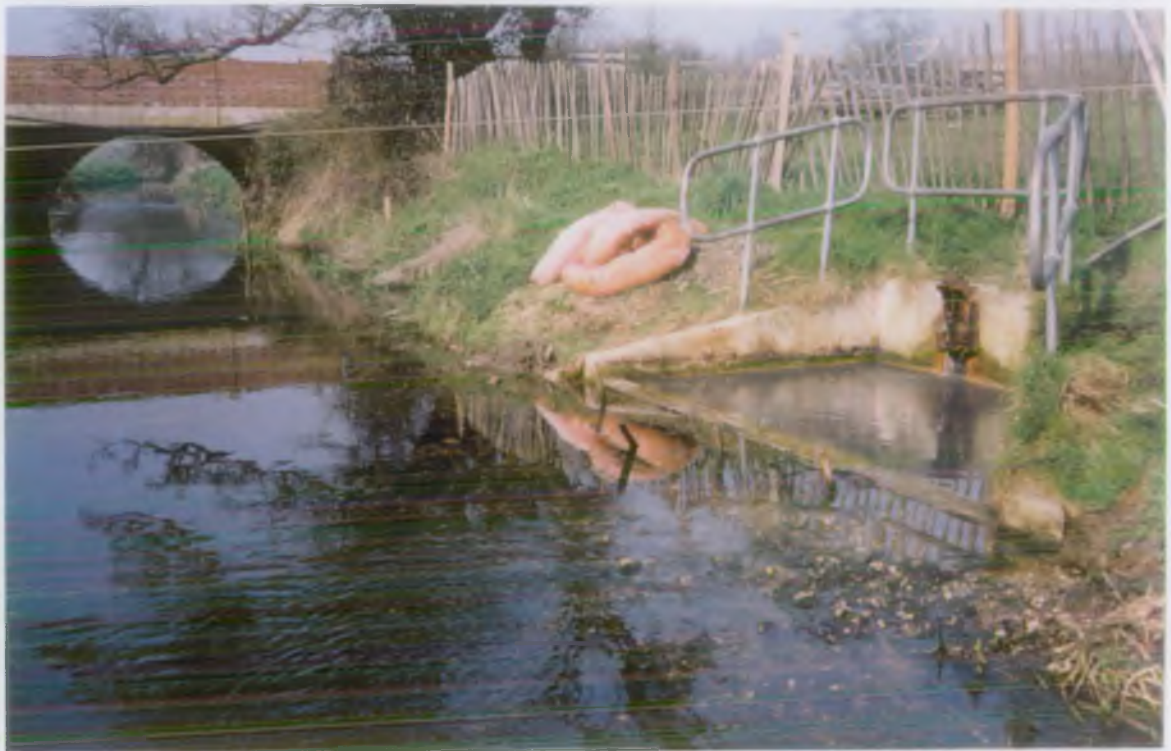
Outfall from Carless Oil Terminal

At present the consent for the surface water discharge from the Carless Oil Terminal at Holybourne has only a "no oil or grease" standard attached, with no quality standards. Bearing in mind the deoxygenation problems the discharge can have in the river, this needs to be reviewed to include standards for BOD and dissolved oxygen.

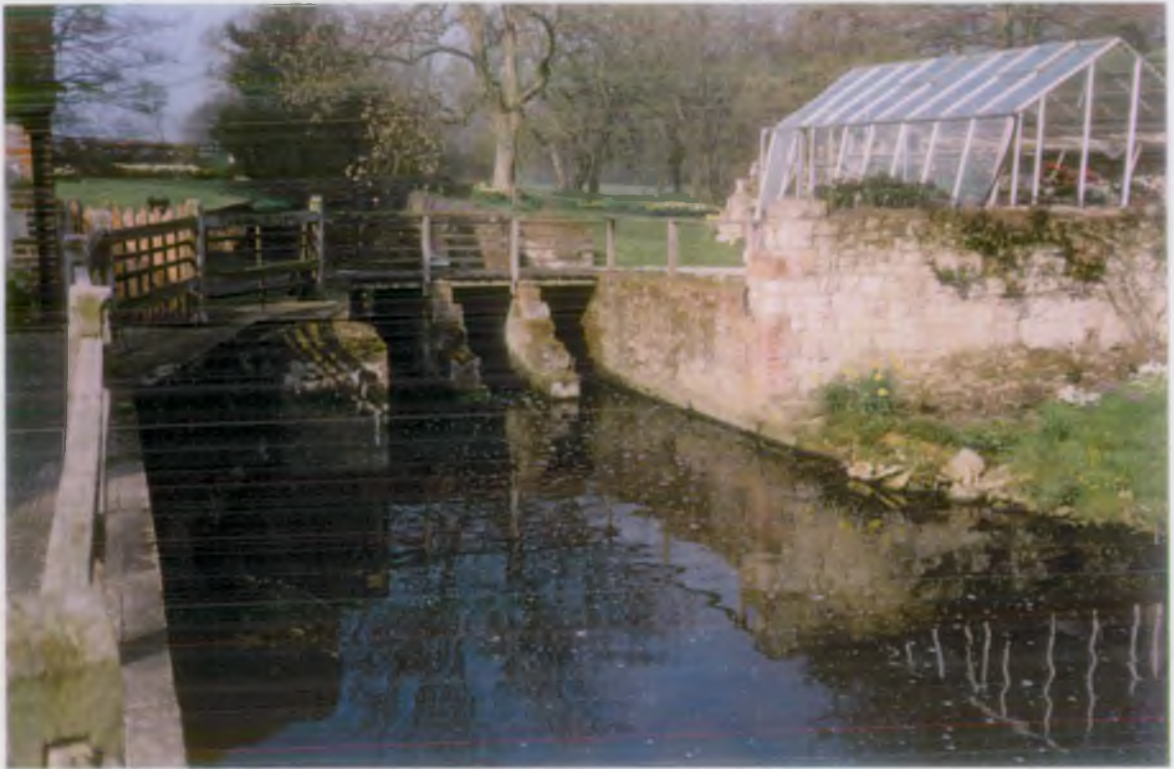
Wey North at Mill Court Weir

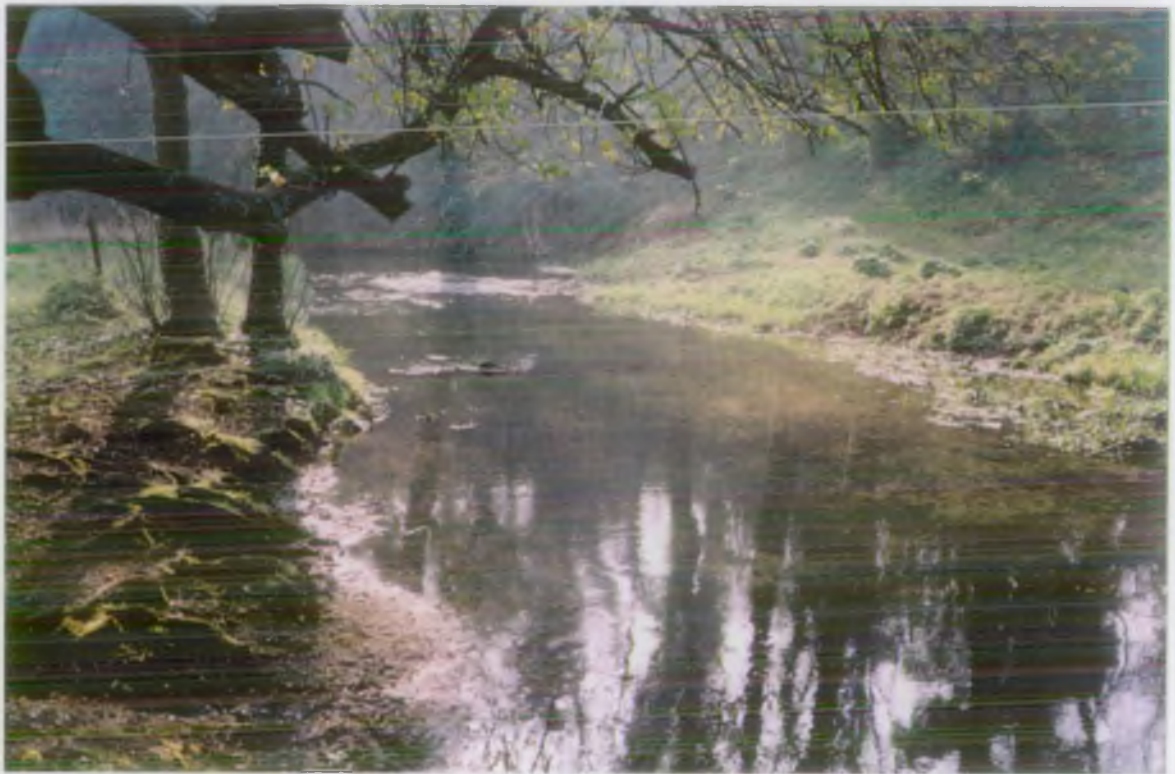
Wey North at Mill Court Sampling Point

It is recommended that the site used for monitoring the river below Alton should be changed from Mill Court, to Haw Bridge, as this site more accurately reflects problems within the vulnerable reaches.

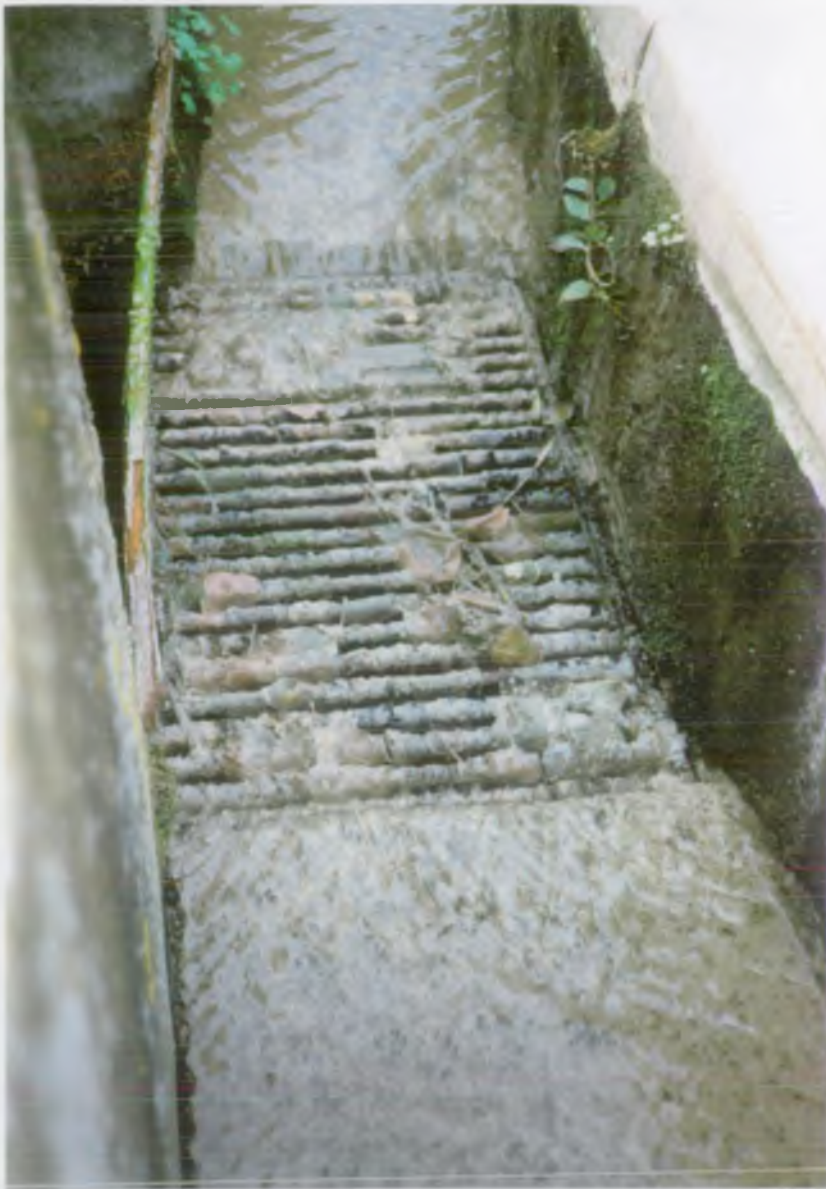
Fungus on Final  
Tanks Serving  
Filter Beds

On the 18th, 19th and 20th September 1991, reports were received of foaming, and discolouration at Upper Neatham Mill. Some dead and moribund fish were also seen at that point. This was traced back and confirmed to have been caused by the effluent from the sewage works. The effluent was visually very poor, much worse than when inspected prior to the 18th. Sewage fungus was seen to be present on the outfall channel, the land plot, and the final tanks, especially those serving the percolating filter plant.

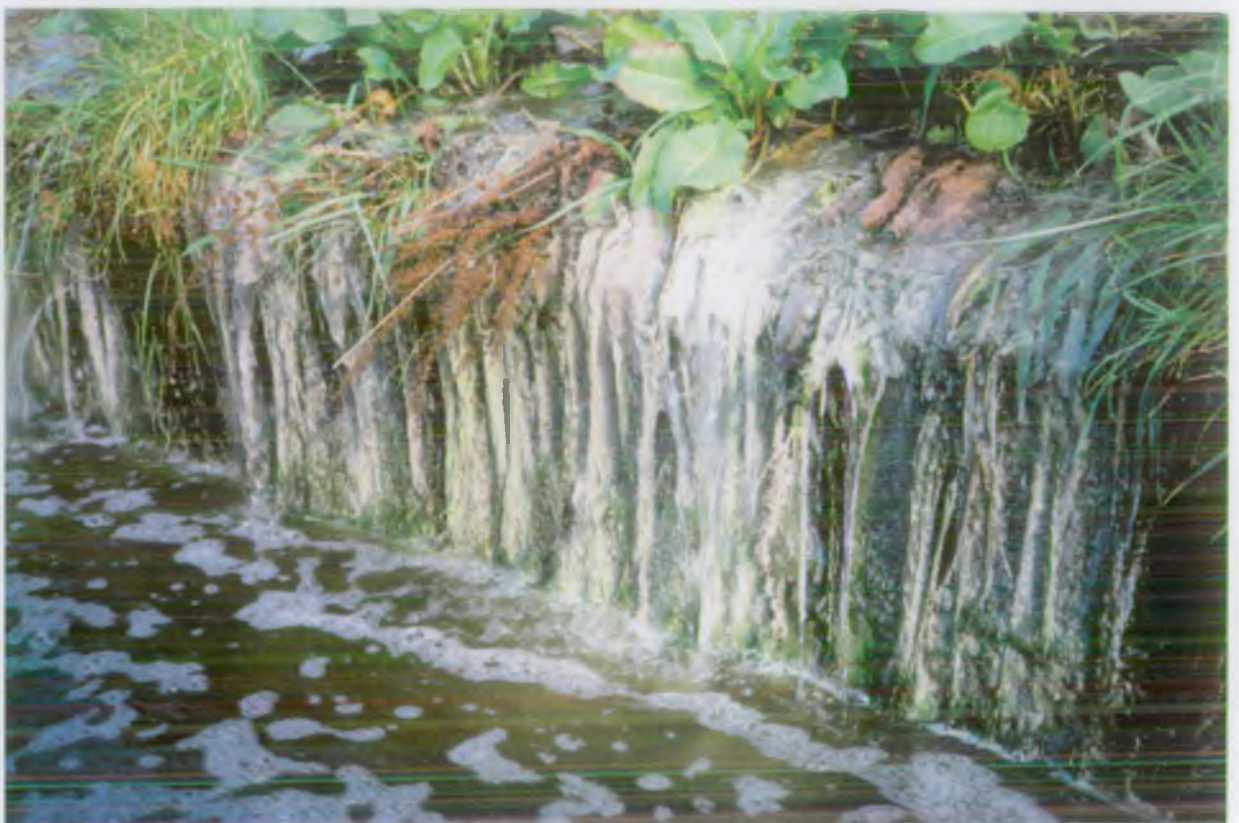
Fungus on Spillway from Land Plot

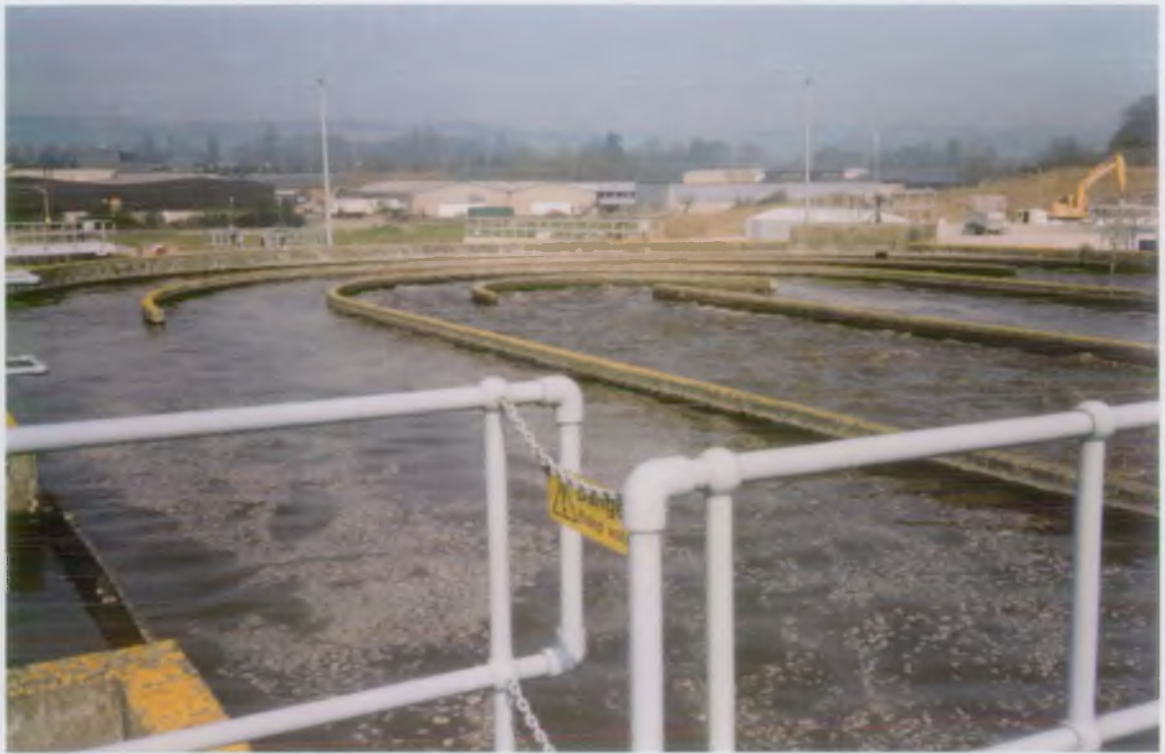
Activated Sludge Plant at Alton Sewage Works

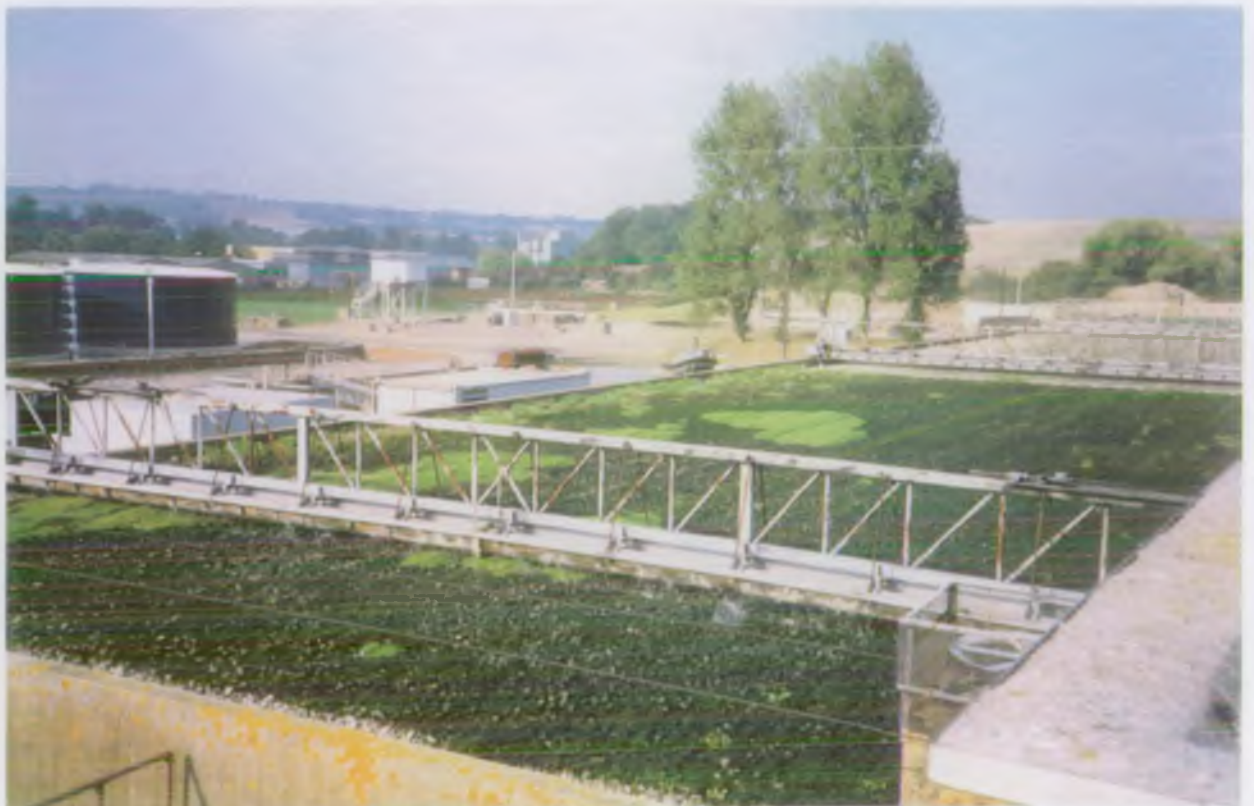
Filter Beds at Alton Sewage Works
