**Calibration of Gauging Stations Using
Portable Ultrasonics.
Supporting Documentation**

R&D Technical Report W6/i646/1

**Project Record
W6/i646/1**

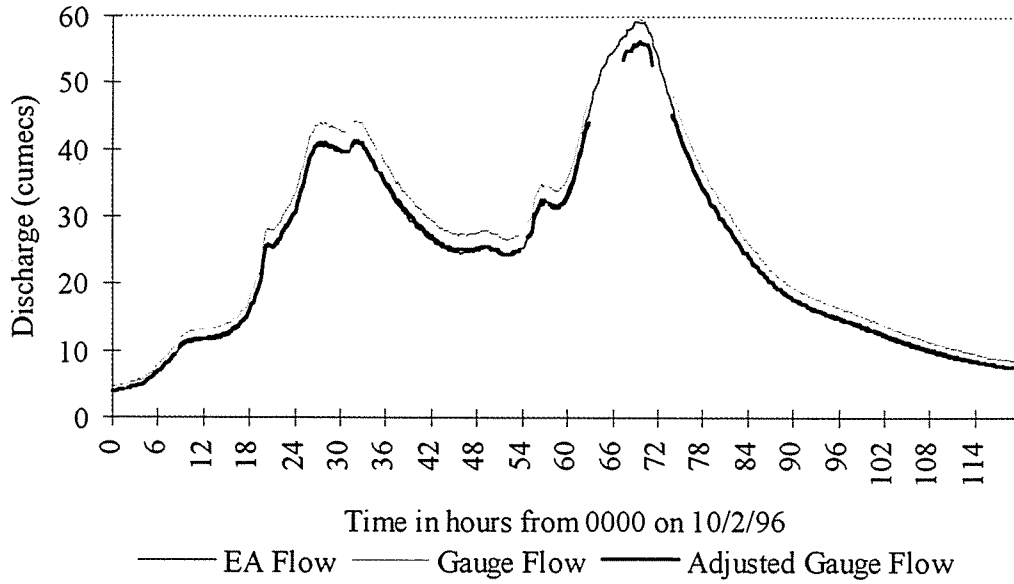
Figure 3.3 Recorded, gauge and adjusted flows at Greenholme between 10/2/96 and 15/2/96

The data were then reprocessed using this revised mean bed level, and the resulting flows are plotted in Figure 3.3, along with the flows initially calculated by the gauge and those recorded by the Agency. From this the improvement in gauge performance can clearly be seen, though it must also be noted that the gauge now calculated the peak flow worse than it did before the bed level was adjusted. If it is remembered that the upper transducer path for this event was only at 0.388 metres, almost 1 metre below the peak water level, and that one of the velocity paths failed during the peak event, this underestimation can be both understood and explained.

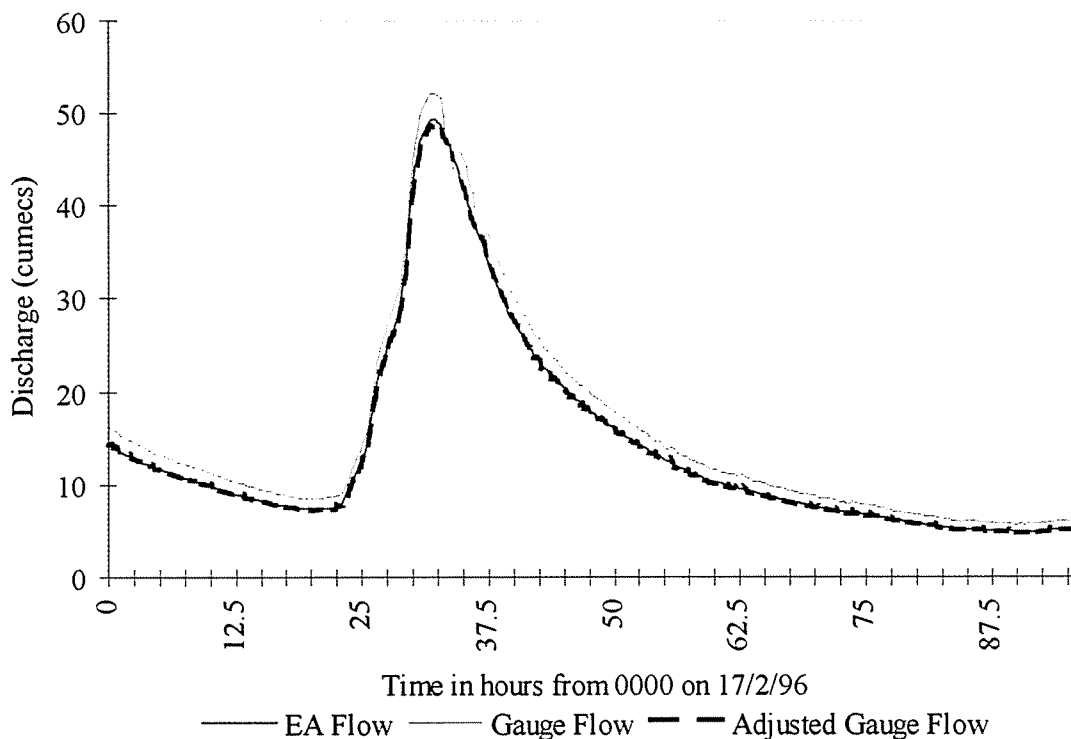
Figure 3.5 Recorded, gauged and adjusted flows at Greenholme between 17/2/96 and 21/2/96

The second event from Greenholme was processed in the same way. Initially the mean bed level was adjusted to the same value used for Event 1, ie -0.32 m. It was found that, due to the upper transducer path being some 100 mm higher, causing the middle section to which the lower path velocities are applied to increase by 50 mm, the level had to be raised 20 mm to -0.3 metres to match the first flow values for this event.

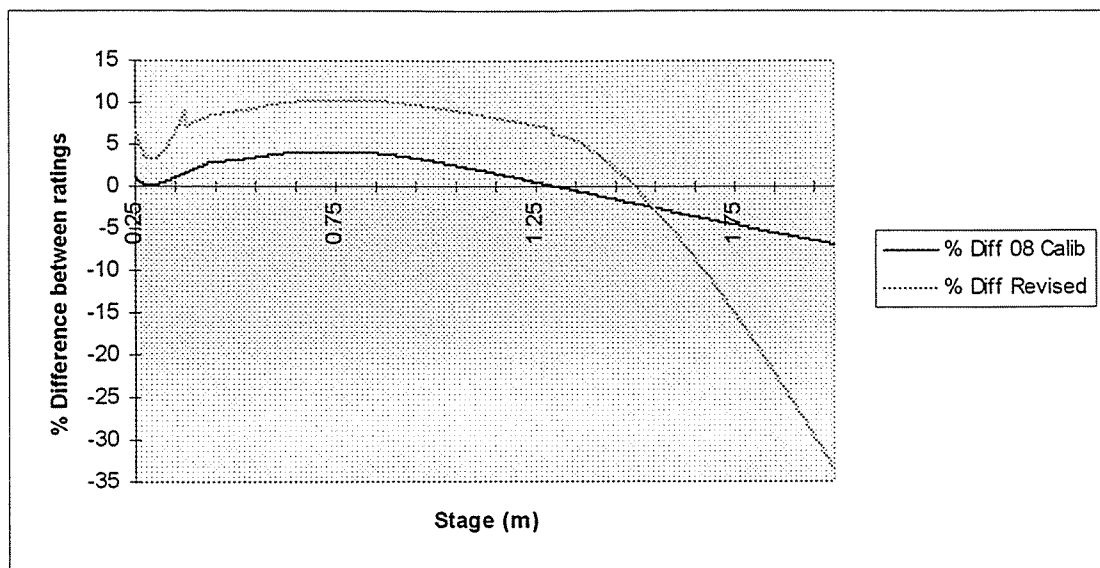
Figure 3.9 % Deviation between the stage discharge relationship derived by the gauge and those used by the Agency.

However, the performance is less impressive when compared to the newly revised rating. Whilst it again performs well up to the 1.5 m level, above that it begins to depreciate significantly with the deviation being over 30% at the 2 m level. It must also be noted that Rating 08 also behaved in a similar way, clearly visible in Figure 3.8, and if the new Agency rating is extended to above three metres it becomes concave once more, eventually rising to meet the two upper curves.

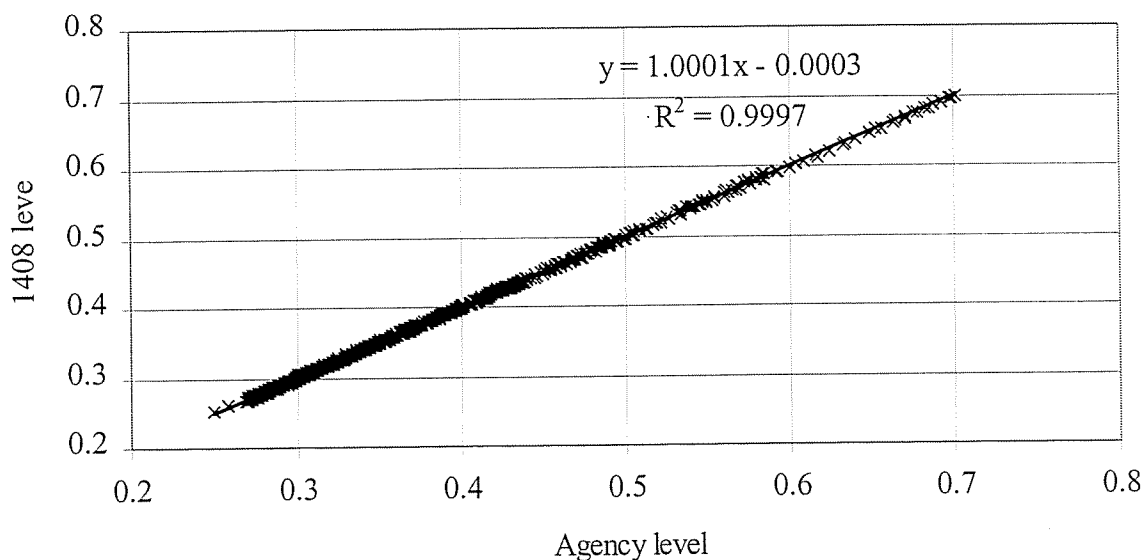
Figure 4.1 Water level data recorded in the Blackford Bridge stilling well by the Environment Agency shaft encoder plotted against the water levels recorded by the Peek 1408 ultrasonic gauge. All levels are expressed as metres, and are relative to stage datum.

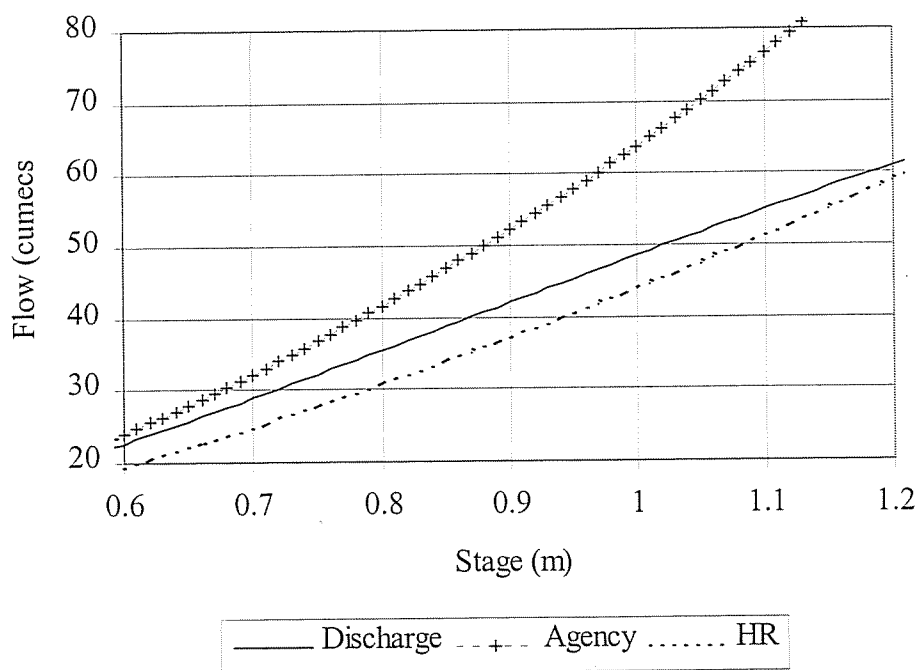
Figure 6.2 The rating curve derived by the stage-velocity method (Discharge) plotted against the Environment Agency and HR ratings for Blackford Bridge between stages of 0.6 and 1.2 metres.

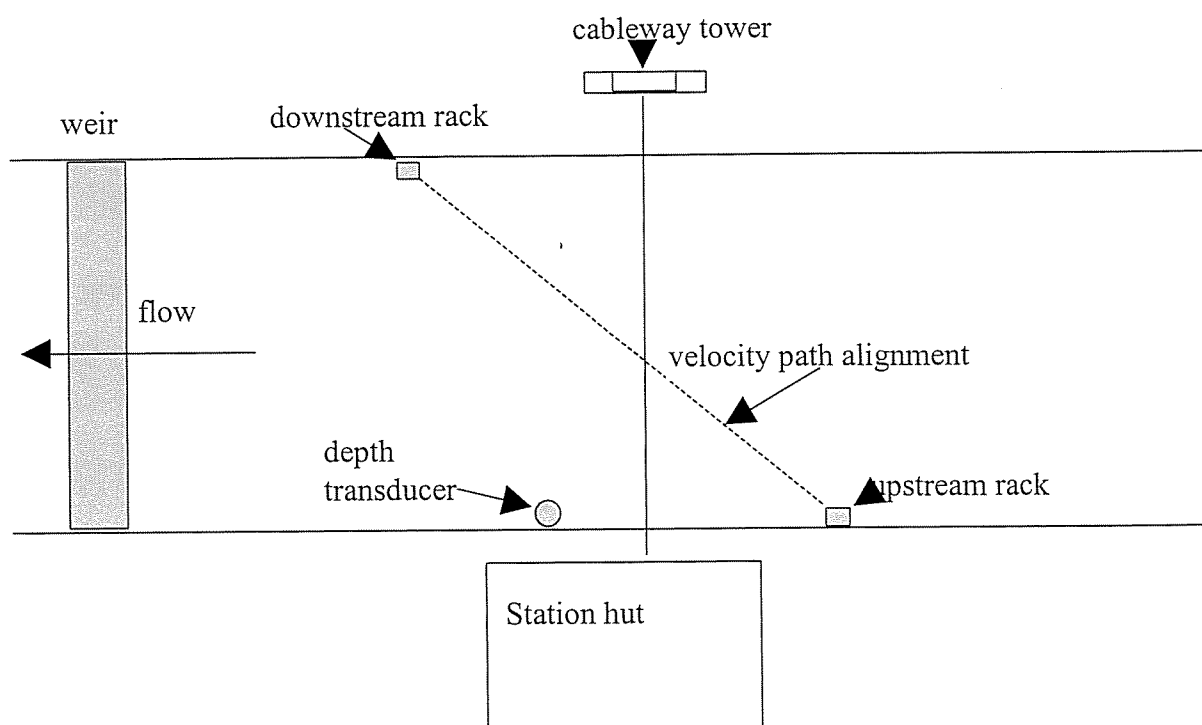
Figure 2.1 Schematic diagram to show the general layout of the gauge installation at Greenholme gauging station (not to scale).

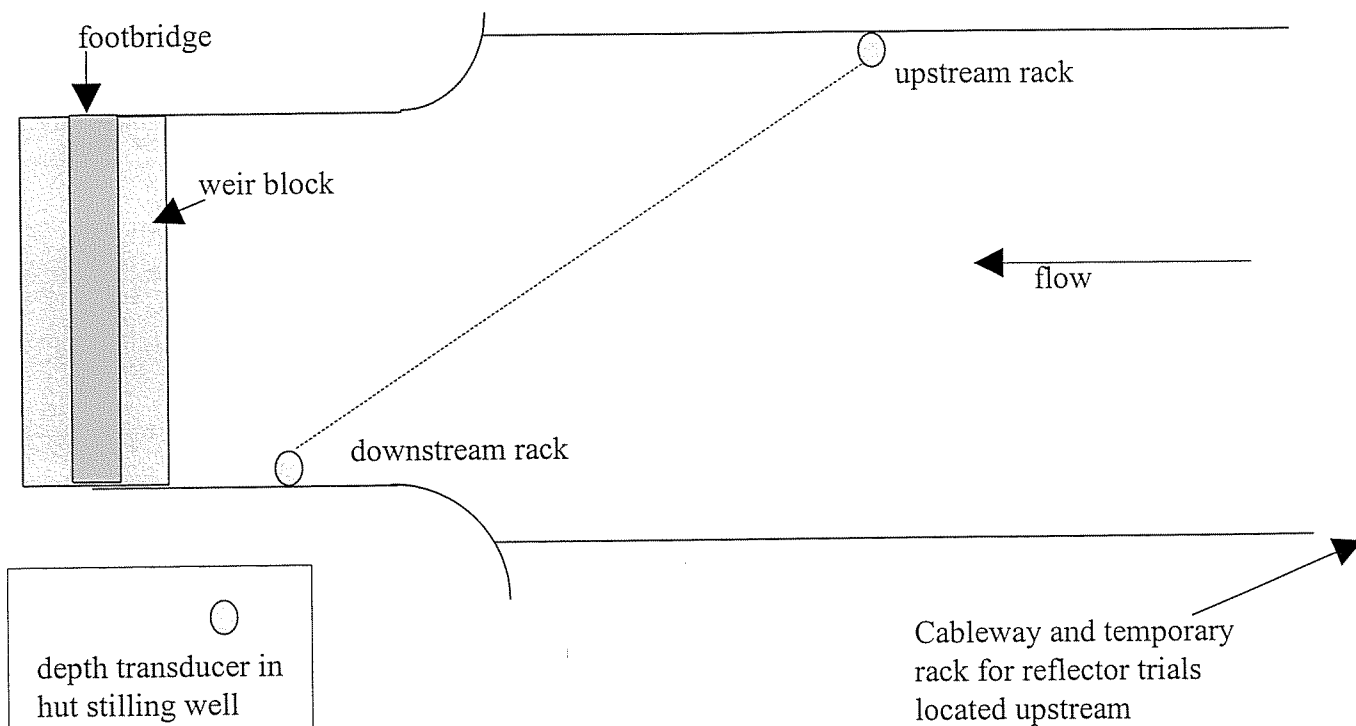
Figure 2.1 Schematic diagram to show the layout of the gauge components at Walcot gauging station (not to scale). The footbridge was used to convey the cables from the far bank.

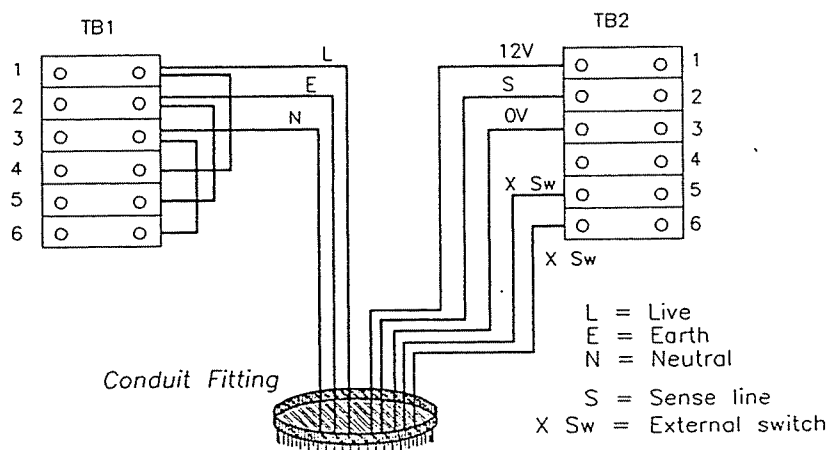
Fig.6 - Power Supply Connections for 120V/110V and 12V External Power Source.

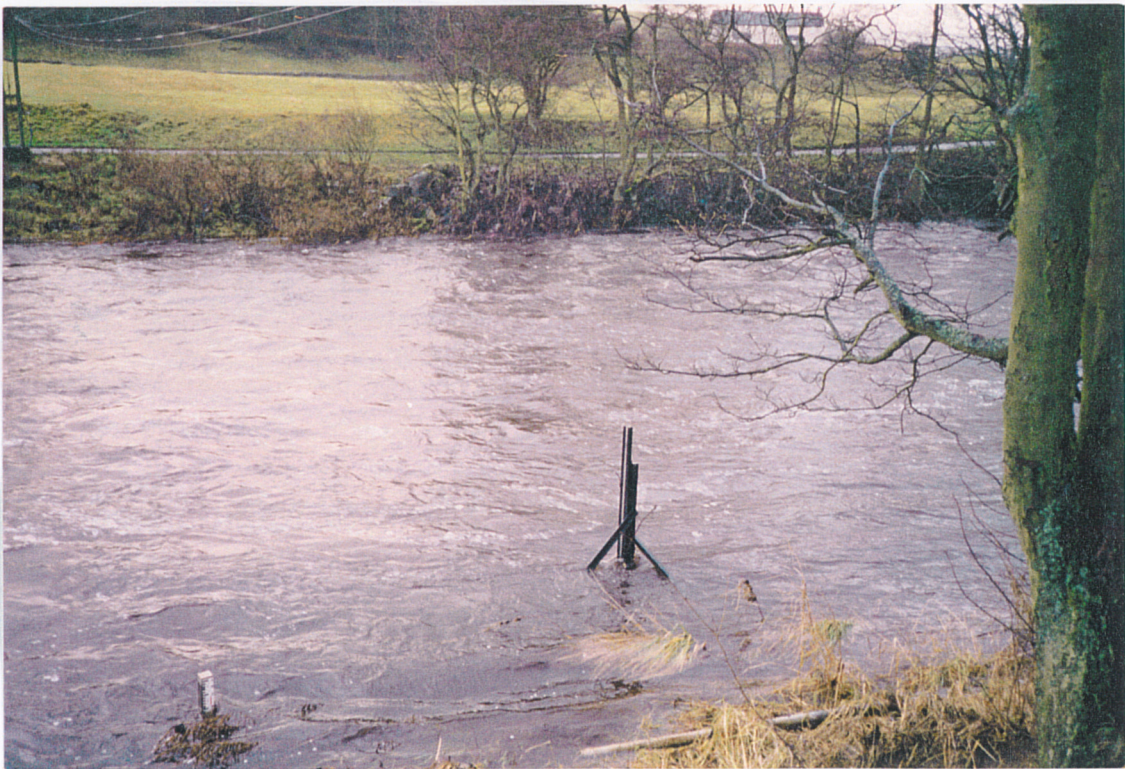
Middleton in Teesdale upstream transducer rack under high flow conditions

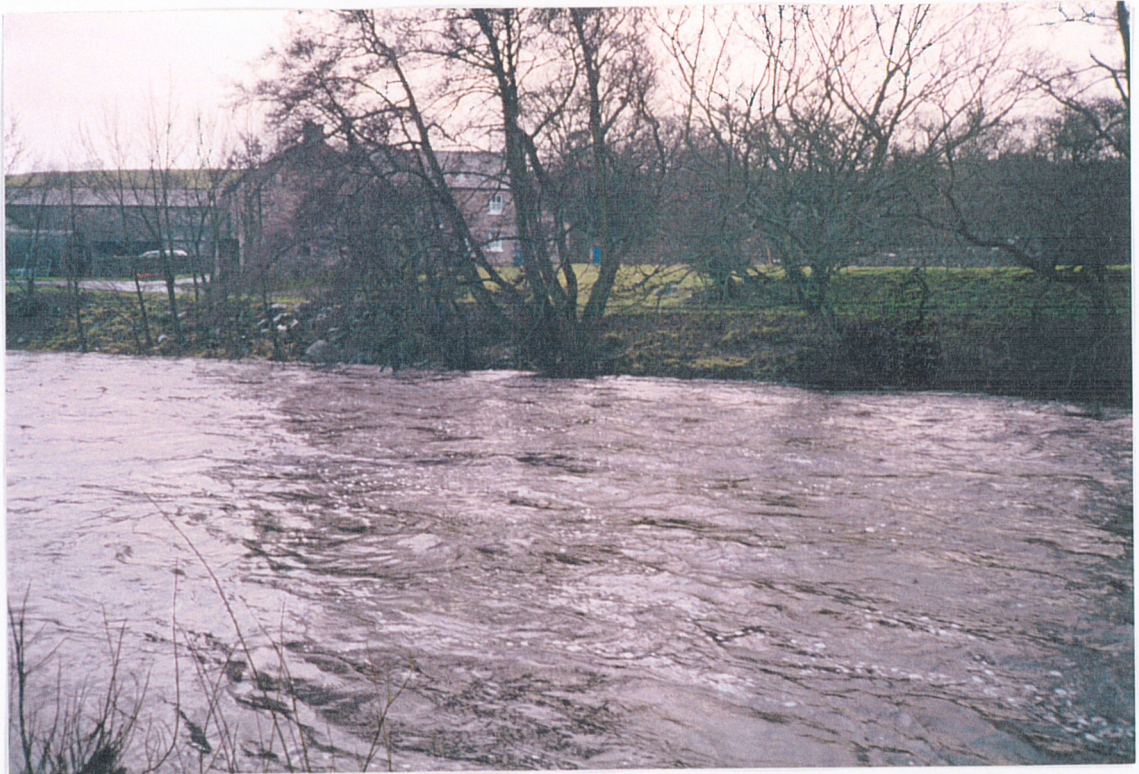
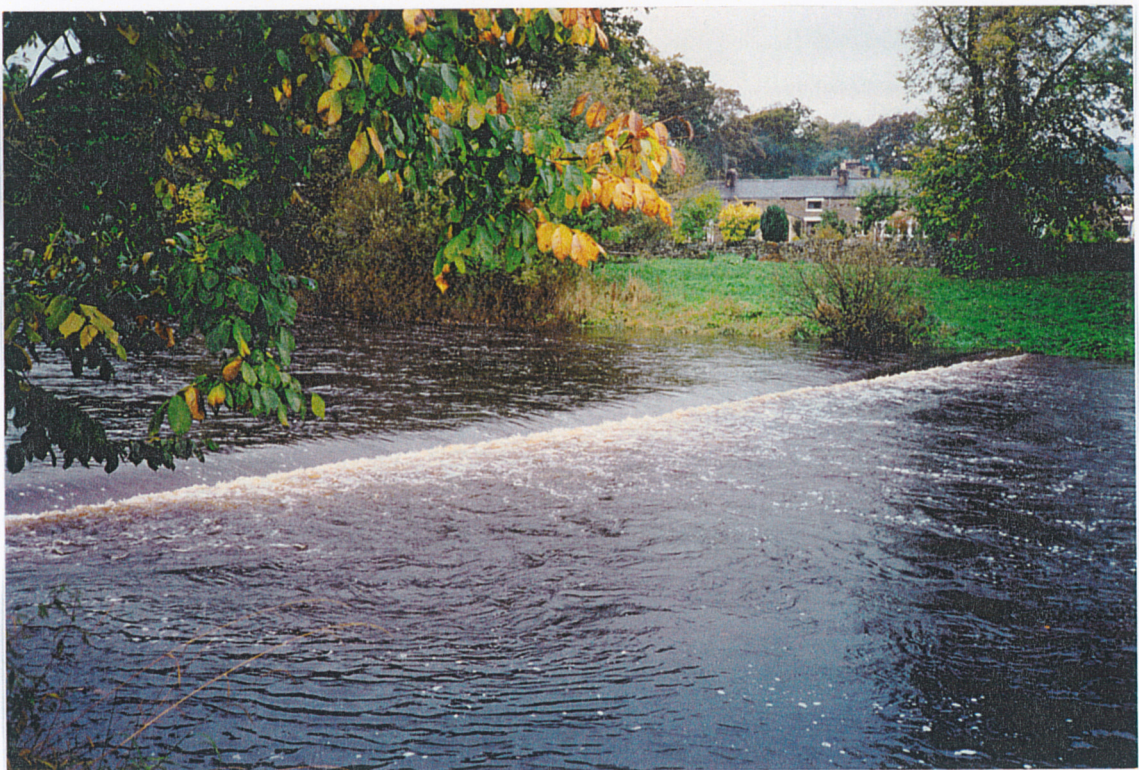
Middleton in Teesdale - view taken looking downstream to weir (top) with transducer rack on far bank just visible, and looking upstream over the weir crest from the far bank (lower).

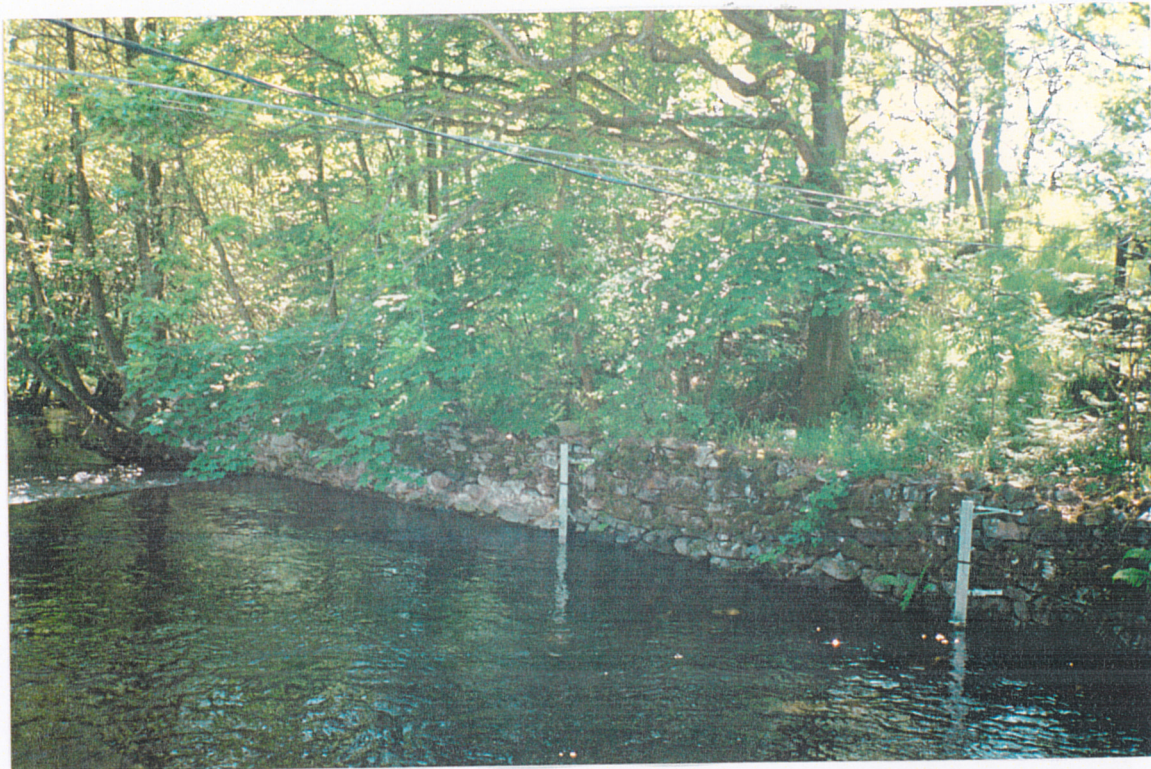
Low Nibthwaite - view downstream to far bank showing transducer racks and weir.

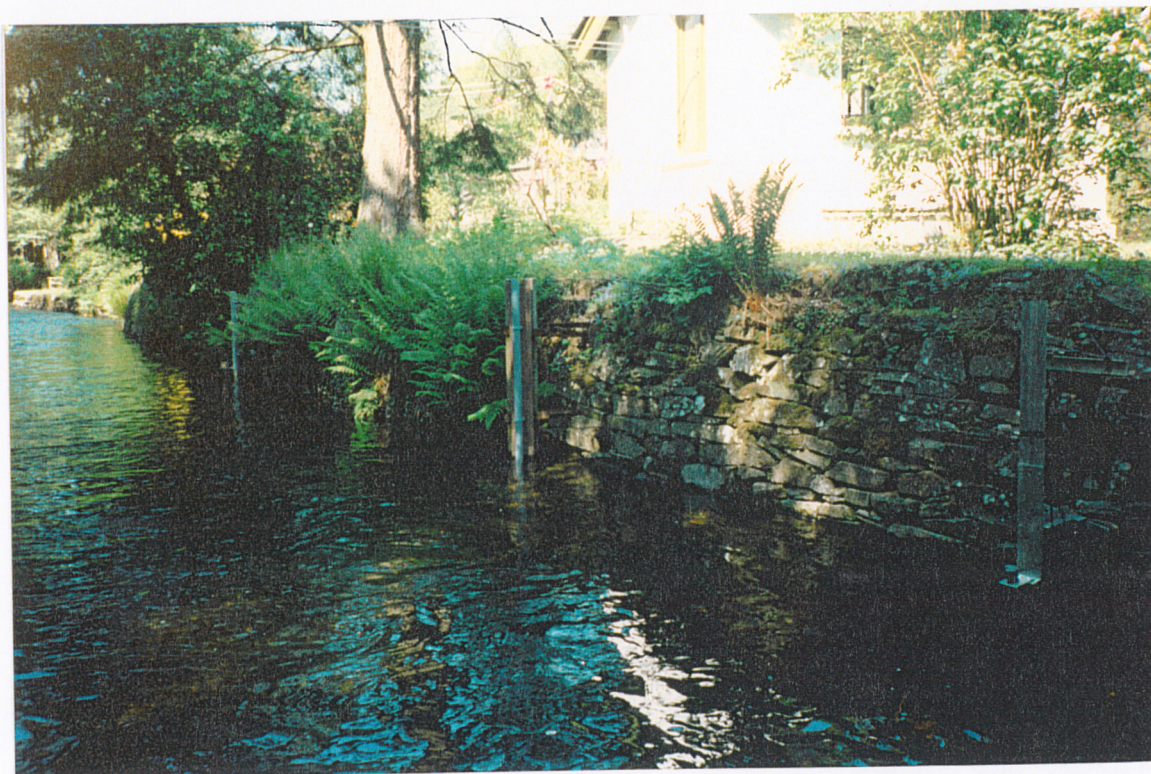
Low Nibthwaite - view upstream to near bank showing the two transducer racks together with the depth mounted in the stilling tube.

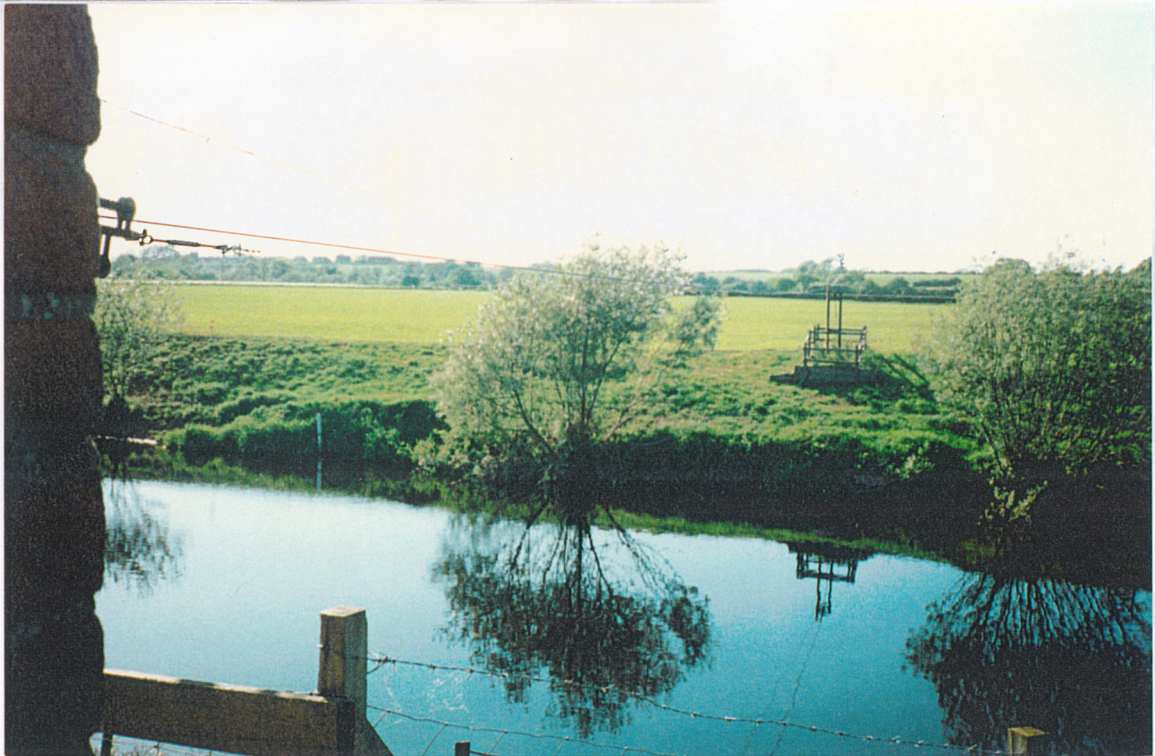
Looking across the River Irthing at Greenholme from the gauging station to the downstream transducer rack under low flow conditions.

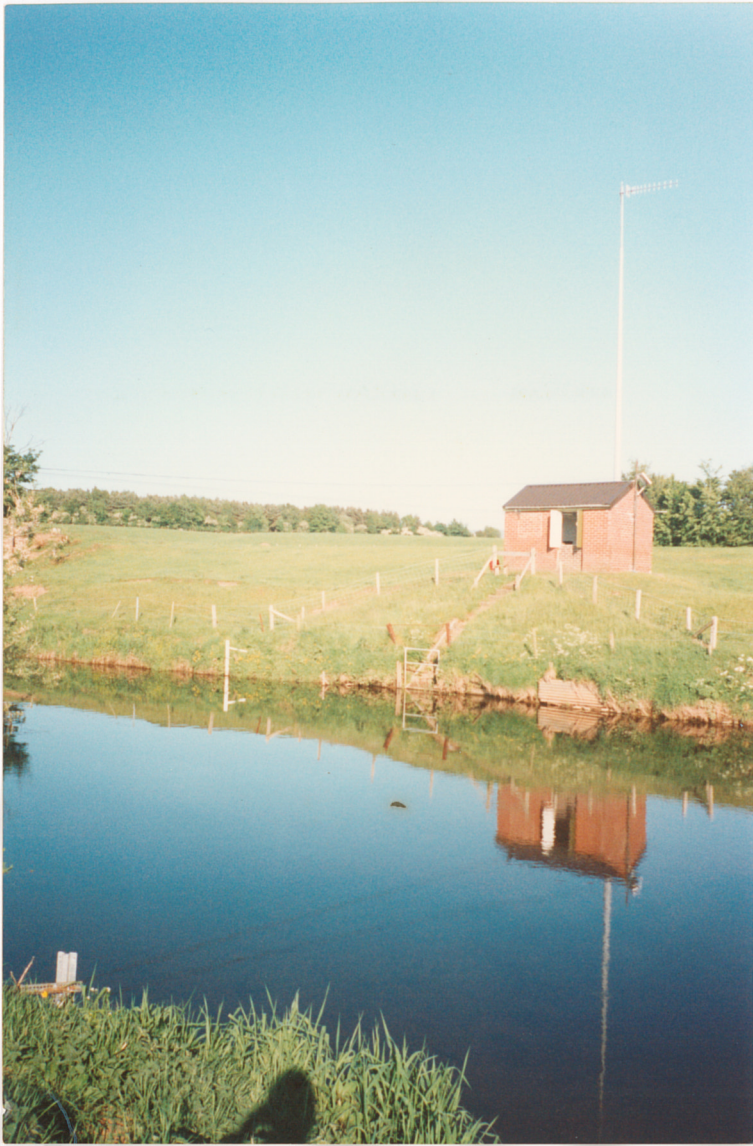
Looking across to the Greenholme station hut along the line of the velocity paths. Transducer racks can be seen in the immediate foreground (downstream) and on the far bank (upstream).

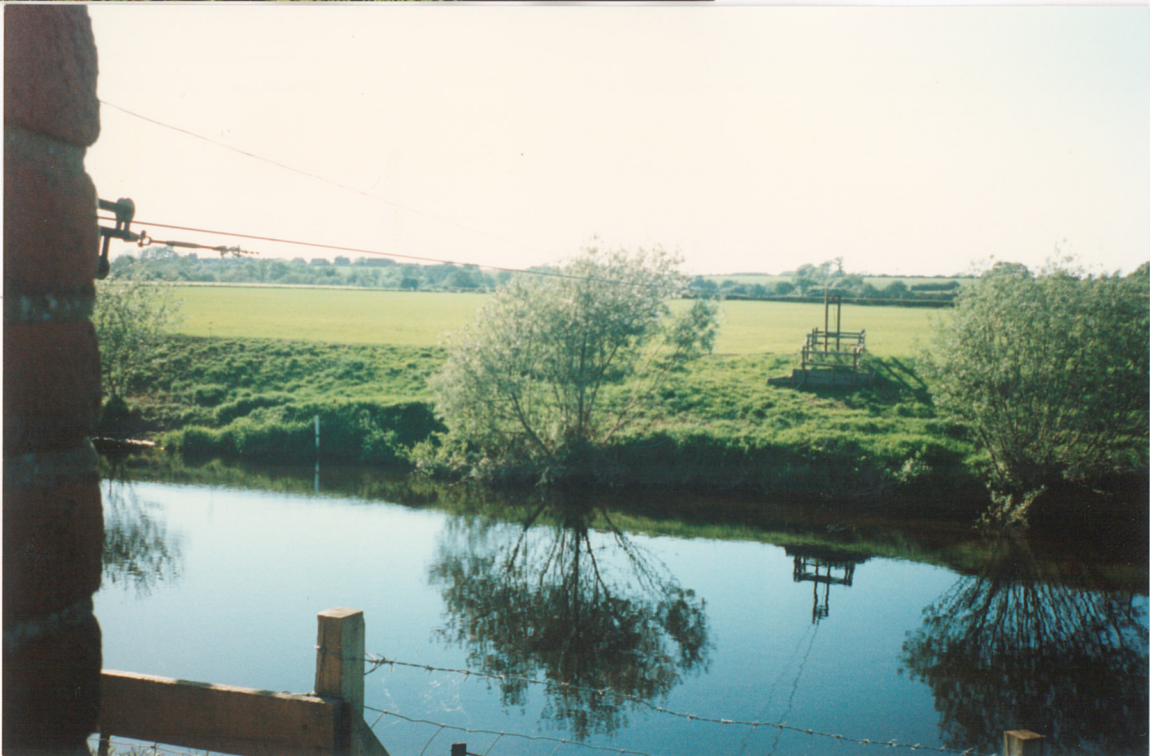
Looking across the River Irthing at Greenholme from the gauging station to the downstream transducer rack under low flow conditions.

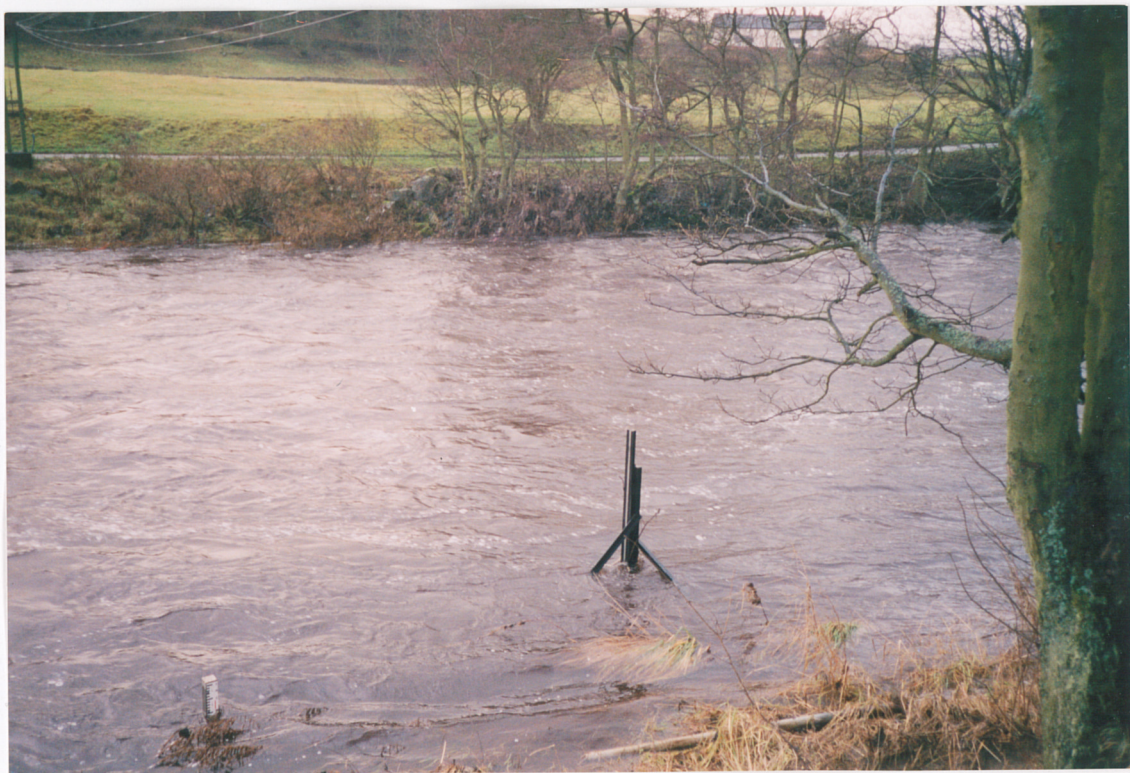
Middleton in Teesdale upstream transducer rack under high flow conditions

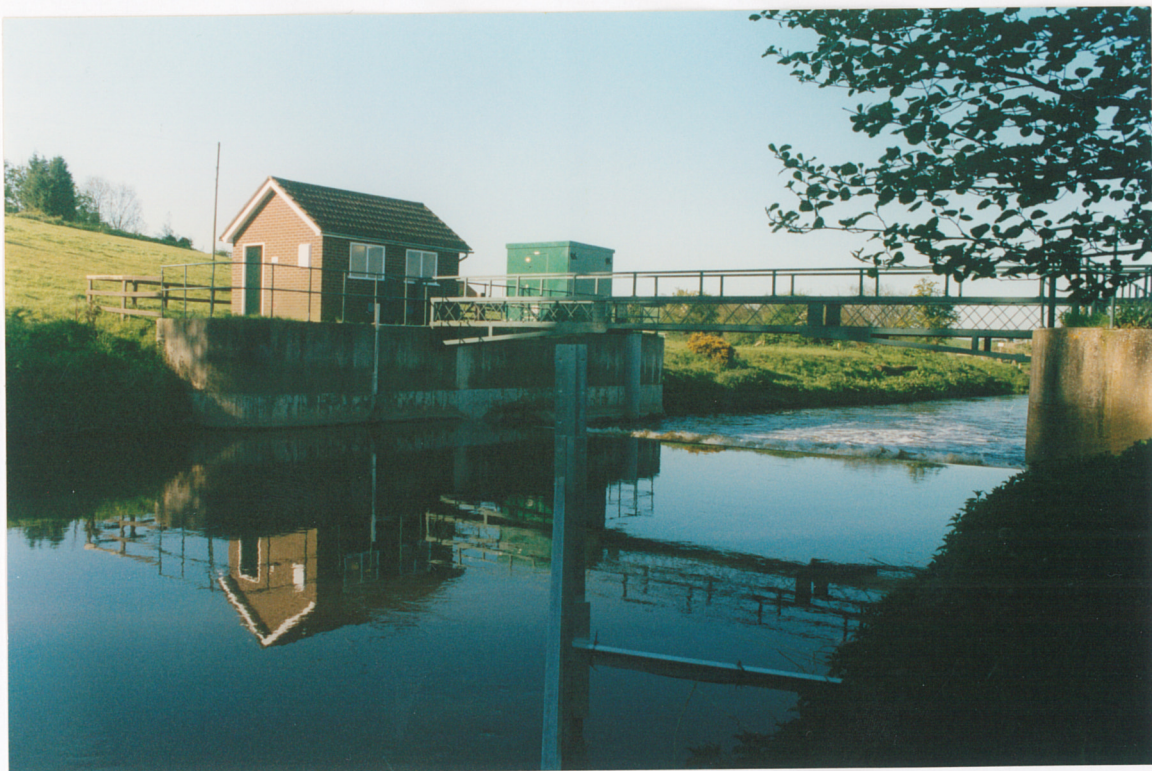
View downstream and across to the Walcot gauging station and weir from the upstream transducer rack, visible in the immediate foreground.
