River Weirs – Good Practice Guide

Guide - Section A

R&D Publication W5B-023/HQP

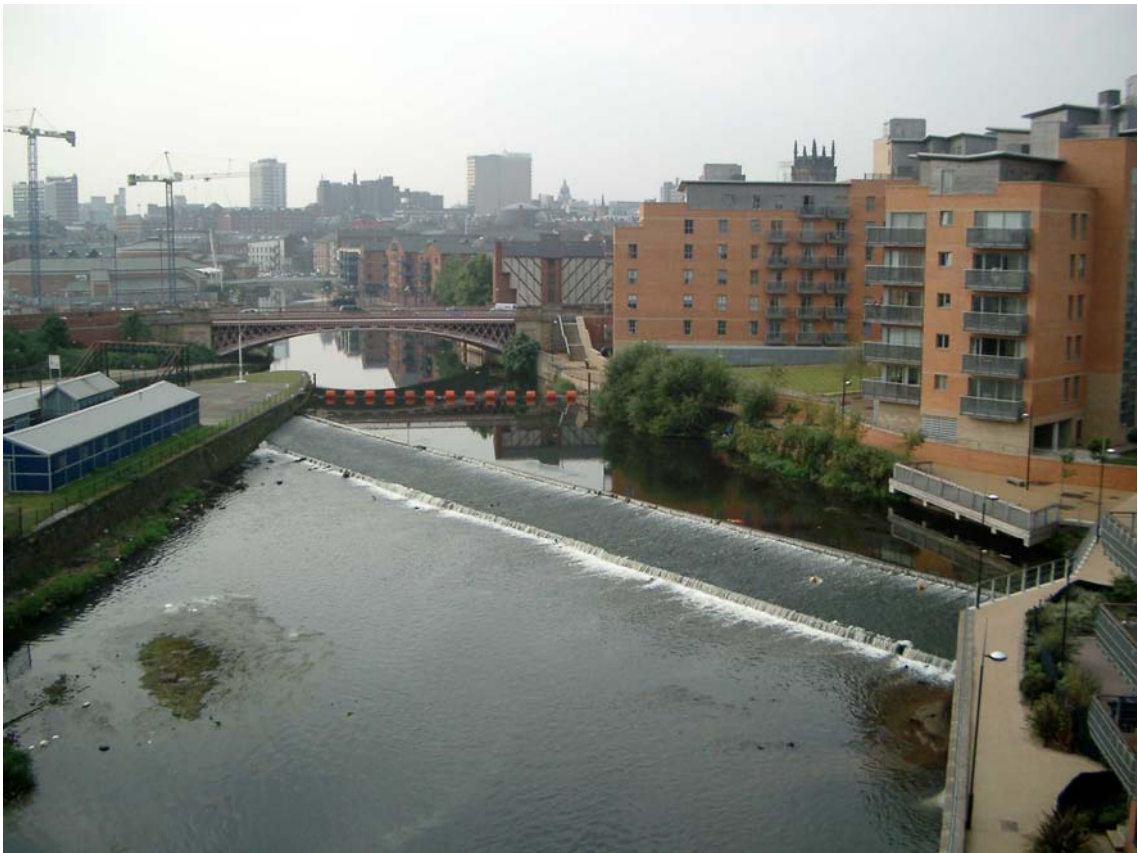
Figure 1.1 Crown Point Weir

Crown Point weir on the River Aire in Leeds is located in an area of renewal and development. The weir is diagonal to the flow to maximise the crest length and thereby reduce water level variation upstream. Note the new riverside walk on the right of the picture, and the historic bridge in the background (photograph courtesy of British Waterways).

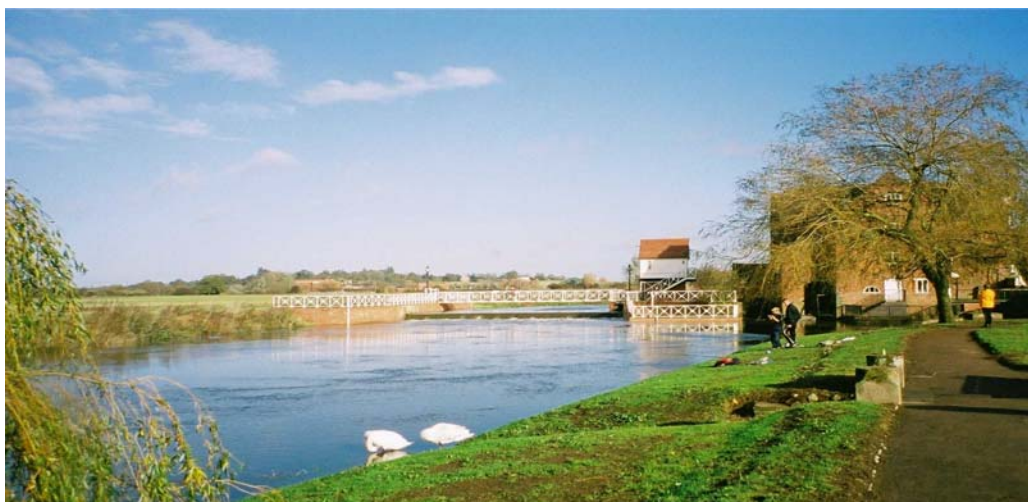
Figure 1.2 Tilting gate weir at Tewkesbury

A former mill weir at Tewkesbury now replaced by a tilting gate allowing precise control of upstream water level. Note that works of this nature can readily blend in with an attractive landscape. The weir is on the right of the picture, and is indistinguishable from a conventional weir.

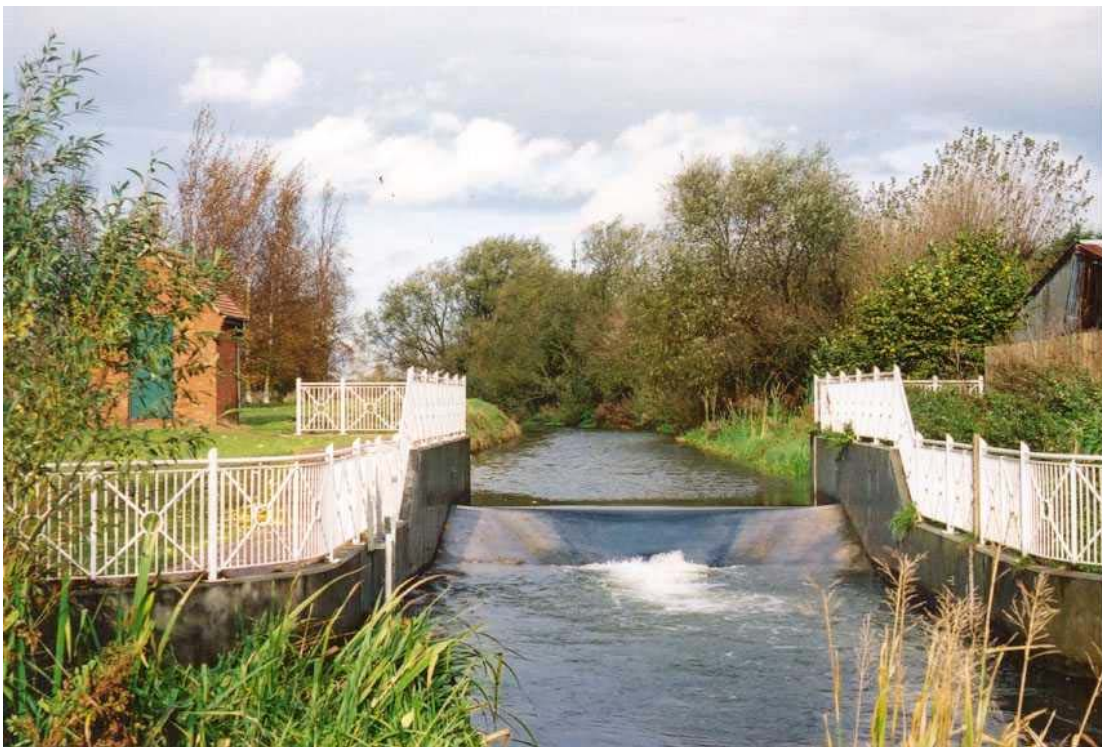
Figure 1.3 Gauging weir at Horncastle

A modern discharge monitoring weir of the flat-vee type. This type of weir is often favoured for its accuracy of flow measurement and suitability for both low and high flows. It is one of the best weirs for sediment conveyance, but tends to make fish migration difficult. Note that it is possible to create an attractive gauging weir that sits well in its surroundings.

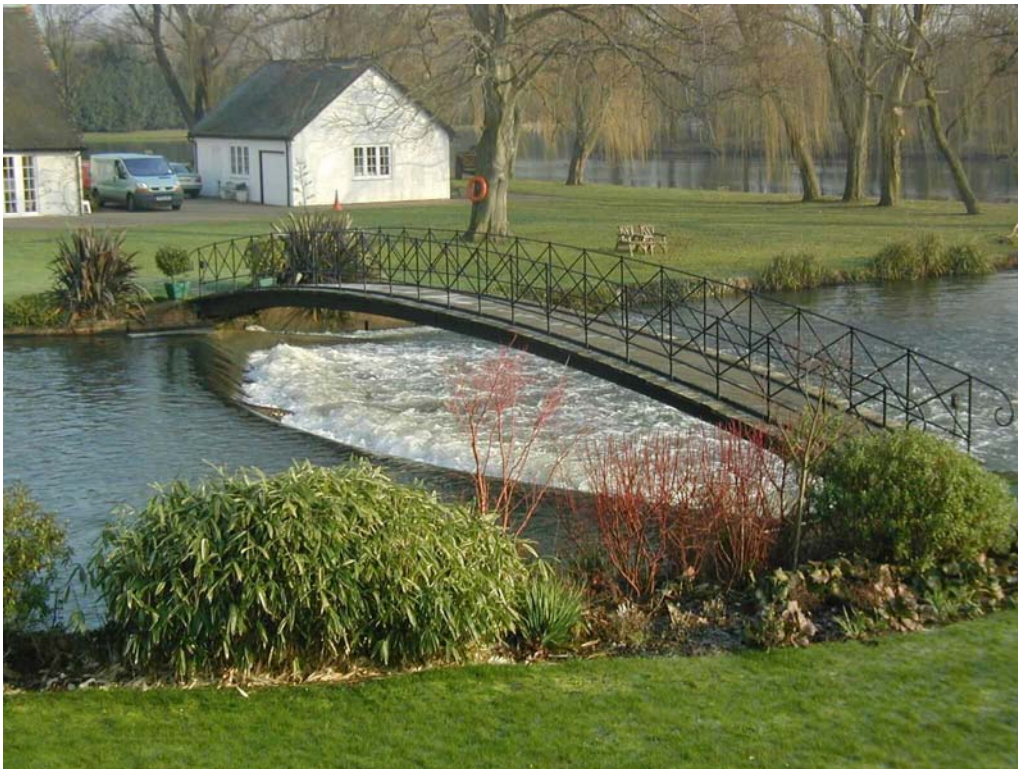
Figure 1.4 Thorney Weir

Not all weirs can be designed to enhance the visual environment as much as this graceful structure with its arching form and matching elegant footbridge, but even a little extra thought at the planning and design stages can yield significant environmental benefits. Note that this weir has two fish passes, one on either flank.

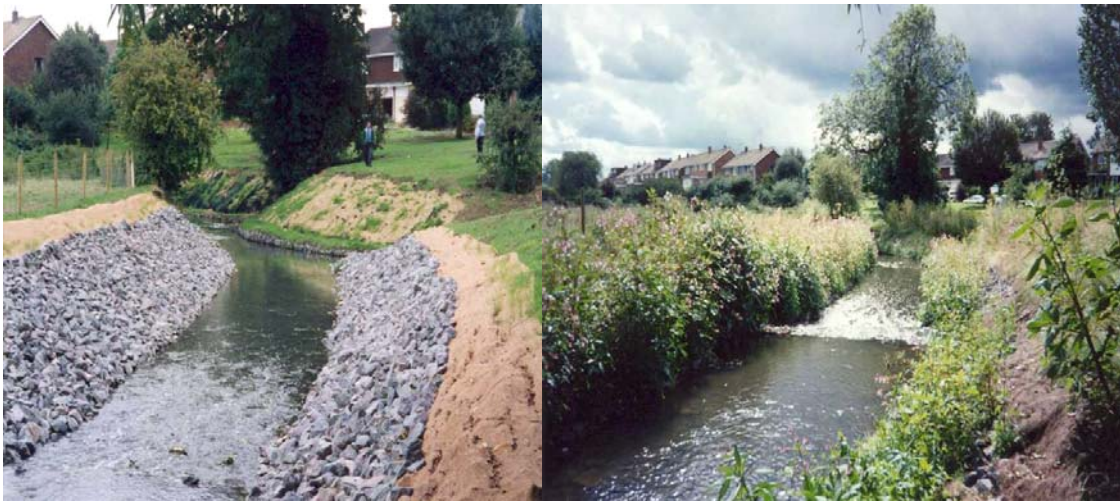
Figure 1.5 Cripsey Brook

The creation of a riffle in a small urban brook can look quite stark immediately after construction, despite the use of natural materials (rock). However, as the second photograph (taken one year later) shows, such works soon blend into the environment.

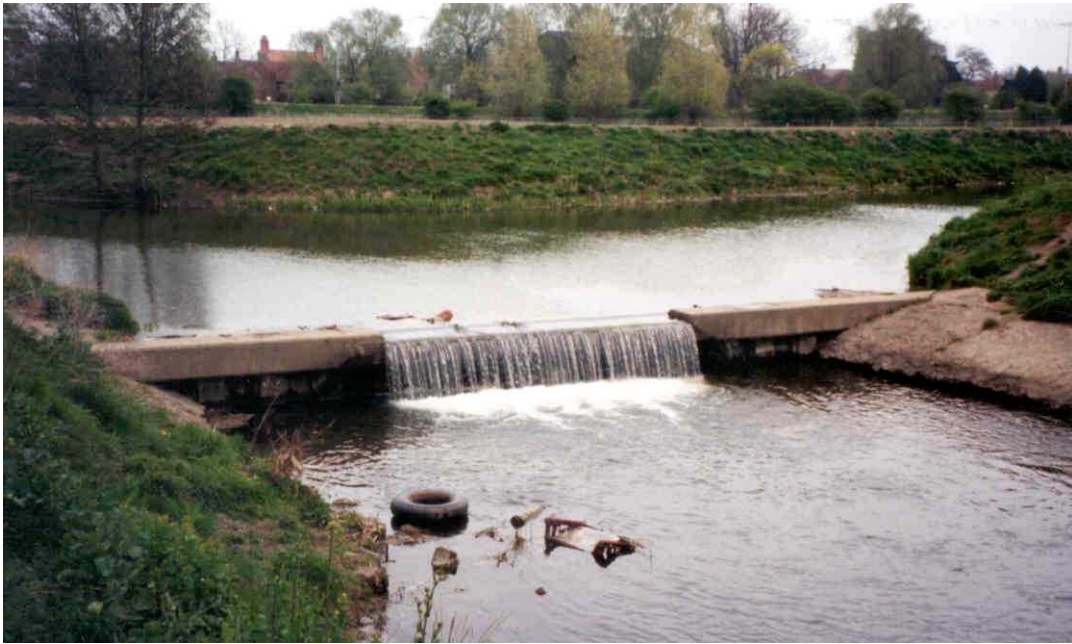
Figure 1.8 Rehabilitation potential

Rehabilitation of a weir such as this offers considerable opportunities for environmental enhancement, as well as improved safety.

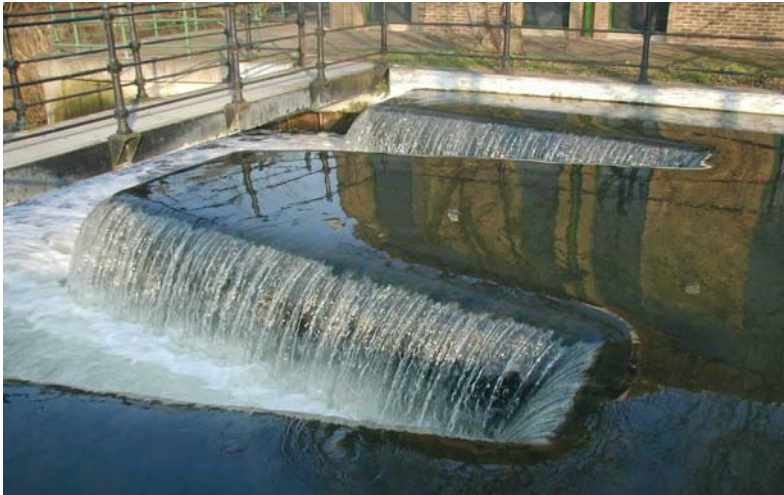
Figure 1.9a Labyrinth weir

The labyrinth weir has a long crest length in a relatively short overall width. It is therefore good for reducing upstream water level variation in low to moderate flows. In flood flow conditions, the labyrinth effect is diminished, and the weir will tend to perform as a broad-crested weir with a crest length equal to the width of the channel.

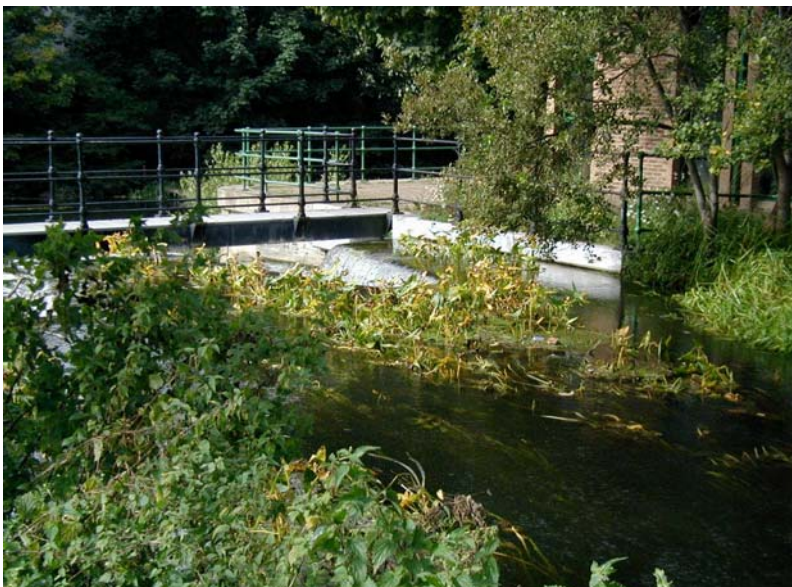
Figure 1.9b The same weir with weed growth

Don't forget that all structures have maintenance requirements.

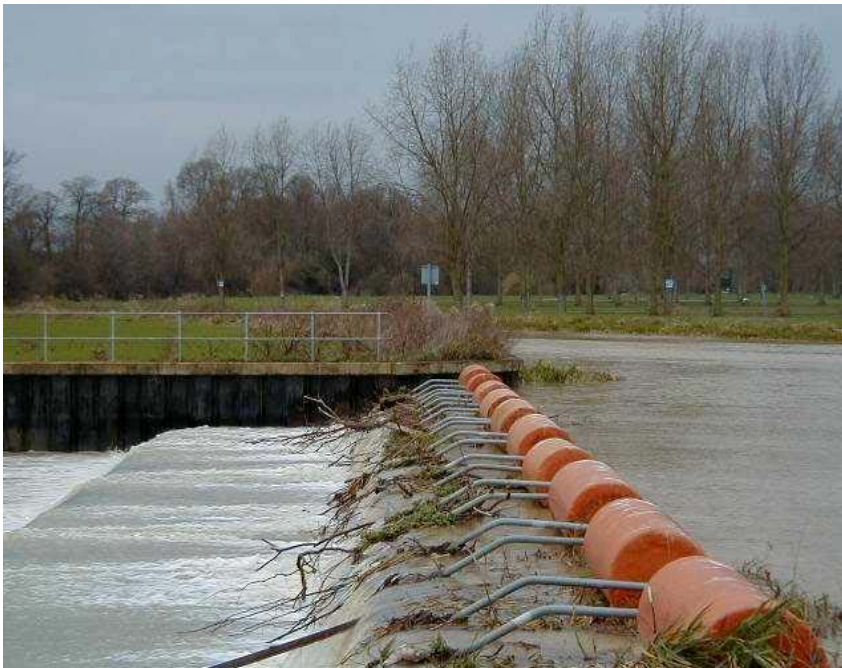
Figure 2.2 Safety boom upstream of a weir

The boom is designed to prevent accidental navigation over the weir. Note that the boom also acts to trap debris, which is difficult to clear.

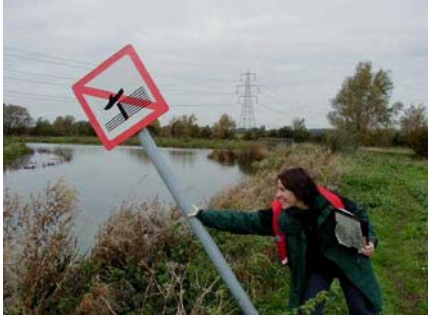
Figure 2.3 Warning sign

Warning signs need to be highly visible and secure against vandalism (NB And life jackets need to be fastened if they are to be effective!). In some circumstances it will be important to provide lighting at a structure, particularly if it is likely to be used (for example by canoeists) in conditions of poor natural light.

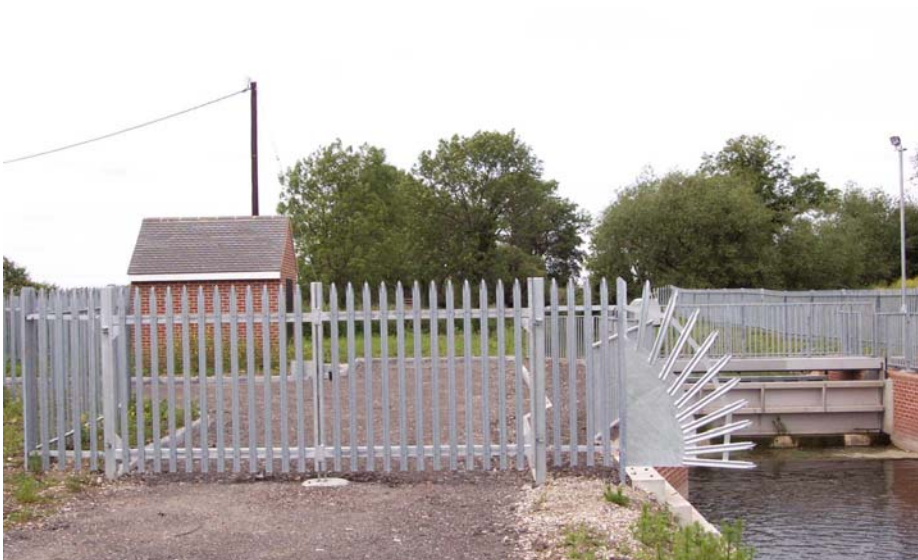
Figure 2.4 Security fencing

In situations where it is essential to discourage access or minimise vandalism, fencing like this may be necessary. Fortunately, most weirs do not require such a level of protection.

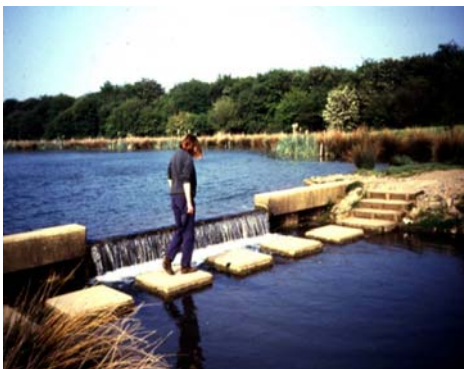
Figure 2.5 Stepping stones

This imaginative way of providing access at a weir via stepping-stones needs careful consideration. Its simplicity and attractive appearance must be weighed against the risks of pedestrians slipping or falling into deep water.

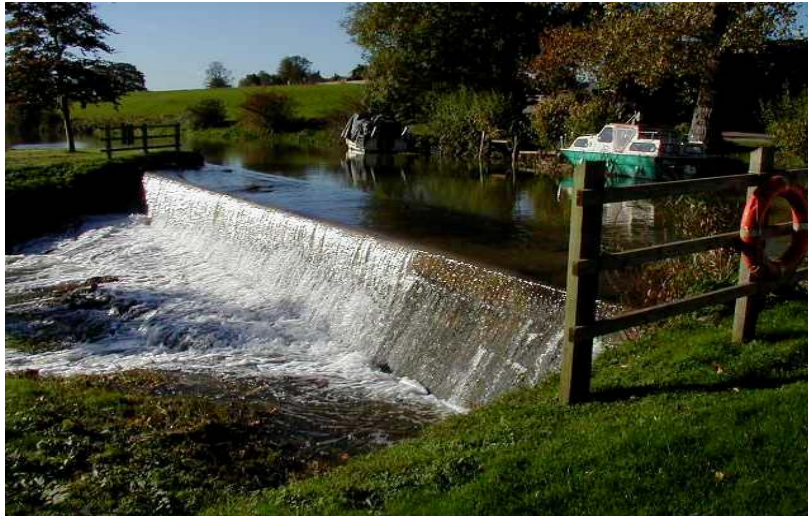
Figure 2.6 Dangerous side weir?

This side weir regulates the water level in the navigation waterway. There are clearly risks associated with people gaining access to the structure, with a steep drop on one side and deep water on the other. Basic risk reduction measures have been provided in the form of fencing and safety equipment, but more could be done. However, it will never be possible to restrict all access or provide comprehensive safety equipment – it is a question of balance.

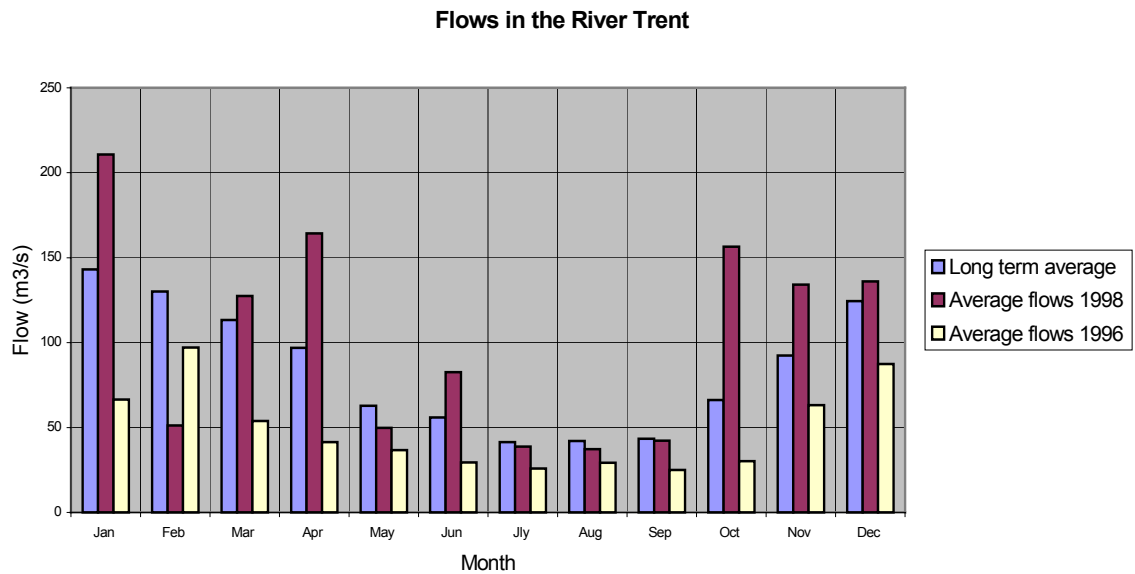
Figure 2.9 Flows in the River Trent

The figure is based on data for the period 1970 to 2001 (32 years of record). It can be seen that the long-term average monthly flow shows a distinct seasonal pattern, with the highest flows generally occurring in January, and the lowest in July/August. However, examination of actual monthly average flows for the years 1996 (a generally dry year) and 1998 (a rather wet year) shows that the average flow rates hide a wide range of variation. So, for example, the long term average flow for the month of October is about 65 m³/s, but in 1998 the monthly average was more than twice this at 155 m³/s, and in 1996 less than half at 30 m³/s. It is important to acknowledge this natural variation, not only in terms of the design of a weir, but also in terms of planning construction activities in the river.

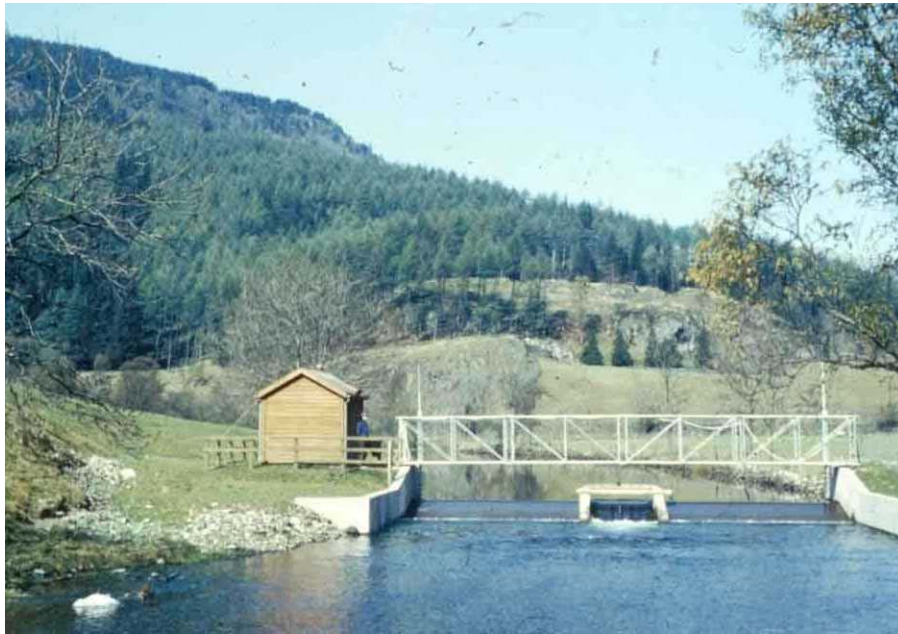
Figure 2.11 A flow gauging weir with a central low-flow section

Flow gauging weirs are often required to measure both high and low flows accurately. One way to achieve this is to have a low flow section in the weir. The flat-vee weir (see Figure 2.12) is another alternative.

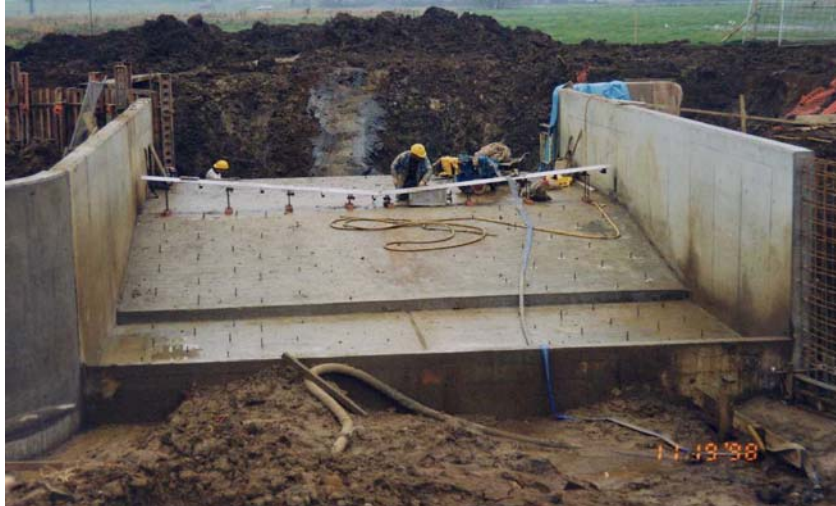
Figure 2.12 Construction of crest for a flow gauging weir

For accurate flow measurement, this flat-vee weir has a steel crest insert that is precisely positioned prior to casting in concrete.

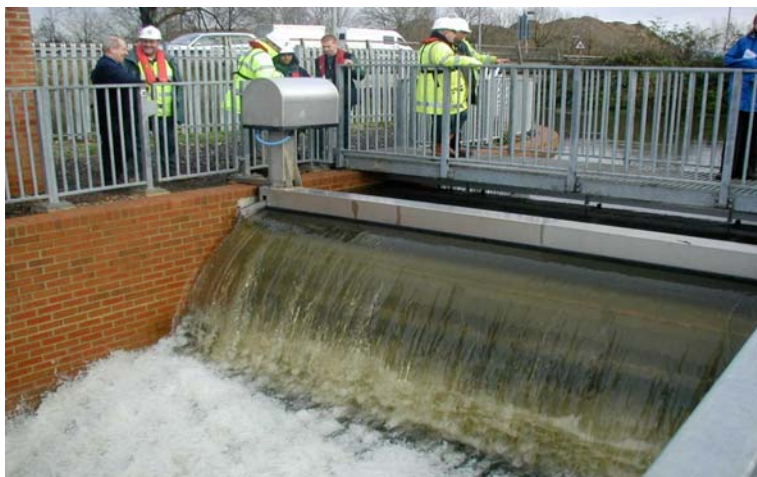
Figure 2.13 Aerated nappe

In this structure aeration of the nappe is ensured by providing a gap between the walls of the structure and the edge of the tilting gate. An alternative way to achieve this is to provide a flow splitting device in the centre of the weir crest. This divides the jet leaving the weir and allows air free access to the underside of the nappe. In both cases the aim is to reduce the risk of vibration of the weir gate.

The nature of water flow over a weir depends on many factors. Contrast the natural cascading flow illustrated in Figure 2.29 with the clean “nappe” of the flow over a tilting gate weir (Figure 2.13 below). In certain situations it is important to achieve a smooth undisturbed flow of water over a weir. This may be for visual appearance, or to reduce the risk of vibration in an adjustable steel weir. In the latter case, the nappe (or jet of water over the weir) is not in contact with the weir glaucis once it has spilled over the crest. The gap between the weir and the nappe can exhibit pressure fluctuations if not properly aerated.

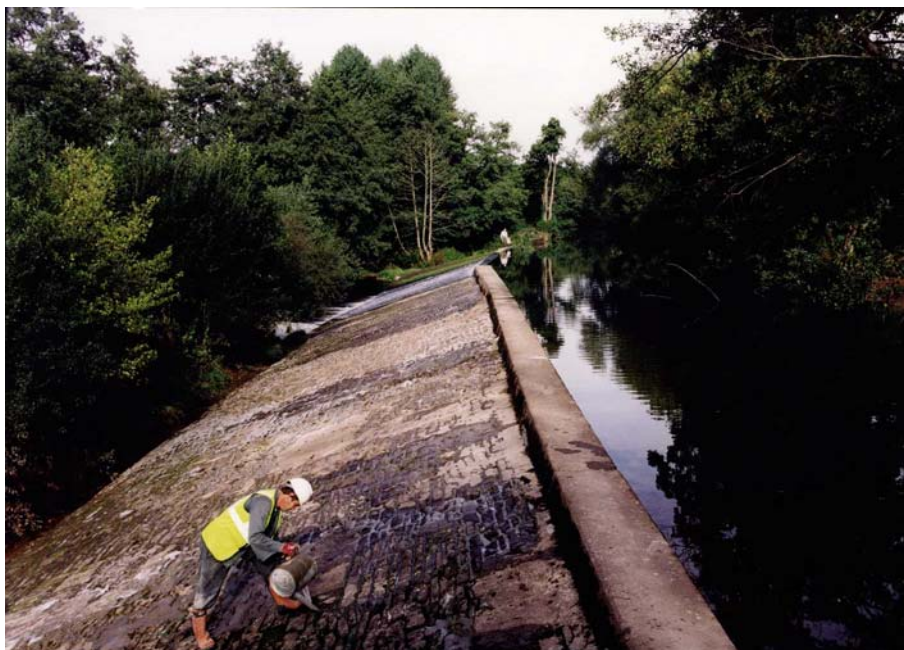
Figure 2.14 Repairs to mortar joints in a masonry weir

Repair of mortar joints in a masonry weir using a proprietary product to resist erosion damage (photograph courtesy of Easipoint, Chorley, Lancs).

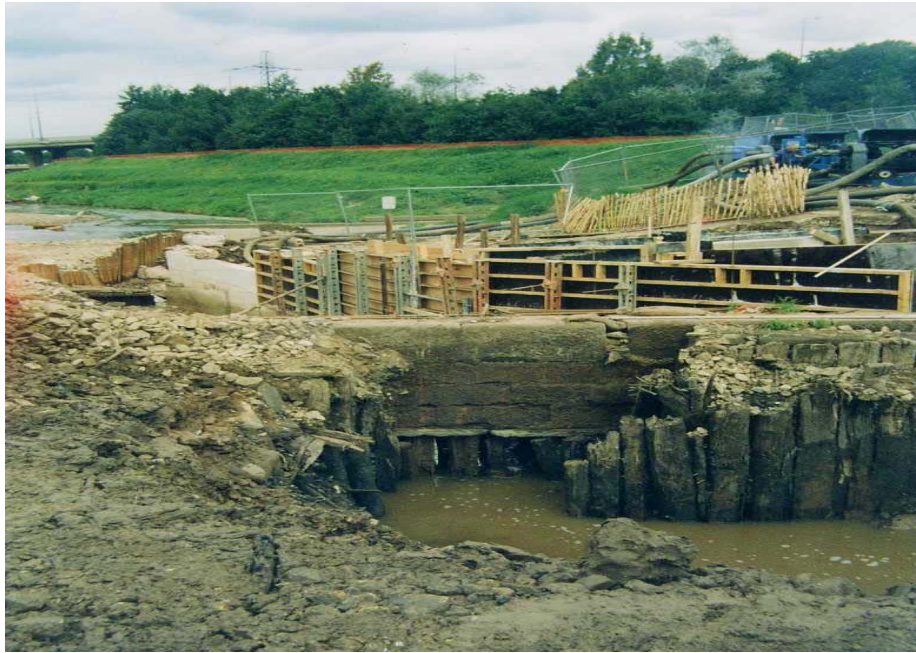
Figure 2.15 Northenden Weir, River Mersey

The presence of old timber piles can complicate remedial works to weirs, especially if it is necessary to drive steel sheet piles through the old timber piles.

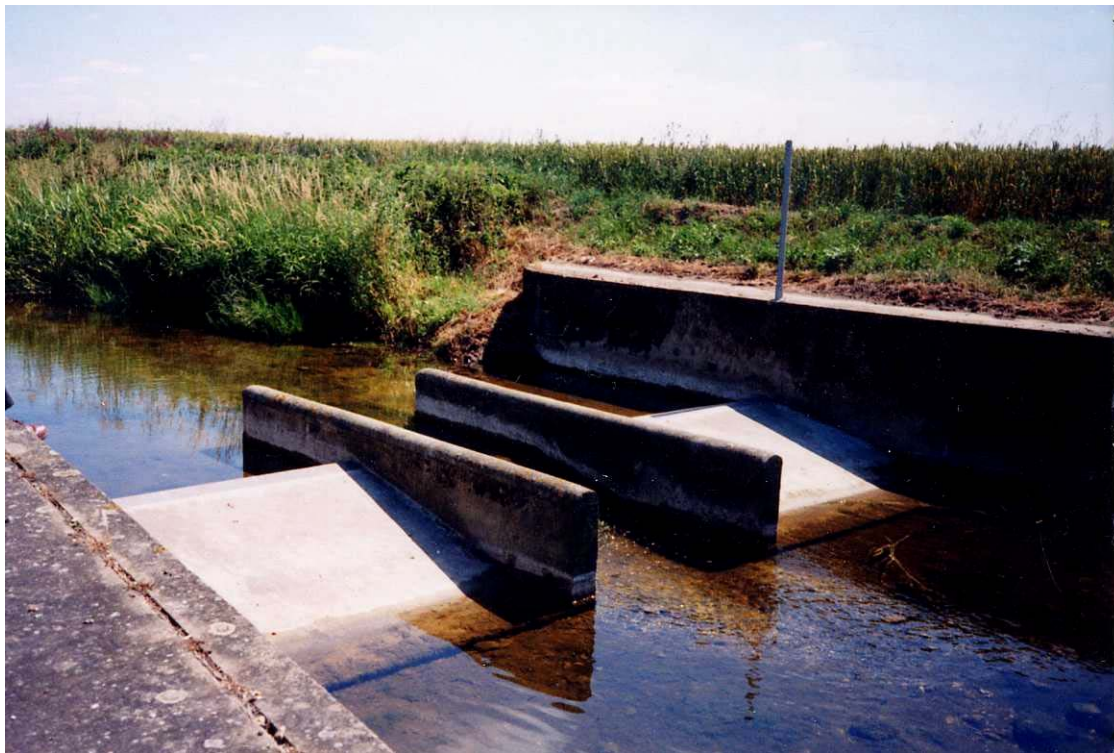
Figure 2.16 Concrete weir

This weir may be hydraulically efficient, but the stark concrete finish makes the structure unattractive (and the lack of hand railing raises questions of safety).

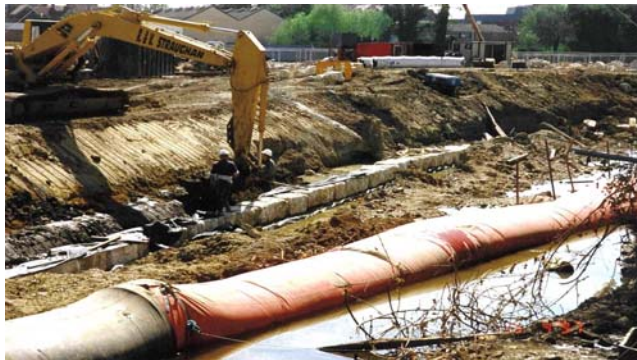
Figure 2.17 Temporary diversion of a stream

The stream in this photograph has been diverted through a temporary fabric culvert, keeping land acquisition and environmental impact to a minimum.

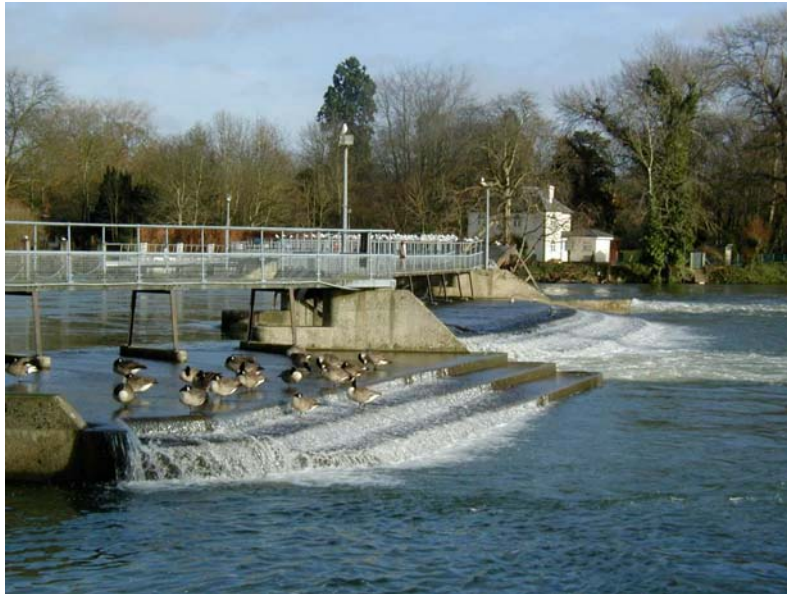
Figure 2.18 A weir on the River Thames

The weirs on major navigable rivers like the Thames are often gated and generally complex structures.

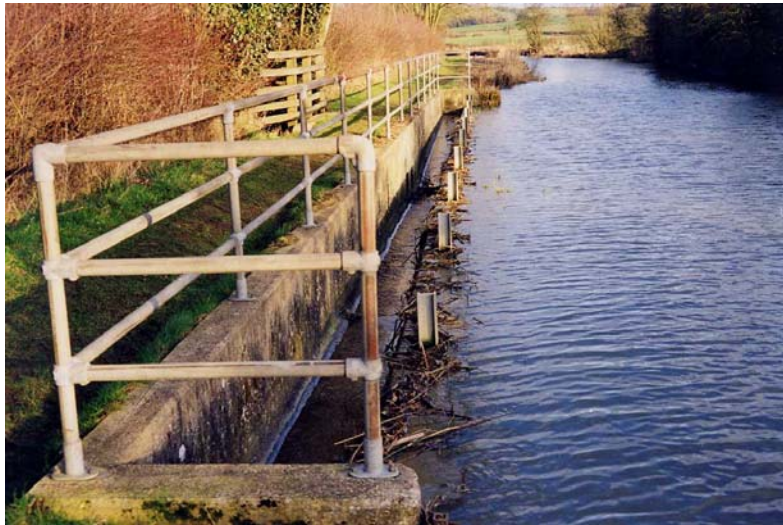
Figure 2.19 Side weir

This side weir has provision for adjustment of the crest level using stop-boards. Note the hand railing to improve safety.

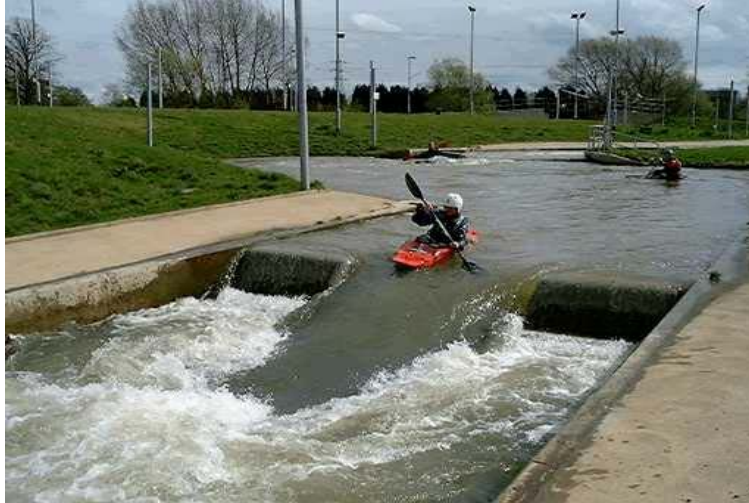
Figure 2.20 Canoe weir

This weir at the Nene White Water Centre near Northampton is adjustable to create different conditions for canoeists (photograph courtesy of the Nene White Water Centre website).

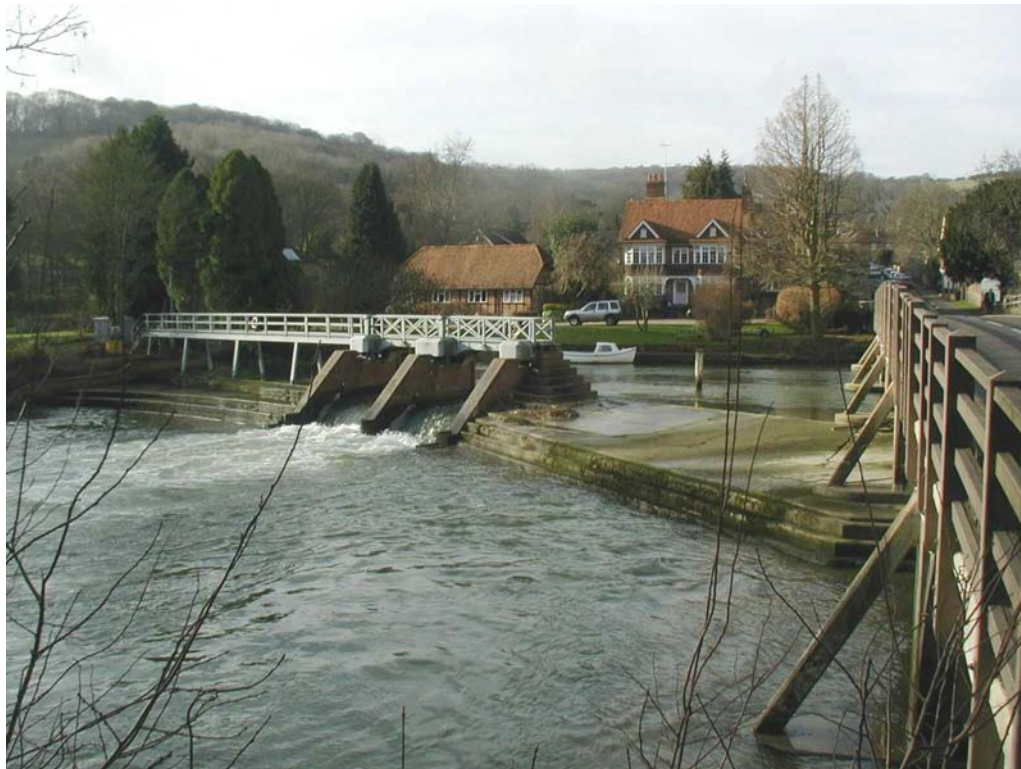
Figure 2.22 A large gated weir on the River Thames

Gated weirs are a common occurrence on rivers throughout the UK. They provide a useful function in terms of coarse and fine control of water levels for flood defence purposes as well as navigation. Gated weirs quite often have a fixed weir alongside, such that it is not necessary to adjust the gates on a day-to-day basis. Although much of the guidance in this document is applicable to gated weirs as well as fixed weirs, there are some particular issues that should be considered on gated weirs. The main reason for having a gated weir is for water level control. The allowable tolerance on water level variation will have a significant effect on the design of the structure.

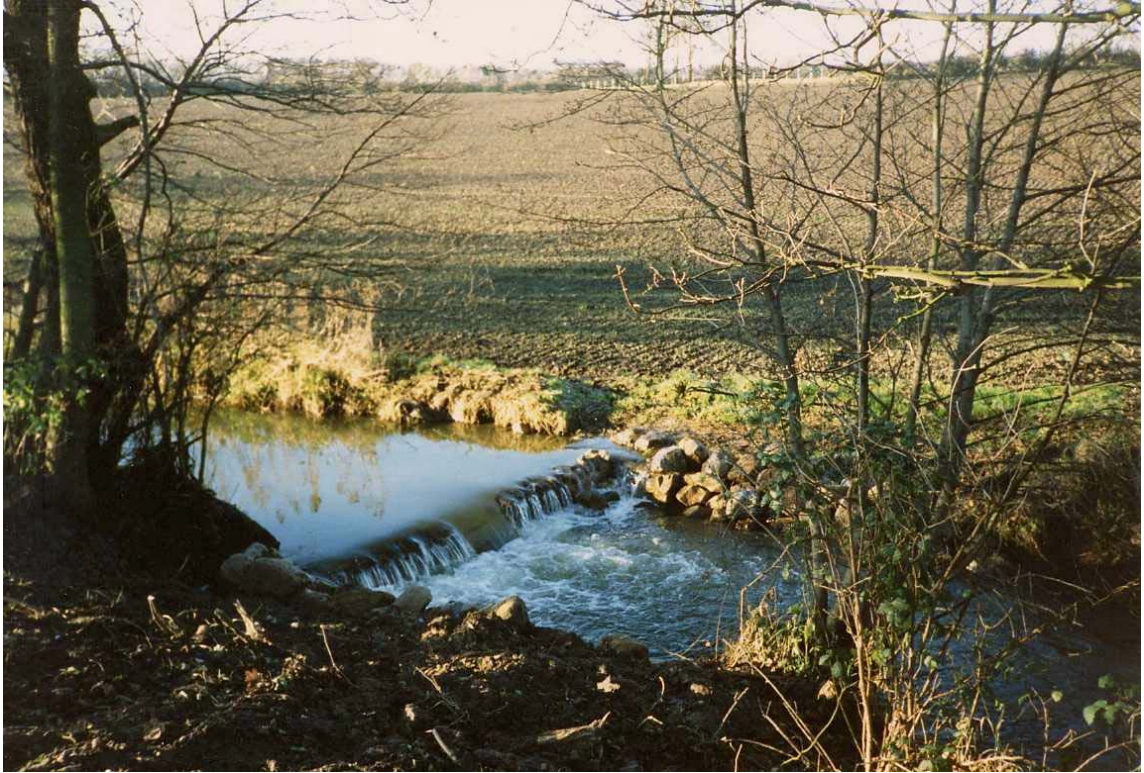
Figure 2.24 Low weir for environmental improvement

This low weir was constructed for environmental enhancement. It has a modest drop so as not to obstruct fish movement, an uneven crest to create interest, and dumped rock on the banks downstream to resist erosion. However, the designer has neglected to confine the river upstream, and there is a risk of the weir being by-passed on the far bank. Construction of a low stone wall would easily solve this problem.

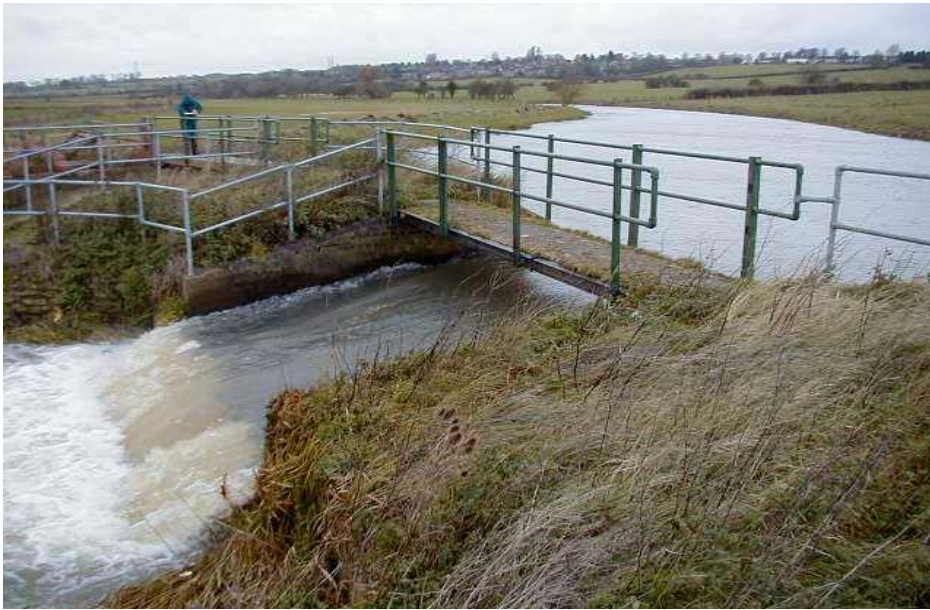
Figure 2.27 Unattractive fencing

There may be sound safety reasons for the proliferation of fencing at this side weir, but the end result is very unattractive, with the fencing dominating the scene. Wherever possible use should be made of more natural materials such as timber, or a more attractive design of fence (see Figure 1.3).

- Careful consideration of associated features. Many historic mill weirs are connected with a complex of mill-races and subsidiary weirs and pools, which are of ecological and historic importance. These should not be swept away as part of the restoration process. Similarly repair of bridges and lock structures, and the construction of associated new headwalls and fencing, need to be carried out sympathetically. “Scaffold-tube” fencing should be avoided whenever possible (see Figure 2.27 and contrast this with Figure 1.3).

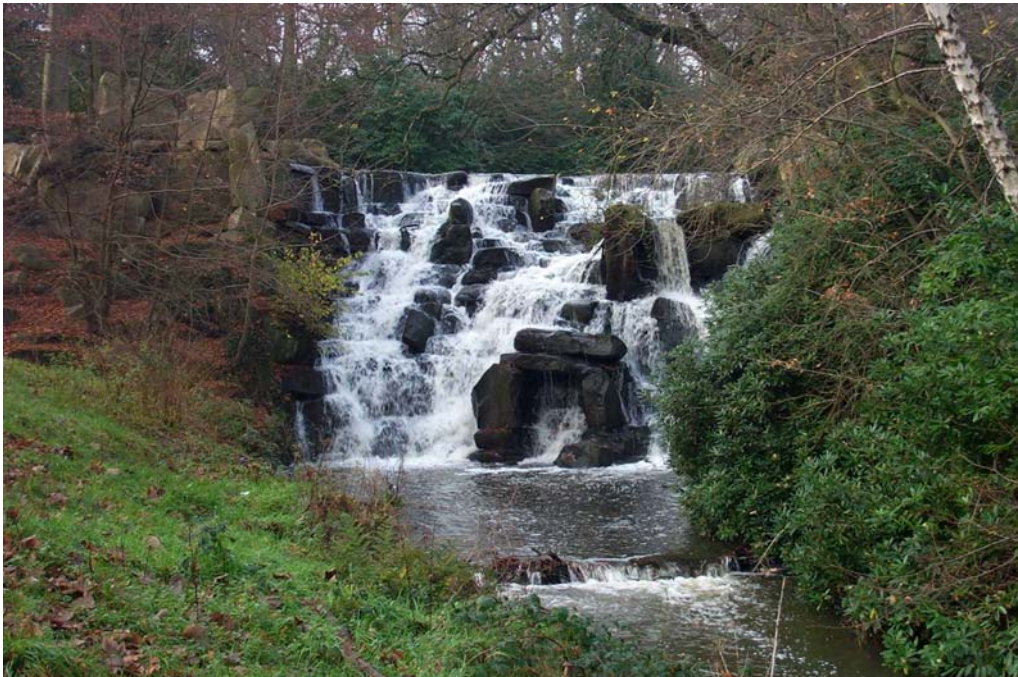
Figure 2.29 Virginia Water

Opportunities to construct weirs like this are very rare. The aeration effect of most weirs is modest, and is certainly not a primary benefit.

It is often said that a weir will improve water quality through aeration of the flow as it cascades over the structure. It is undoubtedly true that water is aerated as it passes over a weir, especially if the flow is turbulent (Figure 2.29), and that this aeration is beneficial to water quality. However, the construction of a weir in a river or stream flattens the gradient, and reduces the opportunity for natural aeration by creating deeper more placid conditions upstream. Many rivers support an effective pool and riffle system, and the riffles are quite effective in aerating the water. In situations where the quality of the water in a river is poor, it is unlikely that the construction of a weir will have a significant impact on the water quality. Indeed, it may create secondary problems such as foaming, which until recently was a common feature downstream of weirs on many of our rivers that pass through industrial areas.

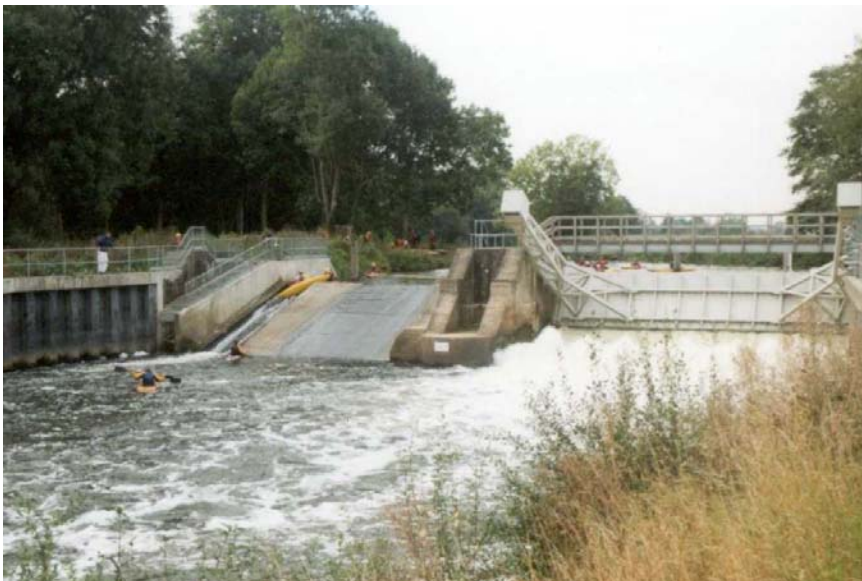
Figure 2.30 Weir with a canoe pass on the River Medway

This gated weir not only has a fish pass (far left) but also incorporates a canoe slide

It will be appreciated from the number of separate sub-sections in this guide that there are many issues to be considered when planning works on weirs. Furthermore, it is virtually impossible to design works on weirs that will fully satisfy the aspirations of all parties who have an interest in the weir or the reach of river in which it is located. Inevitably there will be instances where there are conflicts of interest. For example, a weir that is ideal for discharge measurement may not be ideal for fish migration (ongoing research is addressing this issue); or a weir that is ideal for fish migration may prove less acceptable to canoeists. It is important to realise that, in recognising the constraints, it should be possible to identify opportunities when looking at the options available. For example, it is possible to design a weir that has both adequate provision for fish migration and safe passage for canoeists (see Figure 2.30).

- It is important to note that the provision of good conditions for fish does not have to compromise other weir functions such as discharge monitoring or providing facilities for canoeists. In France there has been considerable research into the design of facilities to allow safe navigation of weirs by canoeists. Such facilities exist side-by-side with similar provisions for fish (see Figure 2.30).

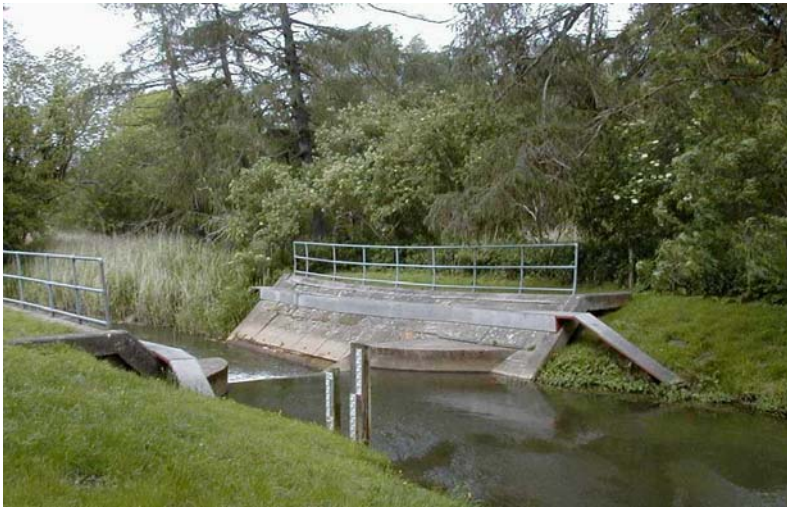
Figure 2.31 Otter ramps

Otter ramps have been retro-fitted to this gauging weir. This particular design is rather flimsy and could collapse under the weight of a child (or several fat otters?). Had the ramps been considered from the outset, they could have been engineered much more effectively.

Any new weir will create a new obstruction and so it is important that appropriate provisions are made for the passage of fish and boats. The layout of the different elements of the weir should be considered carefully, for example in the context of providing conditions suitable for fish and canoeists. Otter passes may sometimes be necessary so that otters are not forced to cross adjacent roads at periods of high flow. (see Figure 2.31)

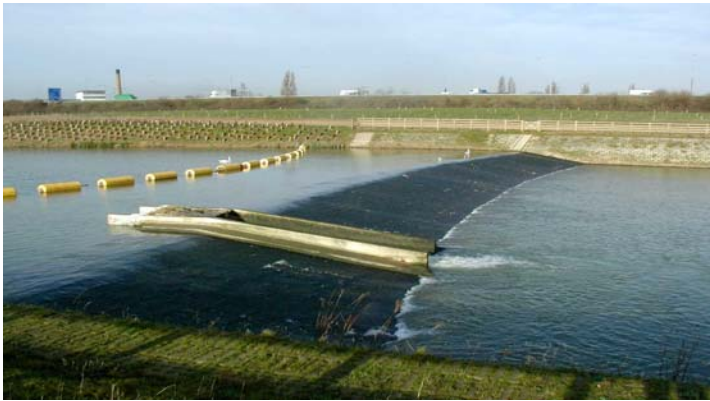
Figure 2.32 Weir on the Jubilee River

The Jubilee River is a man-made flood diversion channel for the River Thames. It has a modest perennial flow to improve its environmental value. The weir in the photograph has been provided to maintain a high water level so that ground water levels in the surrounding area are not drawn down.

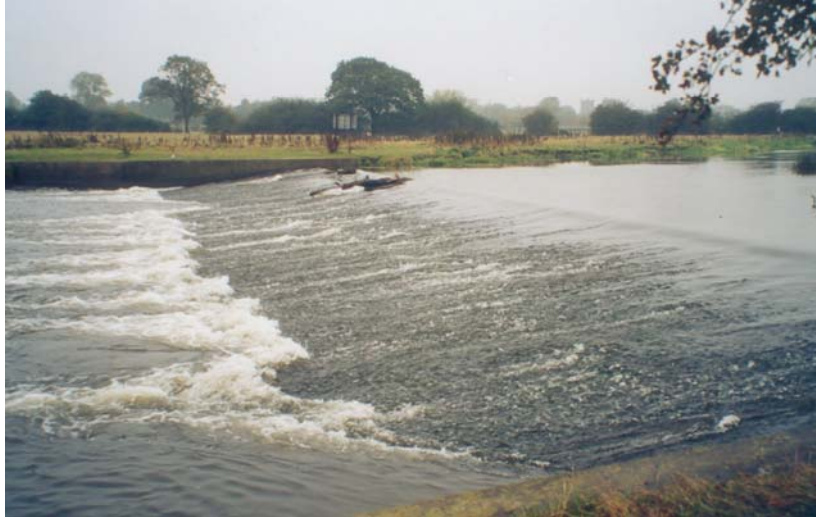
Figure A1 - Alrewas Weir, River Trent

Alrewas weir was originally constructed to provide water supply to the Trent and Mersey Canal. Improvements in water quality over the past 25 years led to increased fish populations in the Trent, but the weir presented a barrier to fish migration upstream. In 1996 the Environment Agency decided to install a fish pass at the weir to further improve the fisheries status.

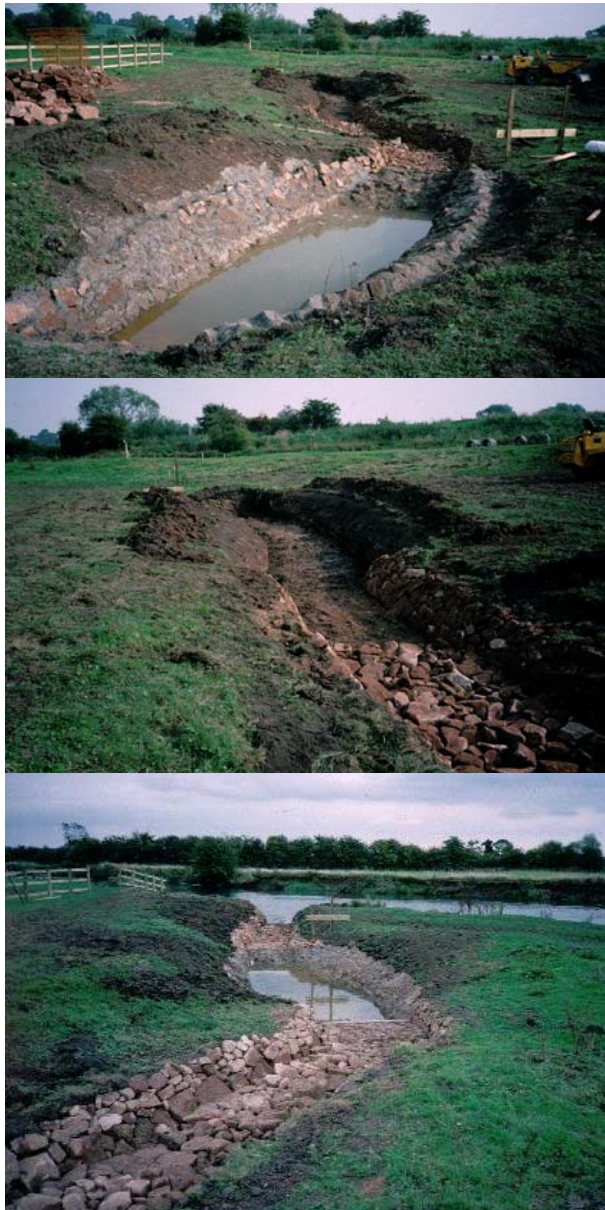
Figure A4 – Three photographs of the construction of the bypass channel and pools

Before construction commenced agreement was reached with English Heritage as to the techniques to be used and the route that vehicles would take to get to the site to avoid the medieval village. As part of this process an additional fee was paid to a local landowner for access rights, and improvements to a bridge were undertaken. In total the cost of the job was approximately £20,000 (1996 prices), including land purchase, otter holt, and planting. Early on in the construction phase the archaeologist

identified some ancient fish weirs. After inspection and following the taking of samples, permission was given for these to be demolished. In total the construction took about four weeks.

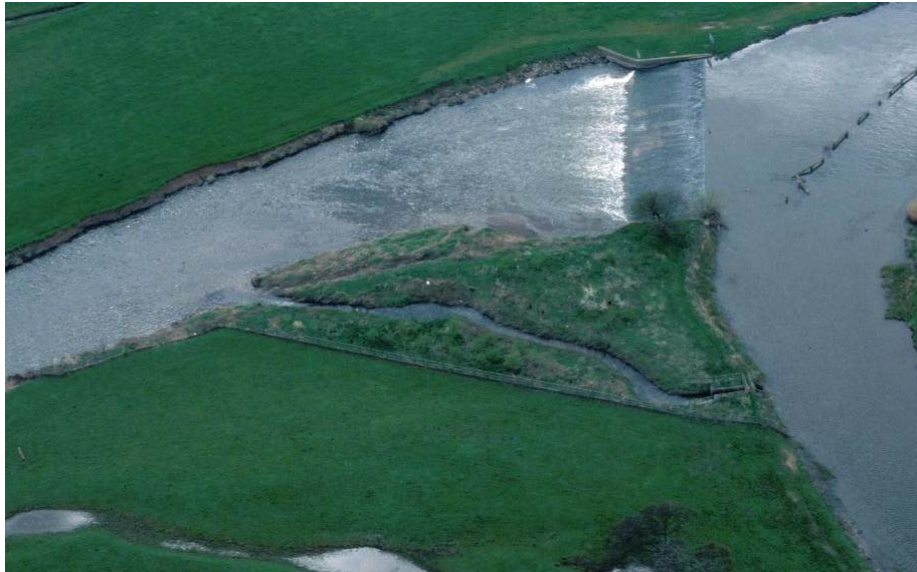
Figure A5 - Aerial photograph of finished channel

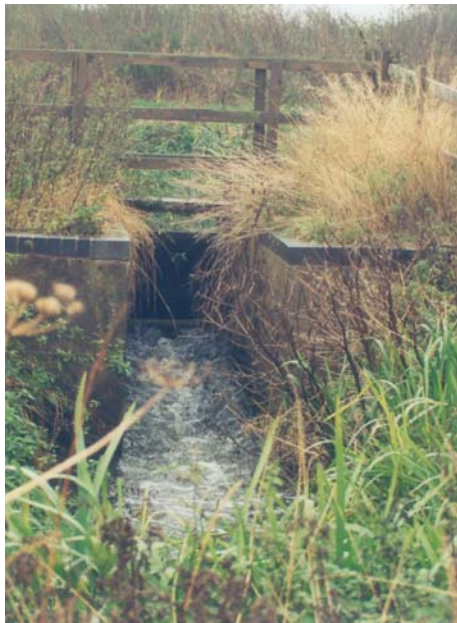
Figure A6 - The fish pass looking upstream towards the canal

Some five years after completion the whole area has recovered, with vegetation gaining hold across the entire site, including the stone facing on the bypass channel. Fish such as chub, dace, barbel and possibly pike are using the pass. Figures A6 and A7 show the current state of the site.
