River Weirs – Good Practice Guide

Guide - Section A

R&D Publication W5B-023/HQP

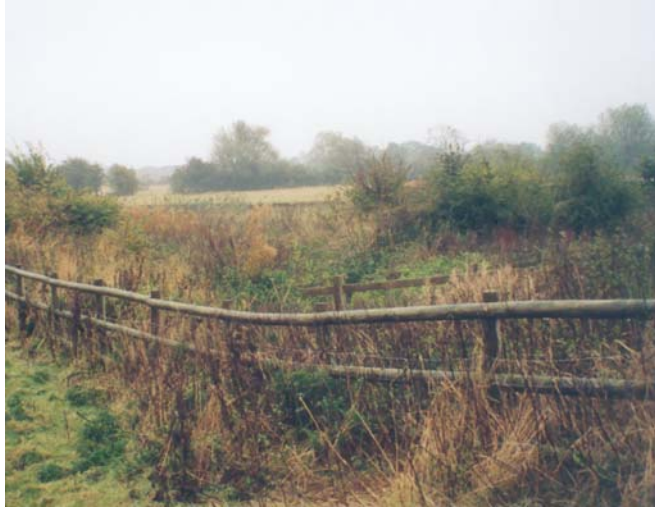
Figure A7 - The site five years after completion showing established vegetation

Some five years after completion the whole area has recovered, with vegetation gaining hold across the entire site, including the stone facing on the bypass channel. Fish such as chub, dace, barbel and possibly pike are using the pass. Figures A6 and A7 show the current state of the site.

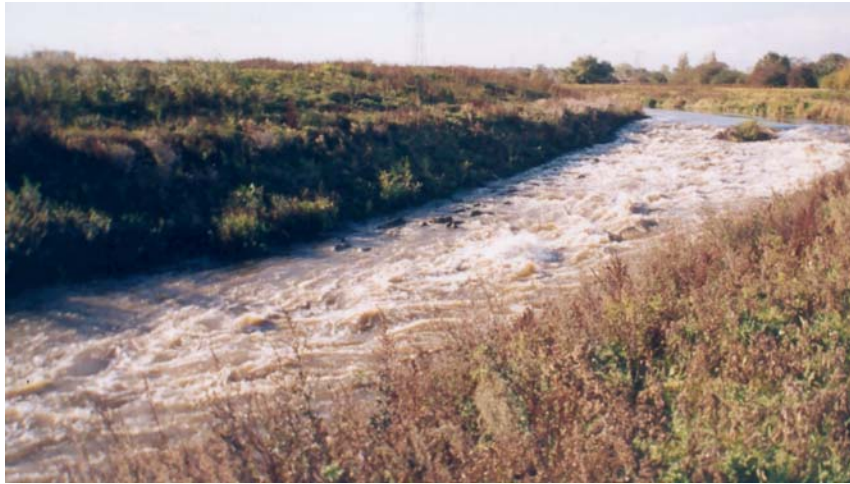
Figure B2 - New rock weir in October 2002

After extensive model testing, to examine crest alignment options, stone sizing and bank protection requirements, a final design for the rock weir was decided upon. A rock chute sloping at approximately 1 in 30, with a drop of 2.8m, was installed into the former river channel over a total length of about 100m. Figure B2 shows a view looking upstream from the toe of the weir once operational. It can be seen that flow is relatively evenly distributed, with a number of pools and protruding rocks. In addition extensive bank stabilisation has taken place, with rock riprap along both banks. The crest at the head of the rock chute is vee-shaped on plan (Figures B3 and B6) to maximise the flow over the weir. The rock used was a magnesian limestone from local quarries, with a nominal rock size of 600mm. The rock was placed to a thickness of 1200mm on a 150mm granular underlayer on a geotextile (NB – appropriate design of a rock hydraulic structure is important – compare with Case Study E). Figure B3 also illustrates one of the disadvantages of such structures, in that they have a tendency to collect debris which is difficult to clear safely. In fact on this weir debris is naturally removed when high flows pass over the weir.

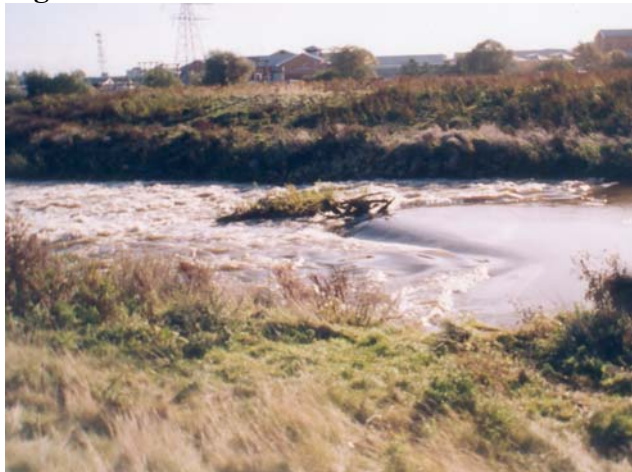
Figure B3 - Debris trapped on weir crest

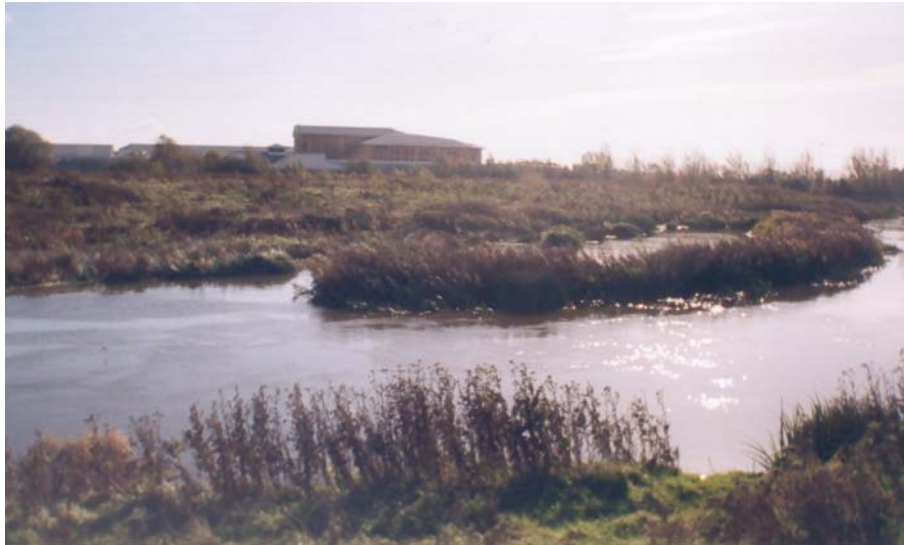
Figure B4 -View of the inaccessible island and refuge for fish

Although only completed in October 2000, considerable improvements in biodiversity of the surrounding area and the river have been achieved already at the time of the writing of this manual. The grass mound, see Figure B4, which was previously accessible is now part of an island which can only be reached by boat. As part of the scheme design, a sheltered backwater area was formed, Figure B4, which provides a fish refuge during high floods, preventing them from being swept downstream. This also acts as a sheltered breeding site for a number of fish species. Since completion salmon and eels have been recorded upstream of the weir for the first time since the Industrial Revolution, and the reach immediately above the rock chute has significant numbers of coarse fish including barbel, chub and dace. This is seen as an indication that the barrier to fish migration has been removed, and a recent study on the downstream slope of the weir has indicated that fish are also resident in certain areas of the weir structure itself.

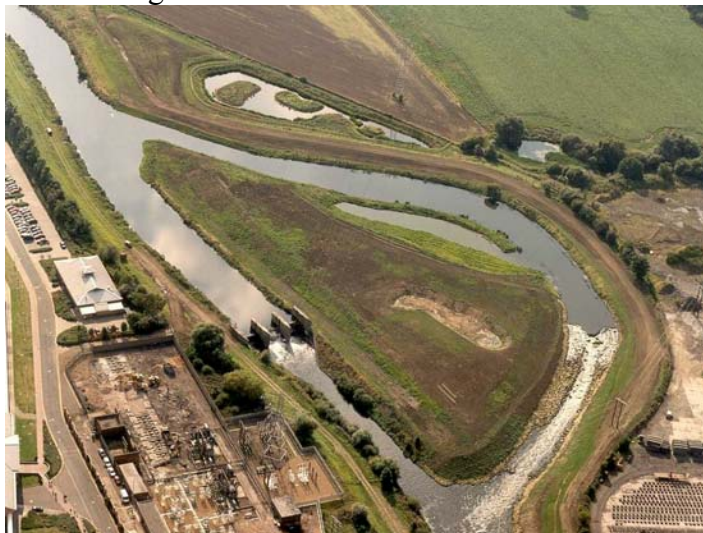
Figure B5 - View of the finished works

The final stage of the £1.1 million project was to decommission the existing sluice, with the removal of the gates and overhead machinery and gantry, and the installation of a mass concrete weir between the existing abutments. The new weir crest was constructed 100mm above that of the rock weir crest to encourage water to pass through the old River Don channel. A notch in the weir in the sluice ensures that some water always passes through it to provide a freshening flow. The finished scheme shown in Figure B5.

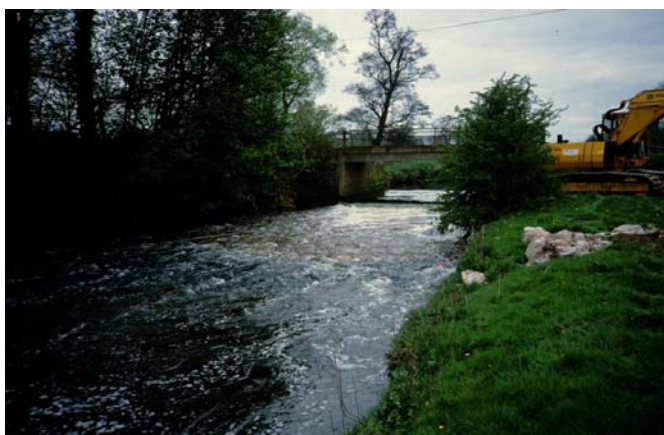
Figure C2 – The completed rock weir in operation

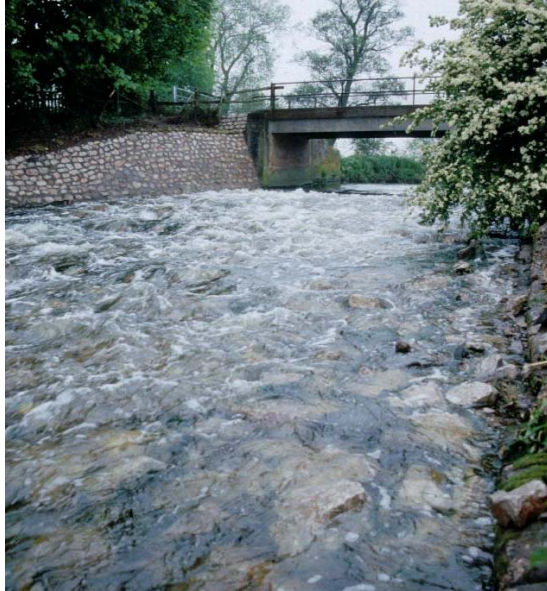
Figure C3 - Completed rock chute with rebuilt bank protection

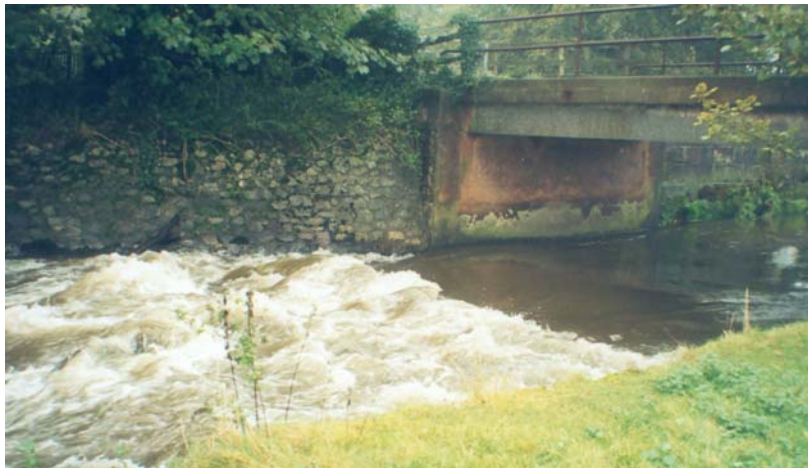
Figure C4 - View of the site in October 2002 with bed remaining stable

The total project cost was approximately £15,000. Such was the success of the scheme that construction workers observed fish swimming past their feet up the chute as they were placing the final few stones. Figure C3 shows the scheme immediately after completion whilst Figure C4 shows the scheme several years later. Although some movement of stone has taken place the chute is still fully operational.

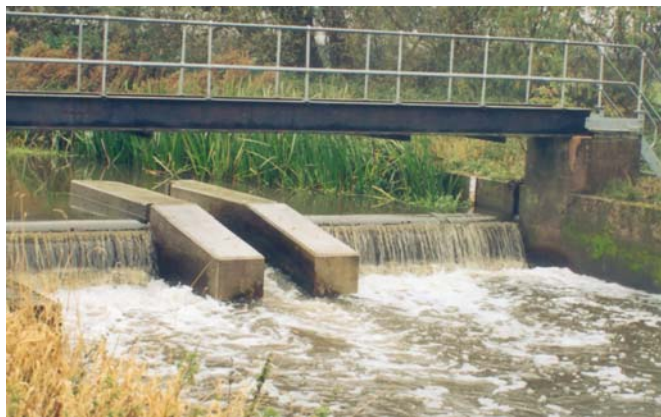
Figure D1 – The original weir with its new fish pass

After discussions with SSW, the Environment Agency indicated that they would grant permission for the additional abstraction on the condition that the water company installed a fish pass. This was accepted and the monitoring weir now has a Larinier fish pass located in the centre of the structure where the notch had originally been located. The pass is 0.6m wide with 100mm high baffles and a 15% slope which gives 104 l/sec (9 ML/d) at a depth of 0.18m

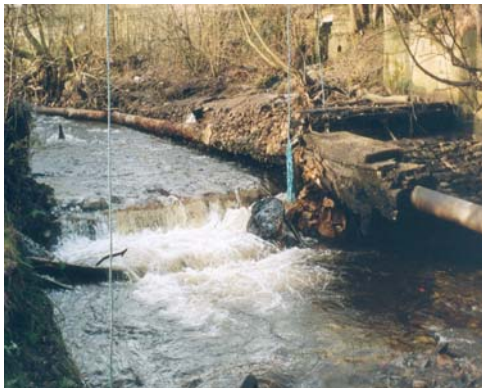
Figure E1 - Weir breach viewed from downstream.

The remaining third of the masonry weir can be seen on right hand side.

It can be seen that the effect of the collapse of the weir was to cause a significant reduction in the effective crest level on the right side (looking downstream) of the river where only the concrete core of the weir was left in place. The remainder of the weir containing the sewer pipework was undermined over part of its length. Figure E2 shows the effect upstream, where water levels decreased by up to 2m causing severe erosion of the riverbed and banks, and exposing the sewer which had previously been covered by the bed material. The sewer did not have a concrete surround.

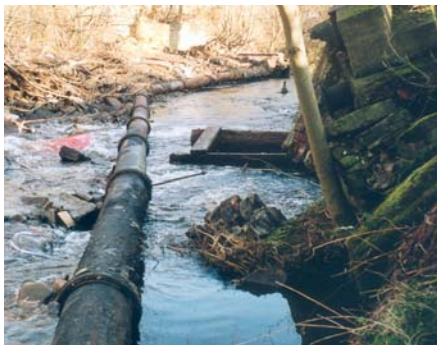
Figure E2 - View from upstream of weir, after breach.

Note the erosion that exposed the foul sewer and the damage to the earth embankment on the right hand side. This caused the collapse of a sluice gate and surrounding brickwork structure connecting to the millpond.

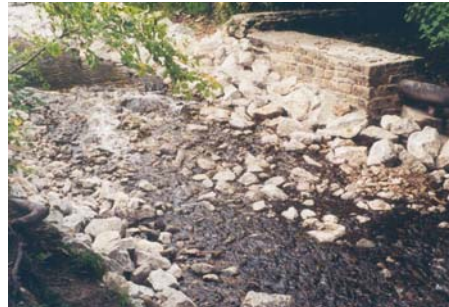
The repaired stone weir was completed at the end of August 2001. Figures E4a and E4b show upstream and downstream views of the weir just before its completion, to a level that was approximately 0.5m below the previous crest level. In Figure E4b some of the gabion baskets used to stabilise the toe of the embankment are visible and improvements to the original weir structure have been undertaken where the sewer pipe passes through the weir. At the same time, the sewer pipe was protected by the laying of concrete filled bags where it was undermined and exposed.

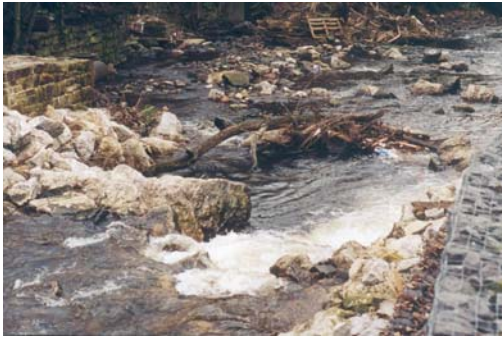
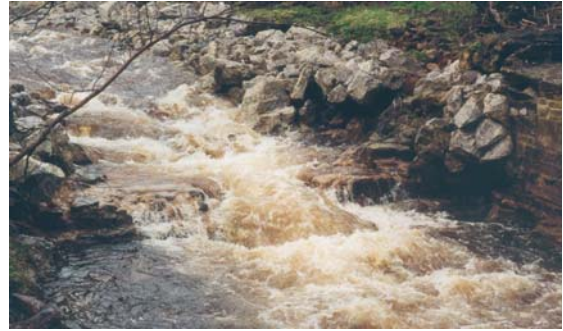
By November 2001, parts of the repaired section of the weir crest began to move until, during flood events in January 2002, the repaired section was completely washed away. The resulting collapse is shown in Figures E5a and E5b. It can be seen that a number of the large boulders placed to form the weir have washed into the downstream pool and undermining of the remaining weir structure has taken place. It should be noted that the gabions installed to protect the embankment and the riprap on the opposite bank provided sufficient protection to avoid any further erosion. However, Figure E6, taken

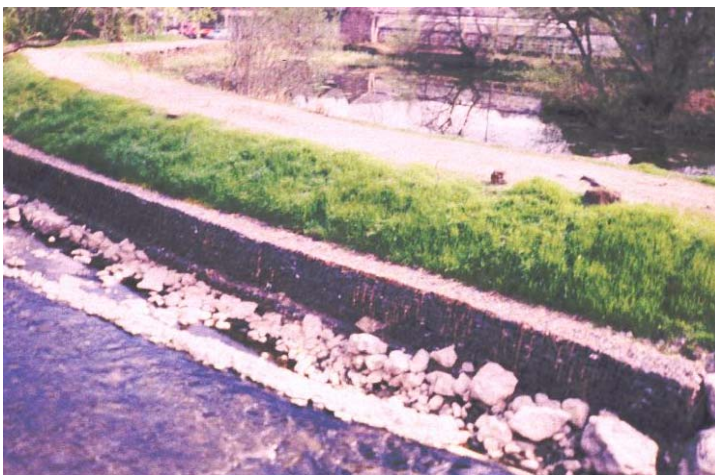
in April 2002, shows that the sewer pipe is once again above bed level, albeit supported with bag-work.

Figure E6 - State of weir, April 2002

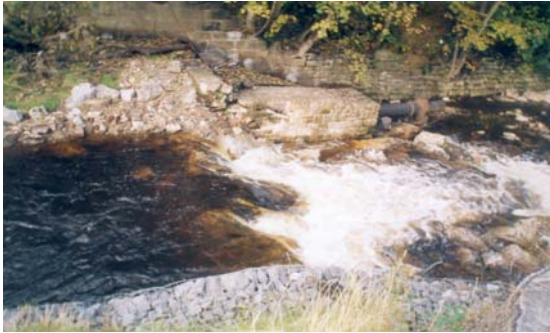
Figure E7

A re-evaluation by various agencies was subsequently undertaken and a decision was made to once again replace the weir. This was completed during September 2002. Once again a rock weir was established, this time with some much larger rocks, Figure E7. Additional measures included creating a riffle upstream of the weir, which has been used to both cover the pipeline that was previously exposed and to form a pool upstream of this, Figure E8. Downstream of the crest of the weir the drop has been spilt into a few small steps encouraging plunging flow and energy dissipation, Figure E9. In addition to this some remedial action has also been taken to place riprap along the river banks to prevent erosion. In October 2002 the weir was operating effectively with good energy dissipation downstream and no evidence of bank erosion or movement of the stone boulders on the weir.

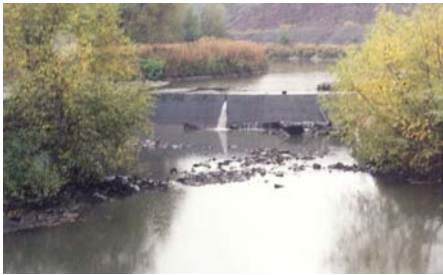
Figure F1 – View of the old weir

Restoration of an open-cast coal mining site required a diversion of the River Rother. The reach to be diverted was regulated by a dilapidated weir (Figure F1), which was known to have significant deposits of contaminated sediment upstream. The solution was to create a new reach of river with a new weir. The most seriously contaminated material was removed from the old channel and disposed of safely. The old river reach, together with the old weir, was backfilled to close the channel and to seal in the remaining contaminated sediment.

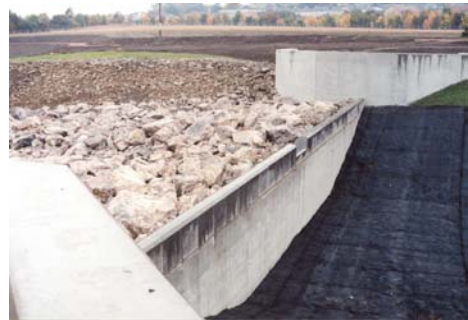
Figure F2 – View of recently constructed weir showing concrete structure and rock downstream

The new weir comprises a concrete structure (Figure F2) with extensive dumped rock downstream to form a riffle (Figure F3). The slot in the concrete weir crest provides a concentration of flow in dry conditions. This, together with the low flow channel in the dumped rock downstream, helps to provide a passage for fish migrating upstream. The new river channel has been constructed to a meandering planform (Figure F4) to ensure that, in the longer term, it takes on the appearance of a natural river.

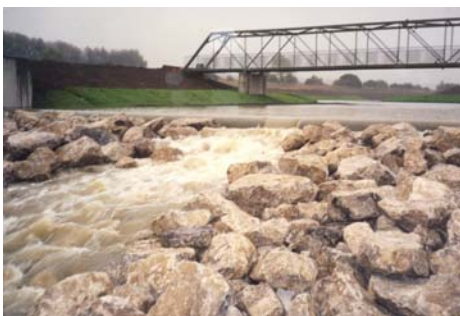
Figure F3 – View of the new weir in operation

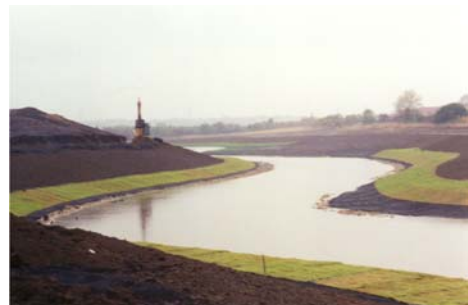
Figure F4 – View of the recently formed river channel

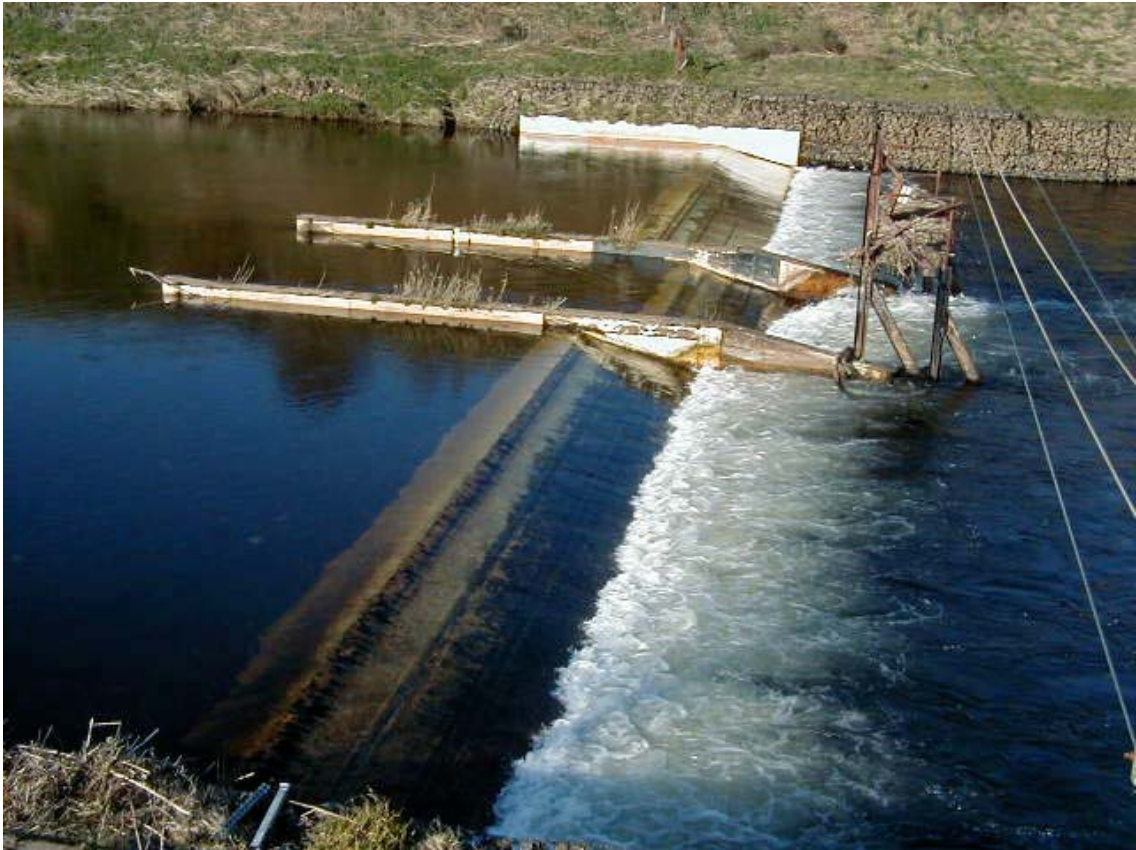
Figure G1 - The Fish-counting Weir at Logie on the North Esk

A fish-counting weir on the North Esk (Figure G1) at Logie has been operational for at least 20 years successfully counting fish, and salmon have been observed ascending the weir against flow velocities of 3.5 m/s. It is therefore possible that the 3m/s rule is conservative as far as fish movement is concerned, and that salmon can cope with higher velocities than has previously been suggested. It is also possible that 3.0 m/s is only achievable by only part of the population and 3.5m/s by even fewer fish at very specific river temperatures.

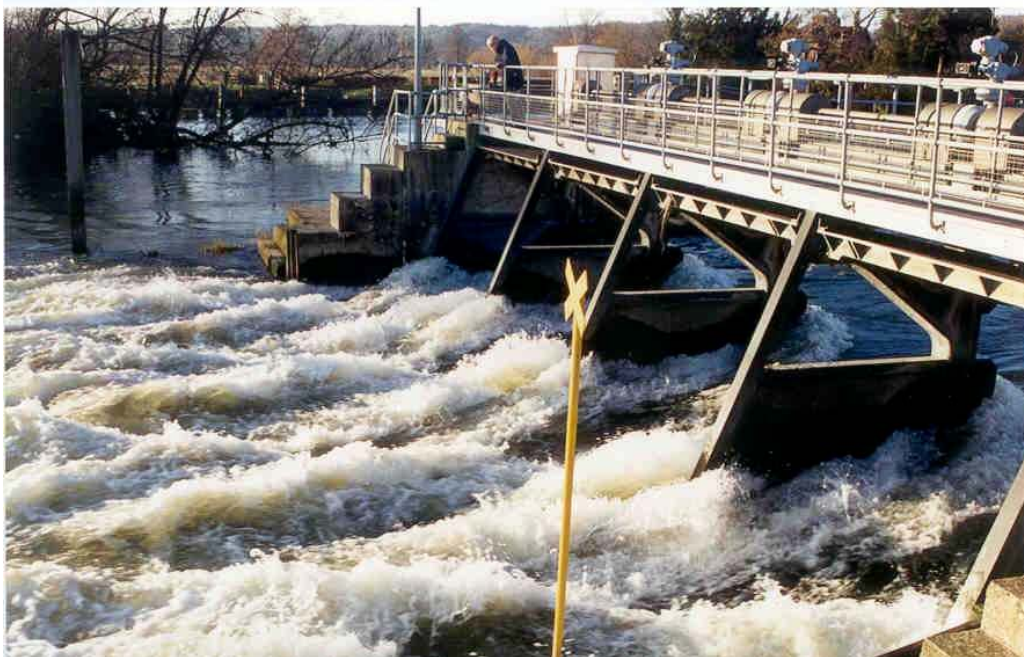
Figure H1 – Before addition of the of the “kicker” devices

As a result of these events several studies were conducted to investigate ways of improving the flow through the weir. Research at the University of Nottingham identified that the addition of a series of kickers (adjustable wedge-shape blocks) on the downstream apron would shoot the flow up before it entered the pool, recreating the wave pattern that had previously been so popular with canoeists.

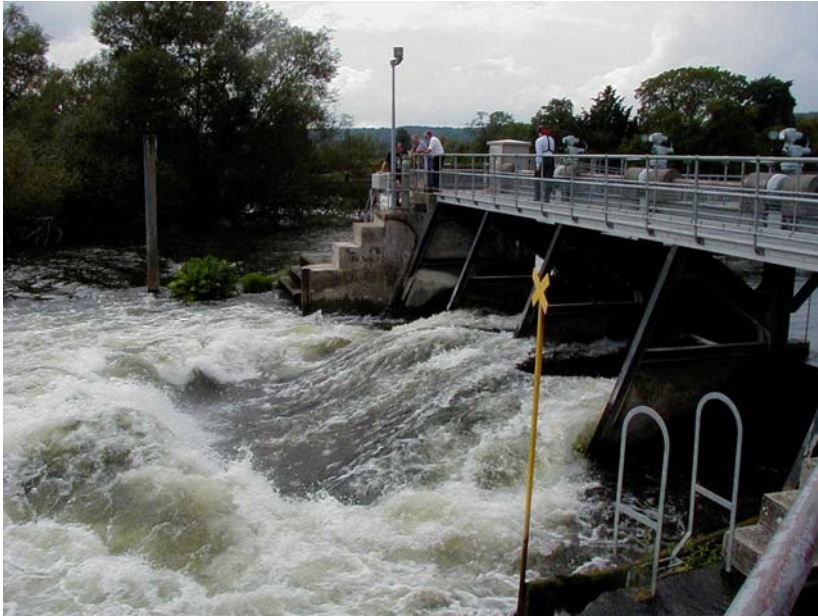
Figure H2 – After addition of the “kicker” devices

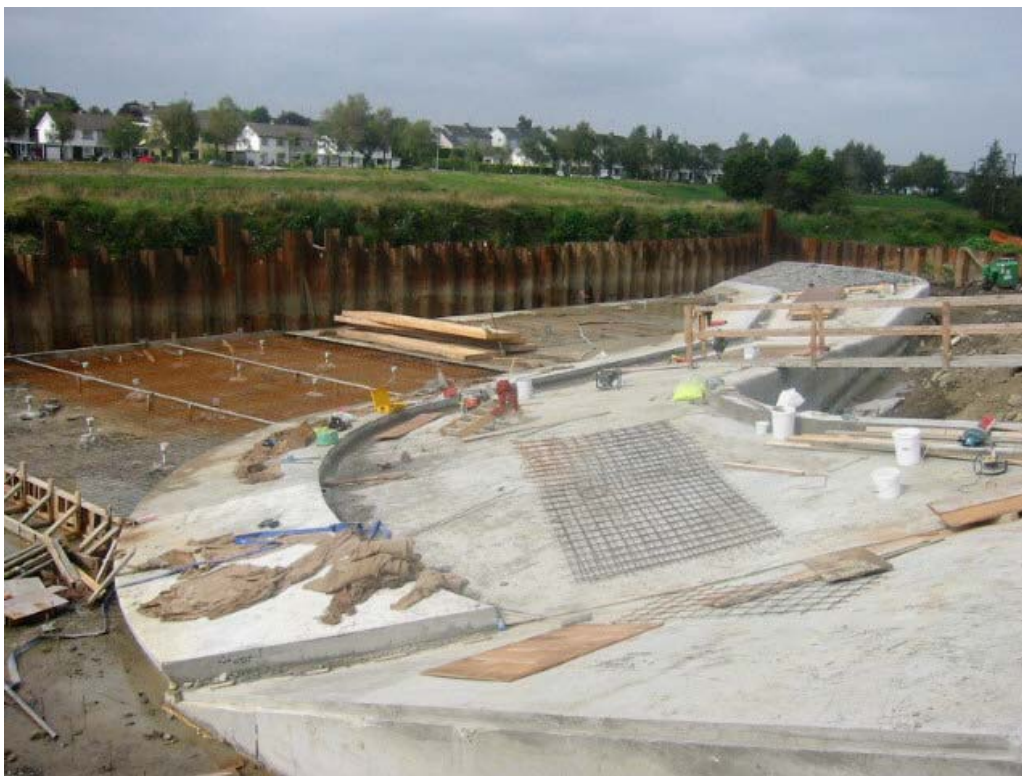
Figure K1 – The first half of the weir under construction.

This is the left-hand half of the weir viewed from downstream. The river is flowing from right to left behind steel pile cofferdam in the background. The furthest part of the concrete is the “nose” of the weir (i.e. the most upstream part). Note:

- the recess in the concrete to take the masonry facing
- the low flow dip in the weir crest immediately behind the temporary footbridge centre-right
- the sloping abutment in the right foreground

The new weir is to have a horseshoe shape on plan to mirror the shape of an existing weir downstream, and is to have a low flow section for visual amenity reasons. The figures below show the weir under construction. The main weir structure is of reinforced concrete, but with stone facing to give the impression of a masonry structure. A steel sheet pile cut-off has been provided to limit seepage under the weir, and this is carried through into the banks to reduce the risk of the weir being outflanked. Dumped stone is being used to form the abutments, avoiding the use of vertical walls for safety and amenity reasons.

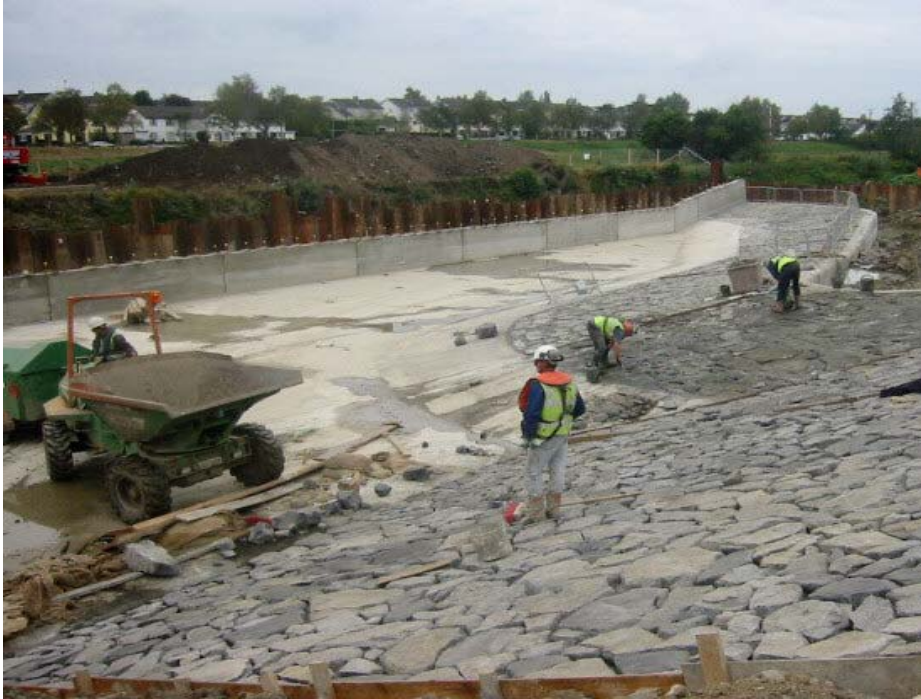
Figure K2 – Similar to Figure K1 at a later stage of construction, with masonry facing in place

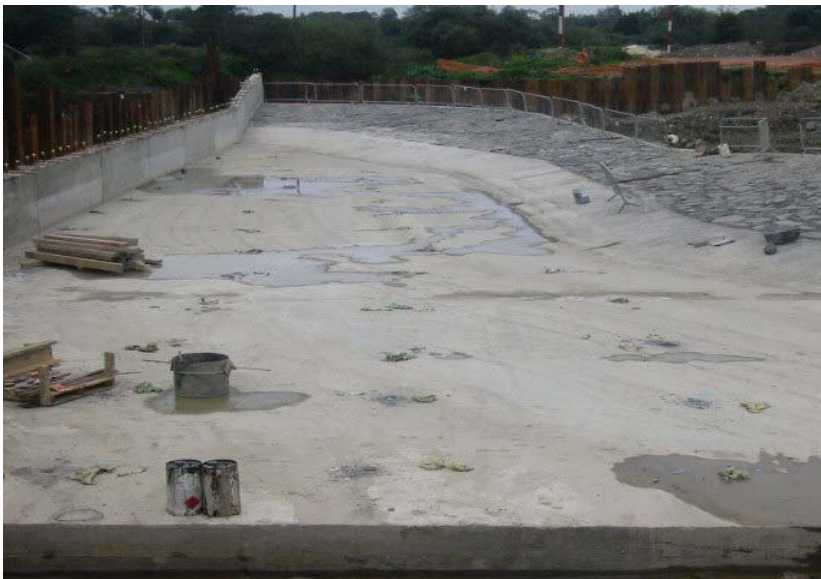
Figure K3 – The left-hand half of the weir from downstream.

Note the concrete wall on the left is a temporary structure that will allow removal of the sheet pile cofferdam when the second half of the weir is constructed. The concrete wall will be removed when the second half of the weir is complete.

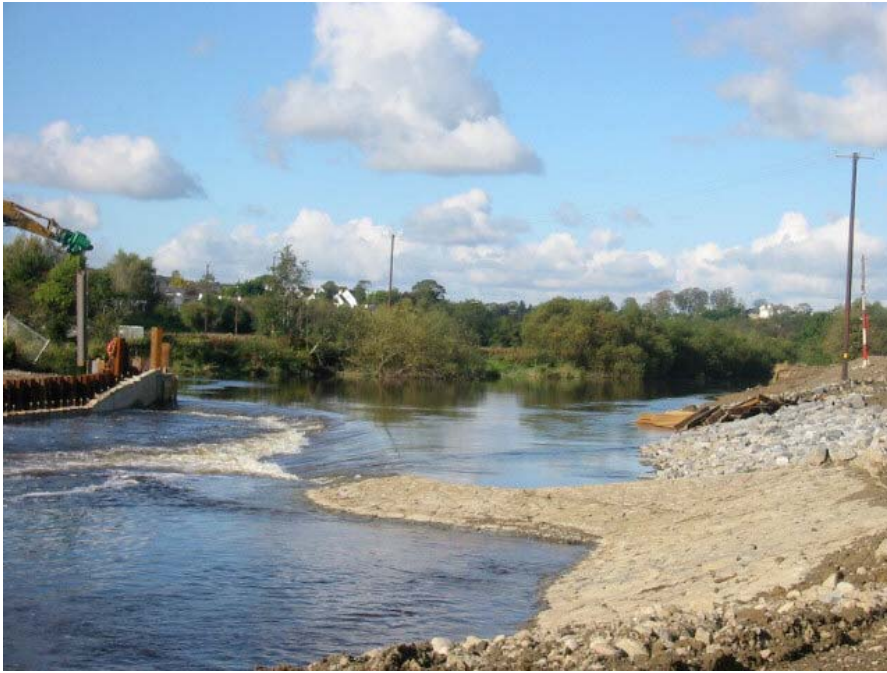
Figure K4 – Flow diverted over the completed left-hand side of the weir

The concentration of flow over the low flow section can be clearly seen by the vee-shape of the white water downstream. The temporary concrete wall keeping water out of the right-hand half the weir (under construction) is just visible on the centre-left.

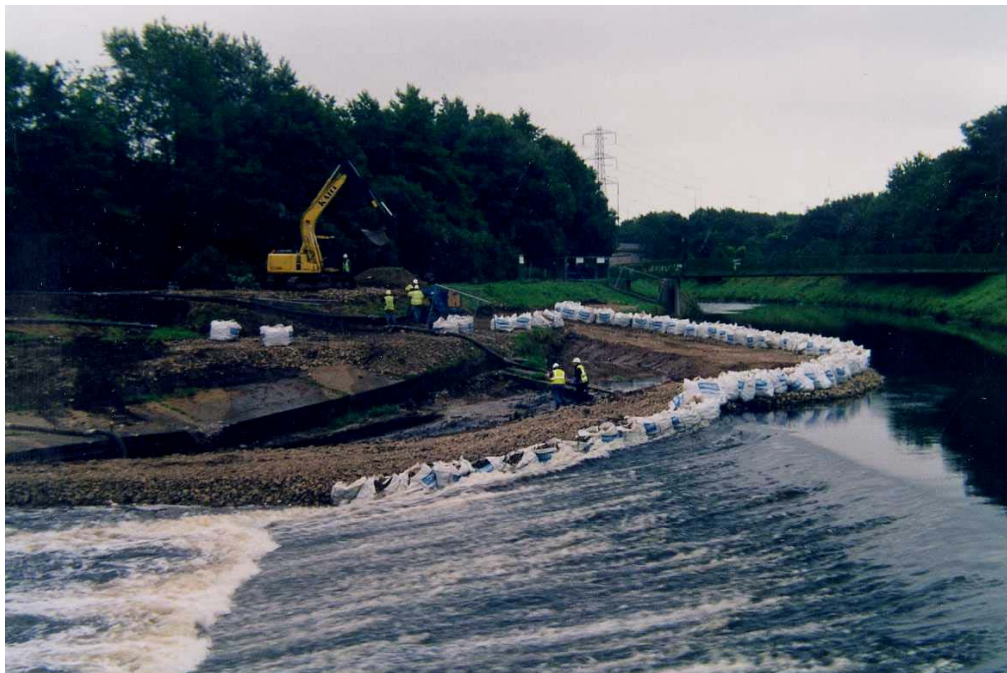
Figure L1 – Part of the weir isolated by a cofferdam to allow remedial works to the weir and the construction of the fish pass

(NB The cofferdam has been formed from a clay core protected by rock, with sandbags providing additional height).

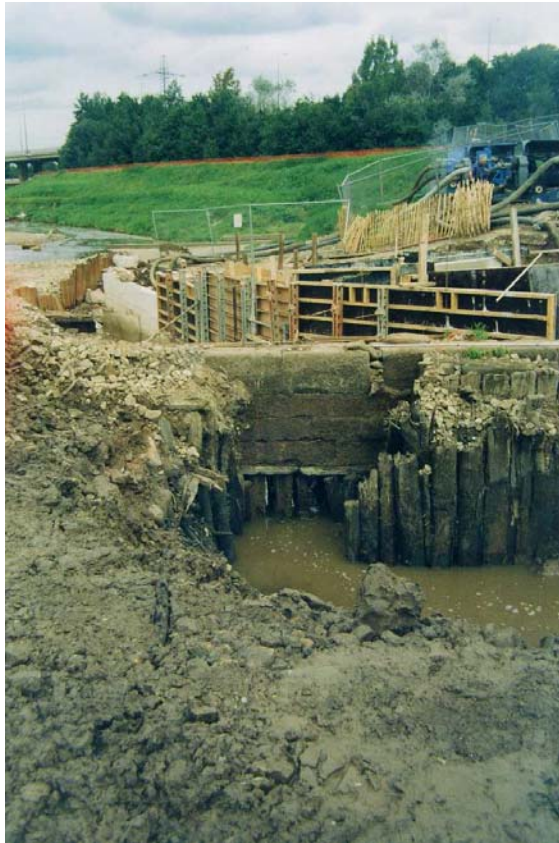
Figure L2 – Excavation reveals the timber piled sub-structure

The weir crest is formed from sandstone blocks, 1.2 m to 1.7 m long and 0.5 m wide. The crest blocks sit on a masonry wall, whereas the masonry apron sits on a grid of timber piles backfilled with gravel and clay (Figure L2). It was apparently designed as a “wet weir”, that is somewhat permeable so that the timber piles remained moist.

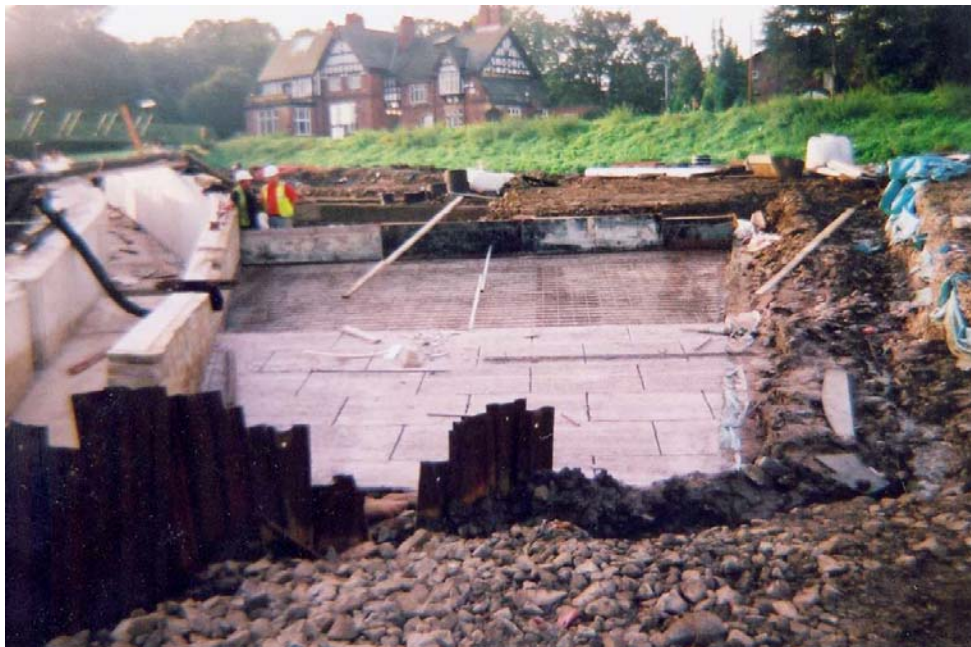
Figure L3 – New weir taking shape adjacent to the fish pass

(Note the concrete finish on the weir glacis to imitate the original masonry).

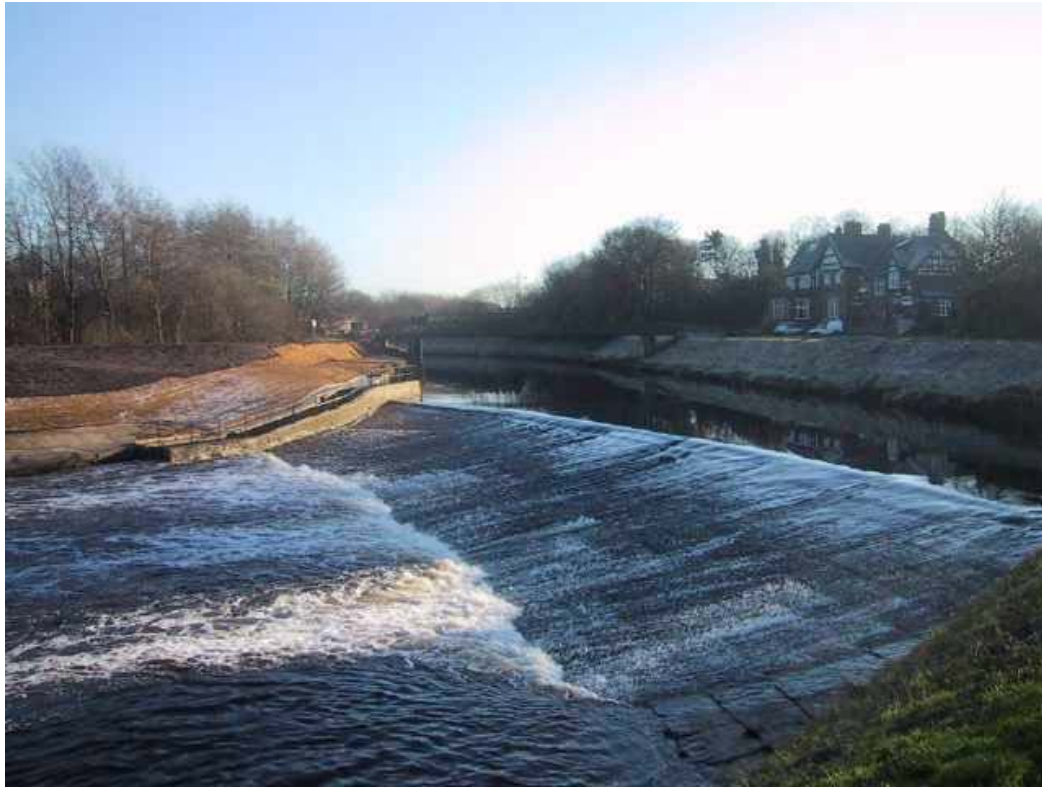
Figure L4 –Completed weir structure with the new fish pass on the far bank

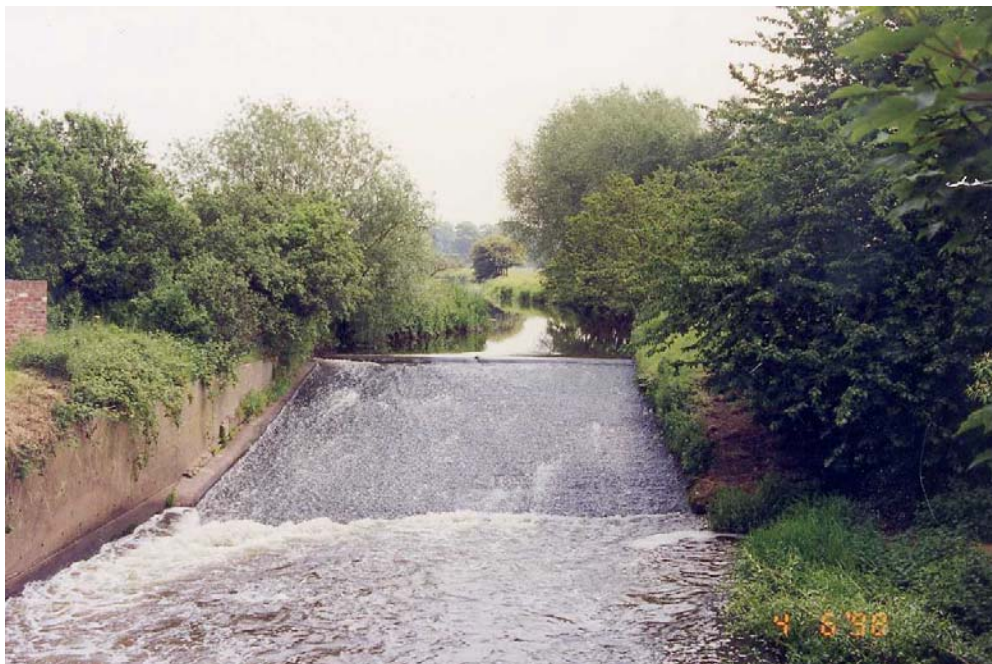
Figure M1 – The weir before the works were carried out

The works involved removing the top section of the existing weir and reconstructing it to comply with British Standards. The new top section was founded using thirty-six 8 metre long concrete piles into the underlying mudstone. Both the wing walls and the weir structure were constructed from reinforced concrete and clad using stone sets. Significant temporary works were required to enable construction but these were designed to provide residual environmental improvements once construction was completed. The weir structure would remain under the ownership of the landowners.

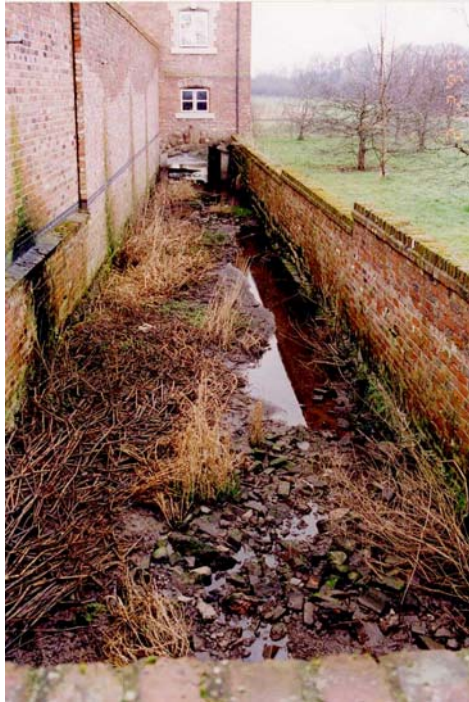
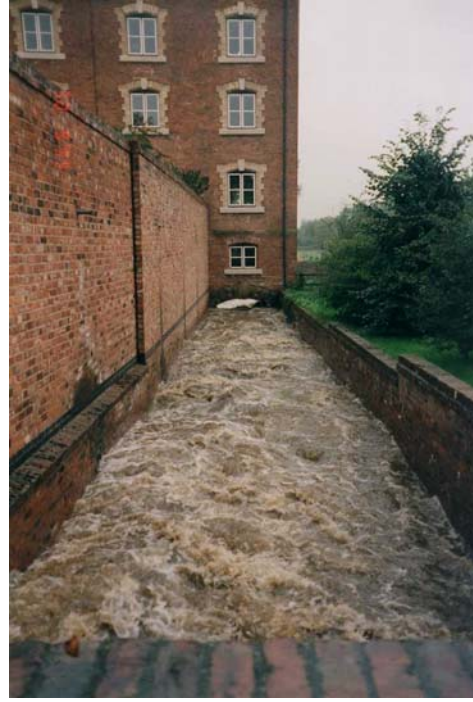
Figures M2 – The millrace channel before the works, and M3 - Carrying river flow during the progress of the works

Flows in the river range from a minimum of approximately $2\text{m}^3/\text{s}$ to an in-channel capacity of approximately $37\text{m}^3/\text{s}$. The higher flows could not be contained within a temporary flume through the work, and there was insufficient space for a bypass channel. The only option was to make use of a badly silted and debris strewn millrace running from upstream of the weir, under a residential mill complex, and discharging some 100m or so downstream of the works. The millrace and structures adjacent to the channel required considerable protection works in order to cope with the expected high flows and velocities.

The design of the temporary works was dependant on the flow capacity of the millrace and the requirement not to increase the frequency of or raise flood water levels upstream of the works. This resulted in a restriction in the height of the sheet piled cofferdam that was designed to overtop before the millrace capacity was exceeded. The works were suspended for some months over the winter period whilst flows were prohibitively high, making activities on the weir face such as piling and laying the stone sets impractical.

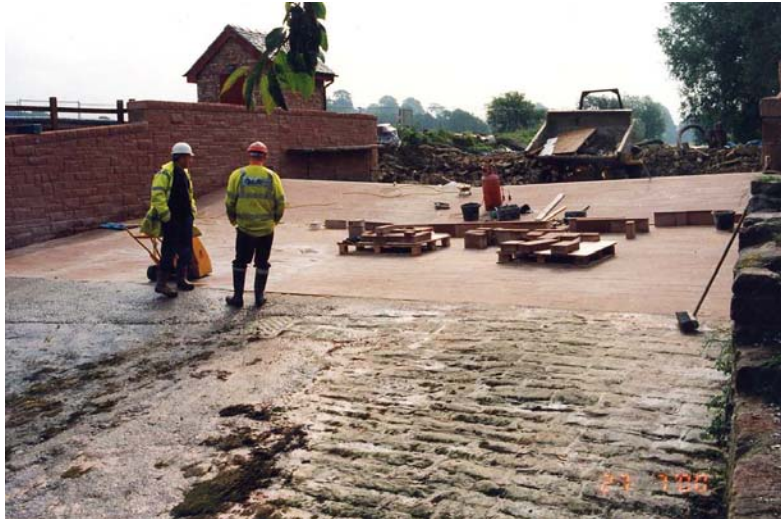
Figure M4 – The new weir crest neatly joining the existing glacis

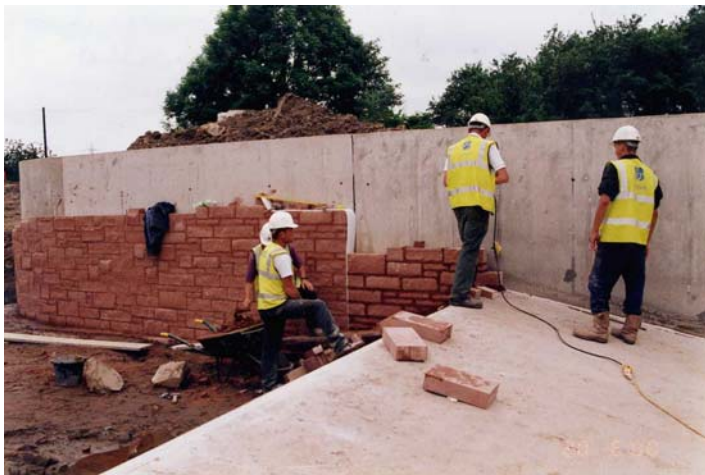
Figure M5 – Stone facing to the concrete walls

The National Trust, as the owner of the weir, also took a keen interest in the development of the design and throughout the construction of the works. The aesthetic appearance of the completed structure was paramount in obtaining their agreement and, following lengthy negotiations, the weir and gauging hut were constructed from materials that complemented the other structures on the estate (see Figures M5 and M6).

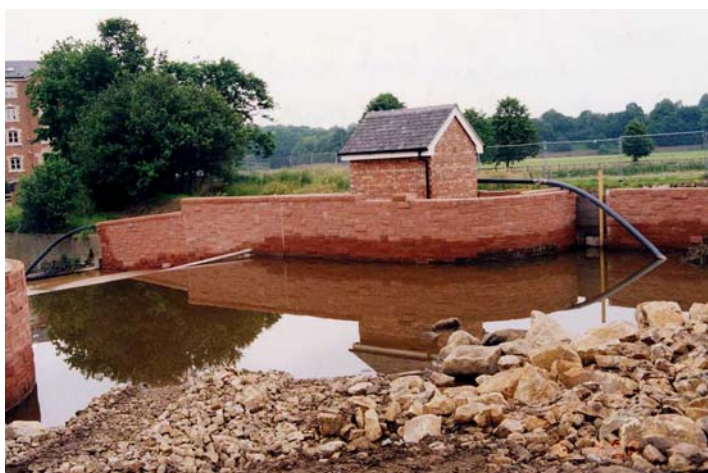
Figure M6 – Completed wall and instrumentation building

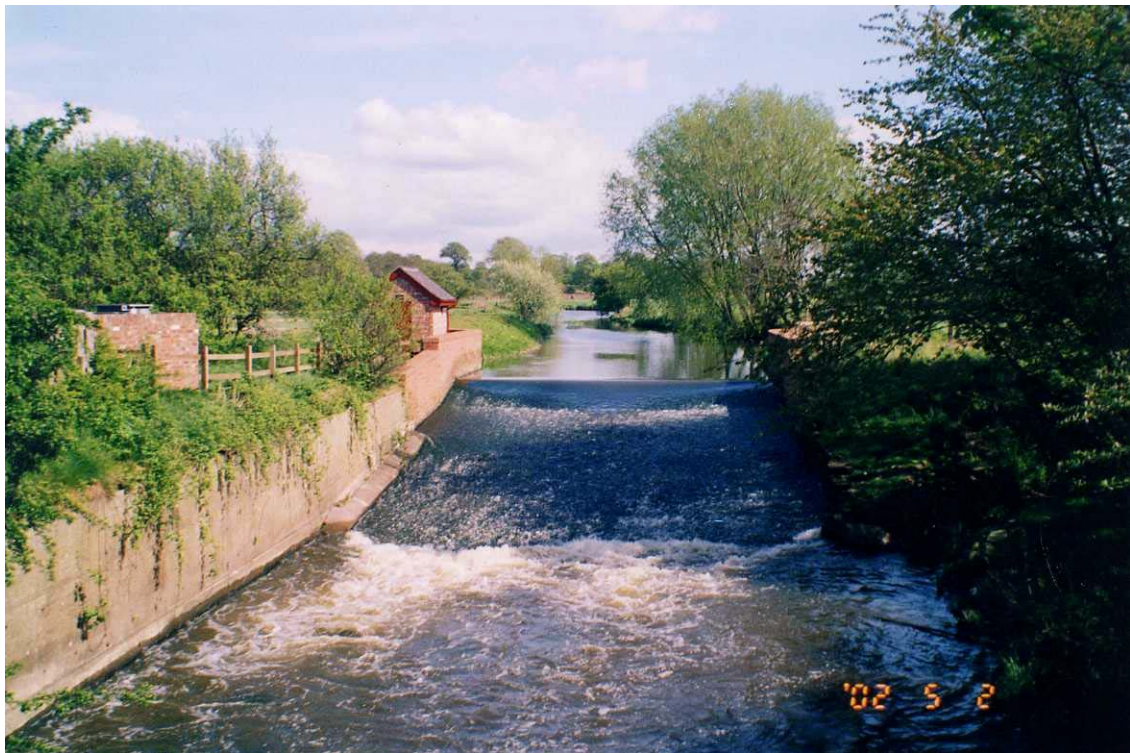
Figure M7 – The completed weir

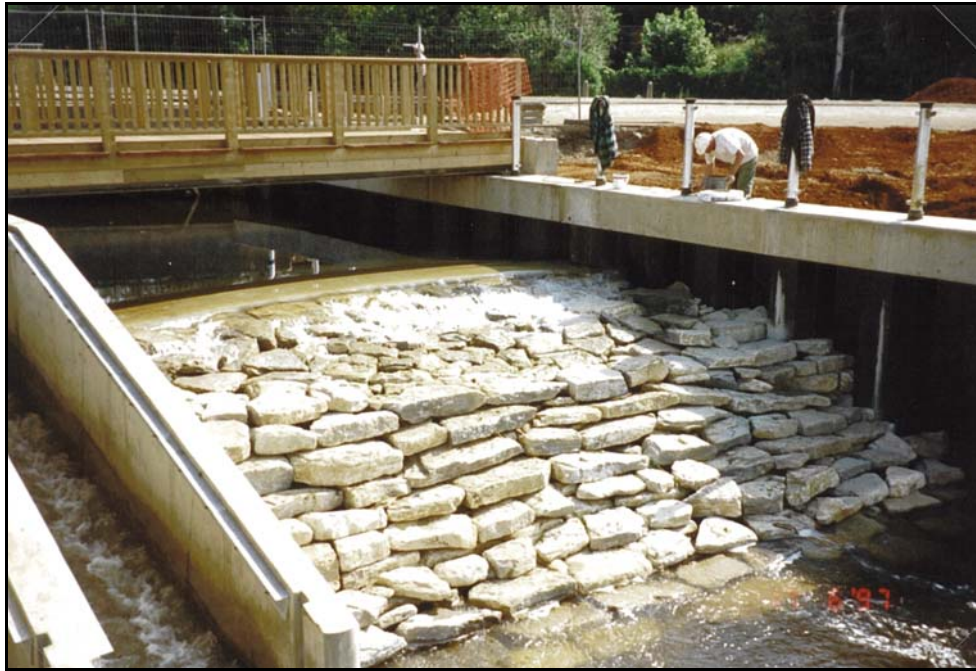
Figure N1 – Weir, as originally constructed

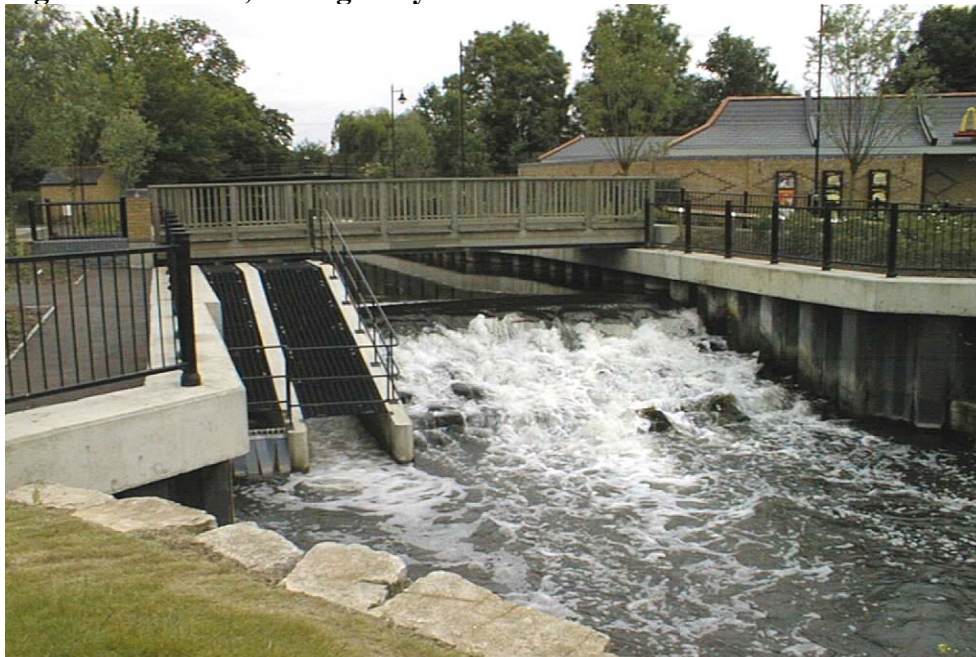
Figure N2 – Weir, with corrected flow

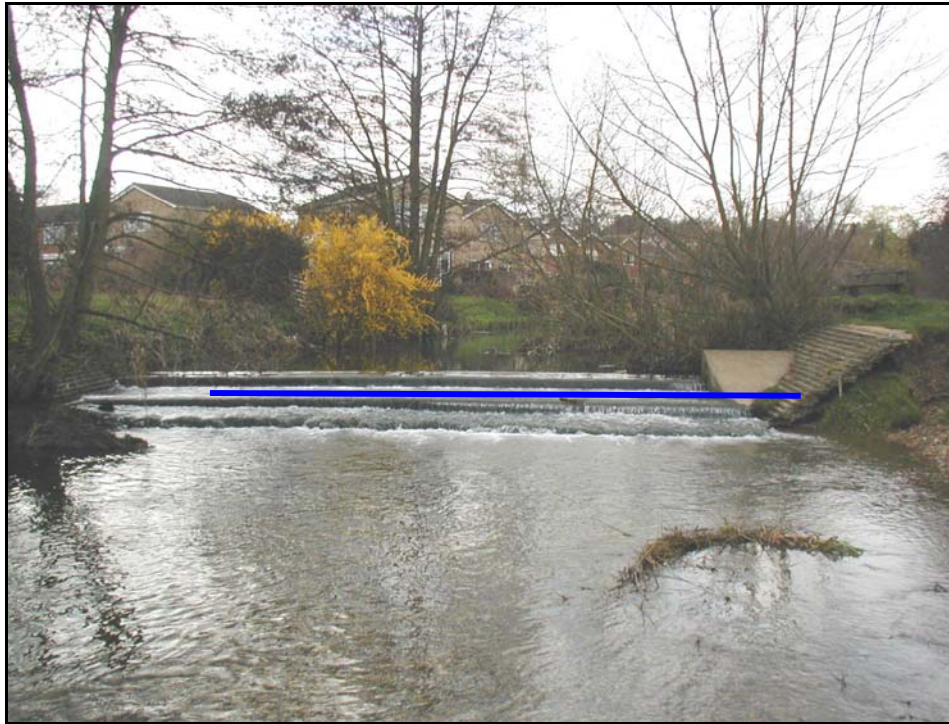
Figure P1 – View from downstream

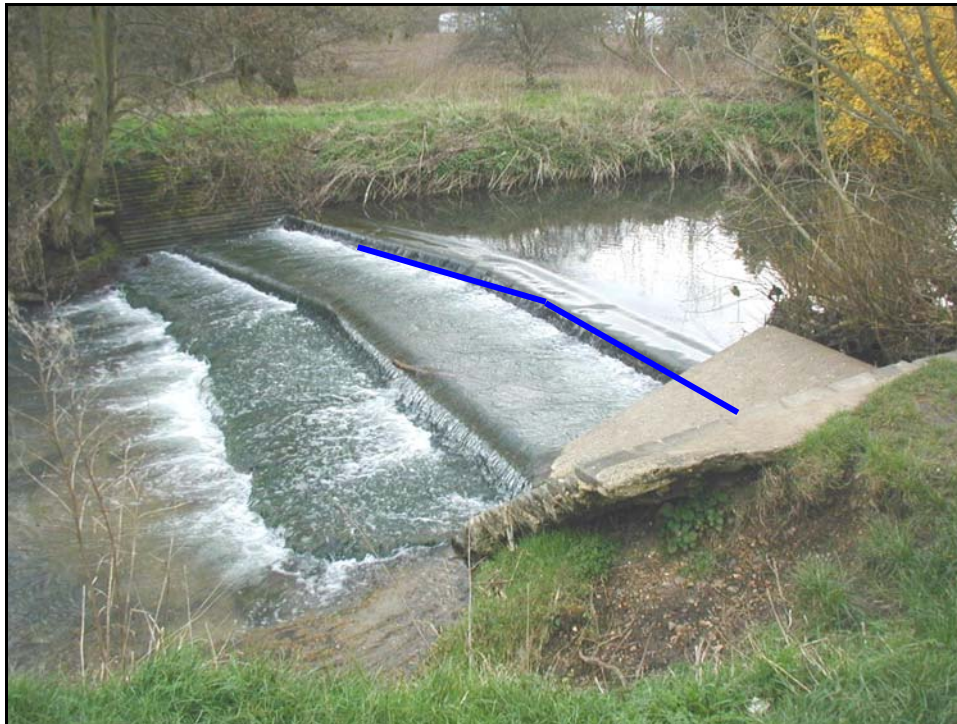
Figure P2 – Undermining at rigid revetment and lack of scour protection downstream
