River Weirs – Good Practice Guide

Guide - Section A

R&D Publication W5B-023/HQP

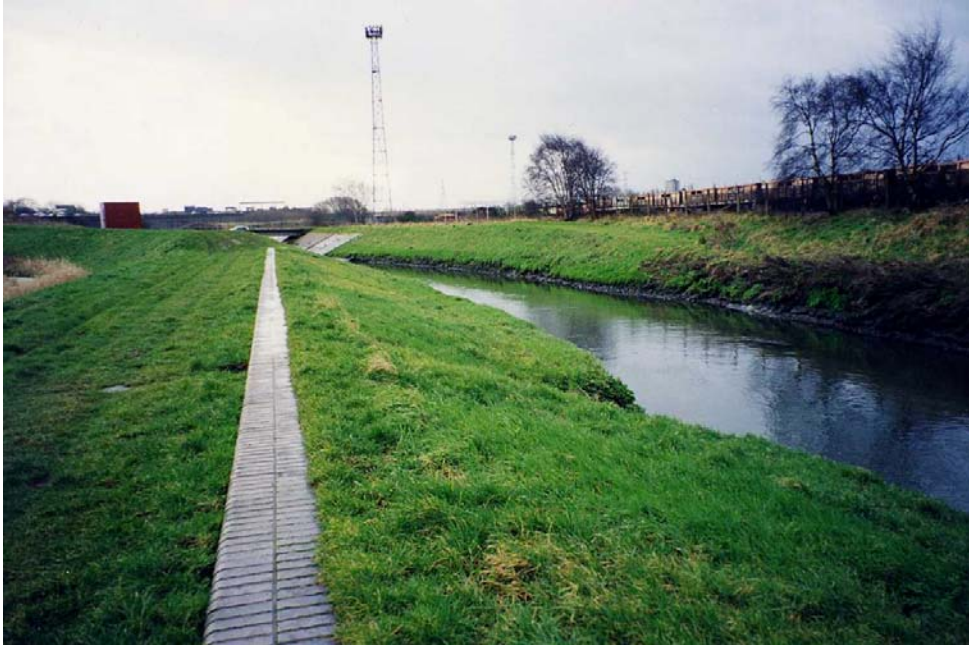
Figure AD1 - Grassed side weir

Here a simple lowered reach of flood embankment acts as a side weir. Note the provision of a hard crest (in this case brick, but it could be concrete) to ensure even flow distribution thereby minimising the risk of erosion of the embankment.

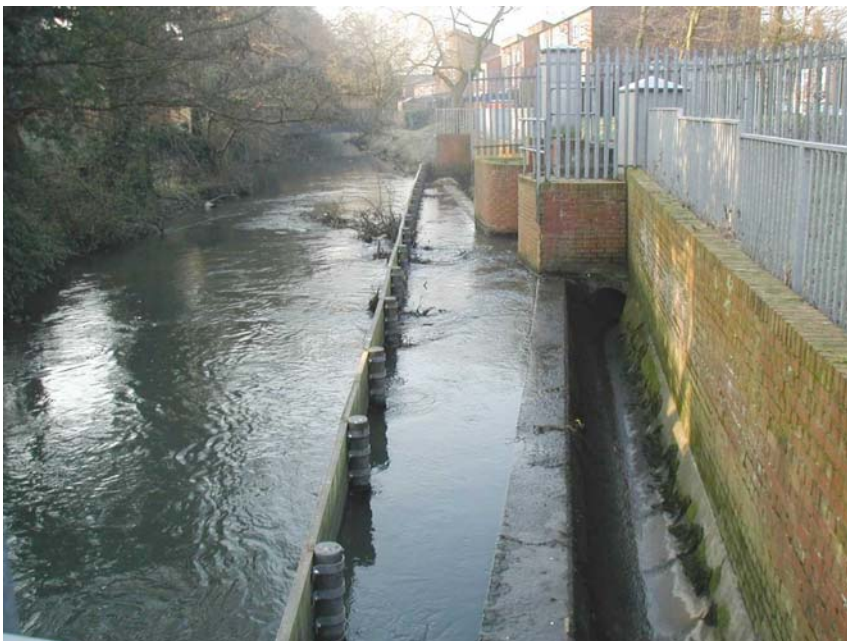
Figure AD2 - Side weir with fixed debris deflector

This side weir has a debris deflector that is just immersed in the water so as not to obstruct flow but to prevent debris getting washed over the weir where it could obstruct the small outfall channel.

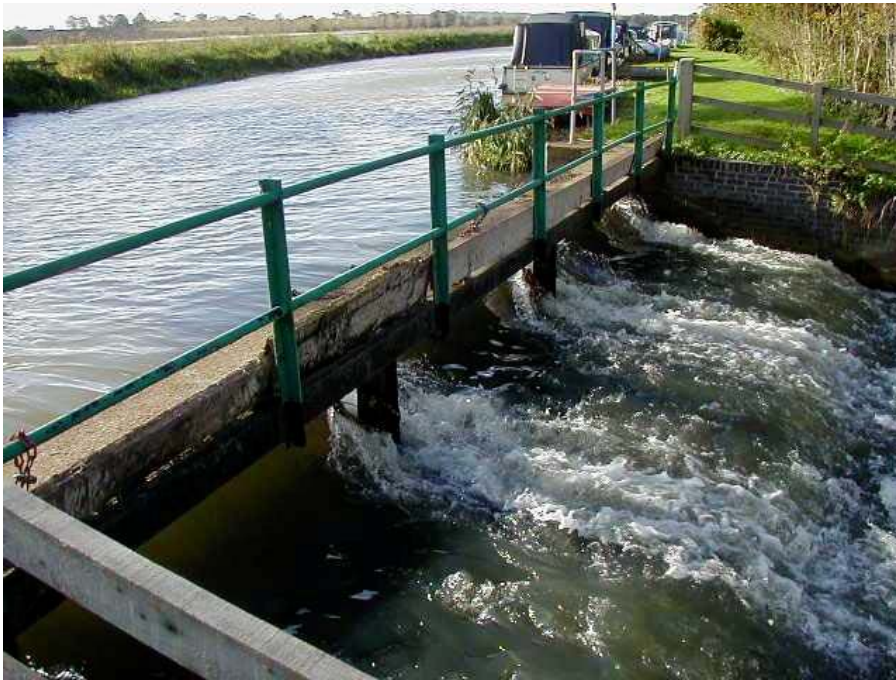
Figure AD3 - Side weir with narrow footbridge

Situations such as this are not uncommon, but it is appropriate to consider the risks posed by the narrowness of the bridge and the lack of handrail on both sides.

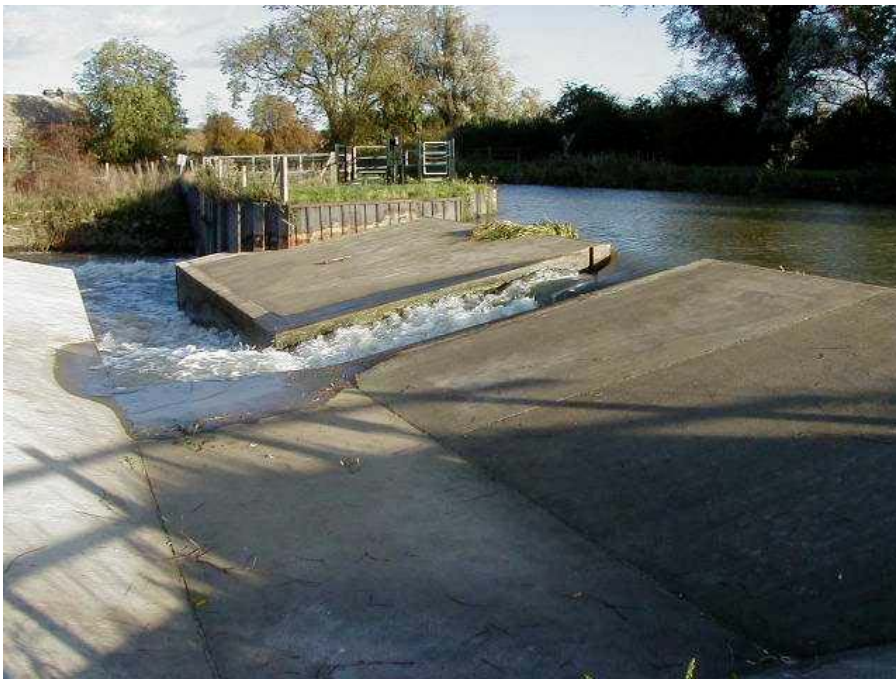
Figure AD4 - Side weir with fish pass

The effectiveness of this fish pass is questionable in view of the difficult approach conditions (shallow flow and sharp turn).

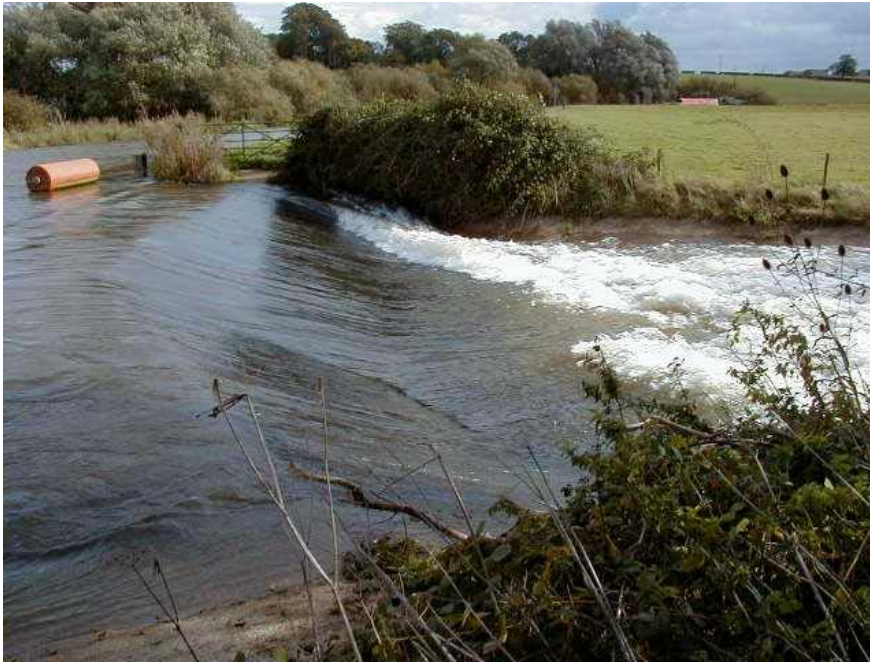
Figure AD5 - Side weir in operation

Note the hydraulic jump downstream of the weir glaxis.

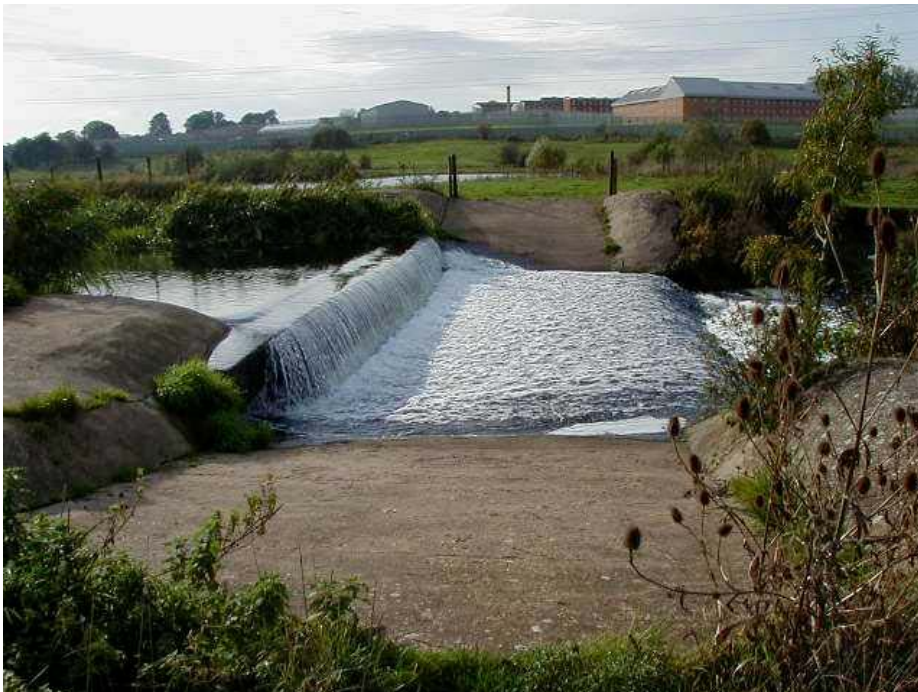
Figure AD6 - Weir with ford

The stilling basin for this weir also acts as a ford, providing vehicular access across the stream. Although safe in the conditions pictured, it is necessary to consider appropriate safety measures for flood flows (warning signs as a minimum).

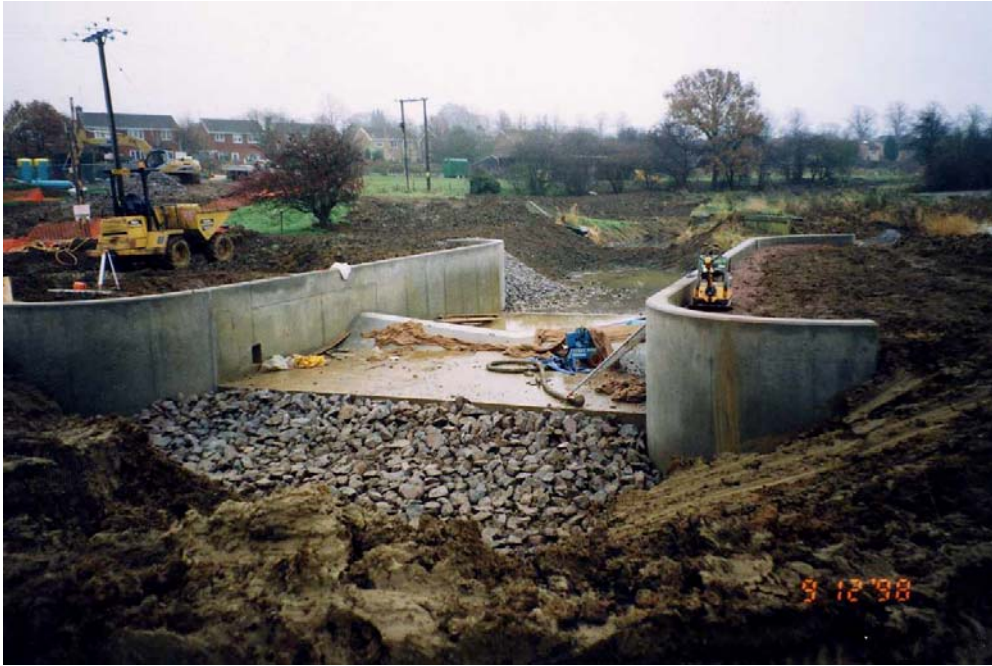
Figure AD7 - Construction of a flat-vee weir

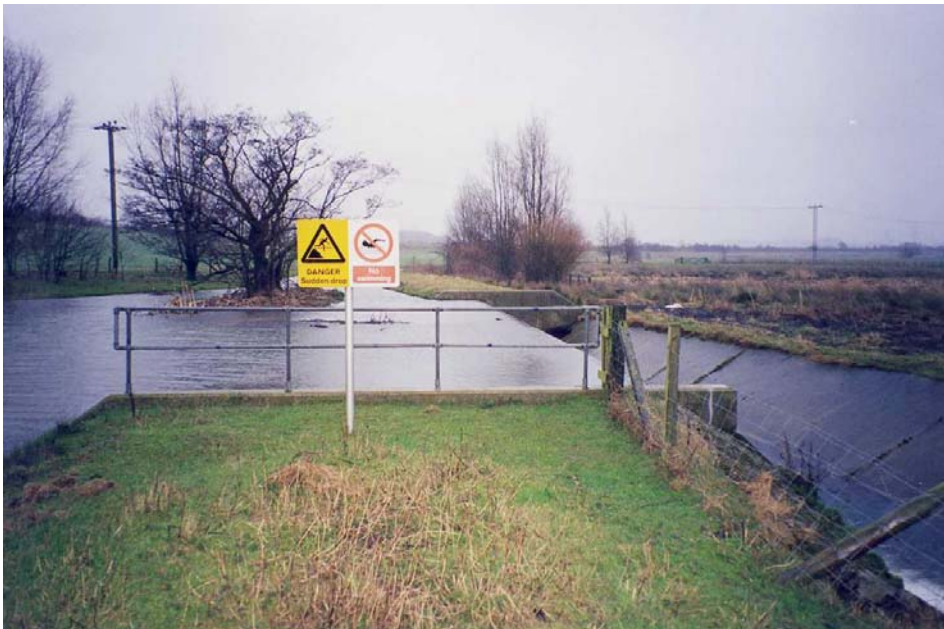
Figure AD8 - Warning sign and fencing

The dangerous condition presented by deep water upstream of the weir, and the large drop downstream might justify more secure fencing.

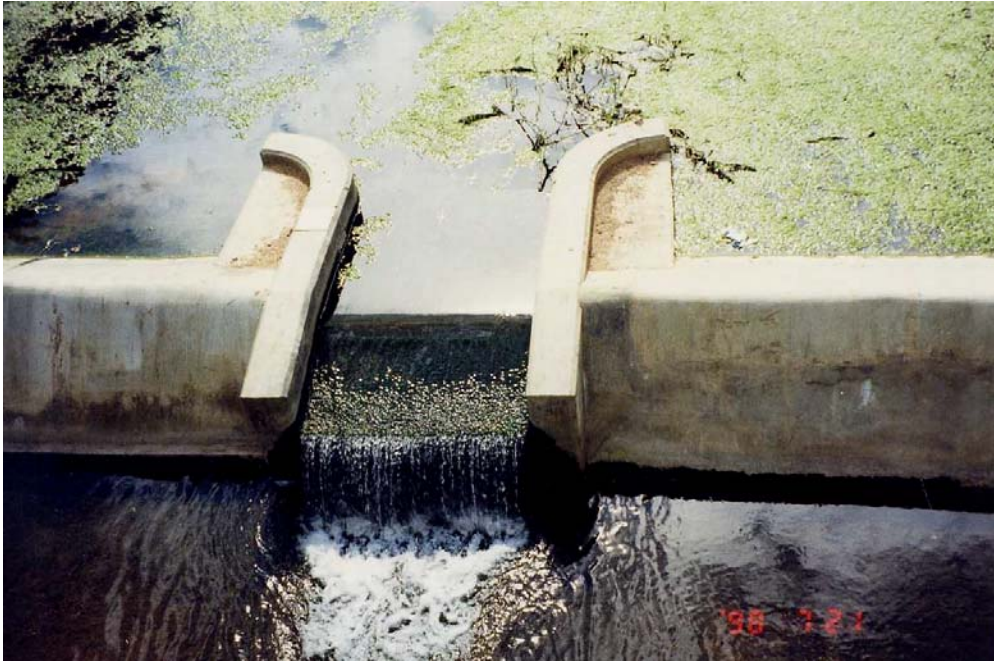
Figure AD9 - Weir with low flow notch

This notch has clearly been added to allow gauging of very low flows.

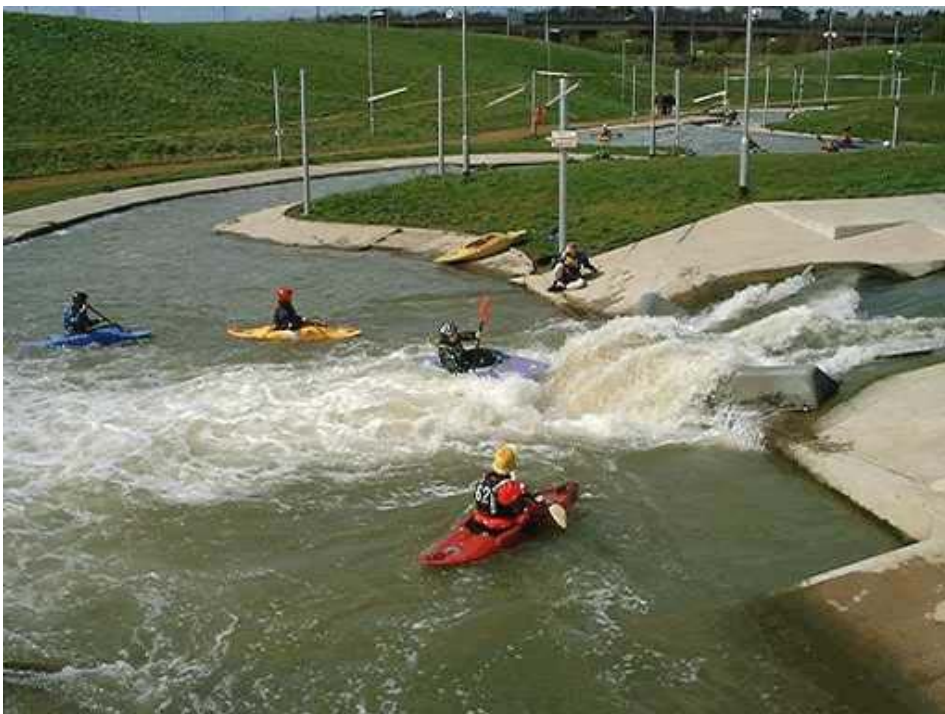
Figure AD10 - Variable configuration weir at the Nene White Water Centre, Northampton

The weirs on this custom-made white water canoe course can be adjusted to give different conditions to test the canoeists' skills.
