AUDIT SURVEYS IN THE NRA THAMES REGION

A report on the surveys carried out in 1992/93 to assess the retention and enhancement of
wildlife habitats during routine dredging operations

Angela M. Walker
April 1993

NRA THAMES REGION : AUDIT SURVEYS 1992/93

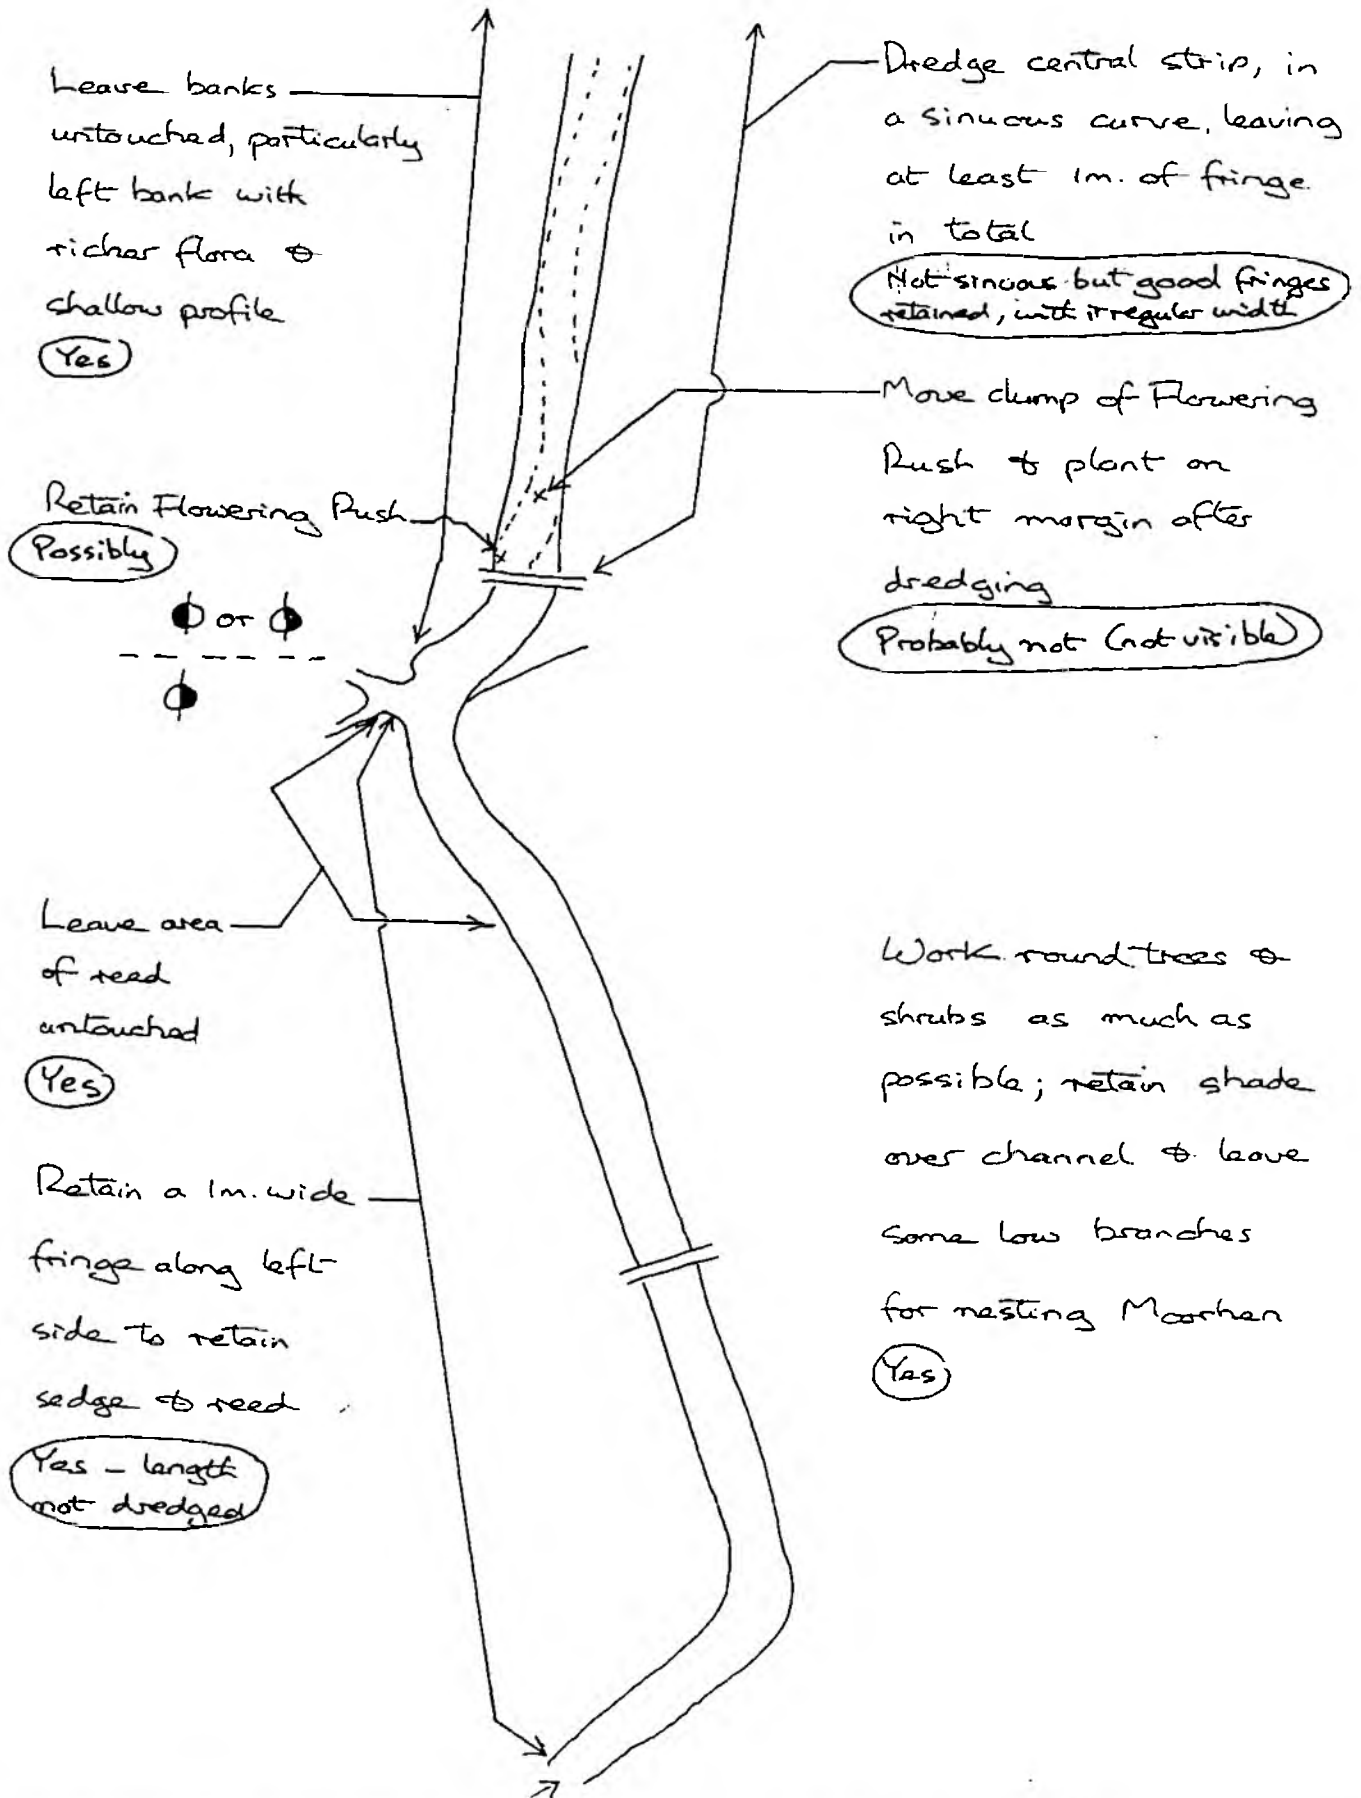
BISHAM BROOK DREDGING RECOMMENDATIONS ①

Care has been taken to work round the trees and shrubs and retain low branches. The partially pollarded willows at the downstream end of length 4 were not re-pollarded as this reach was not dredged.
